P62.30-2913-09

Shown on model 164.8 with engine 629

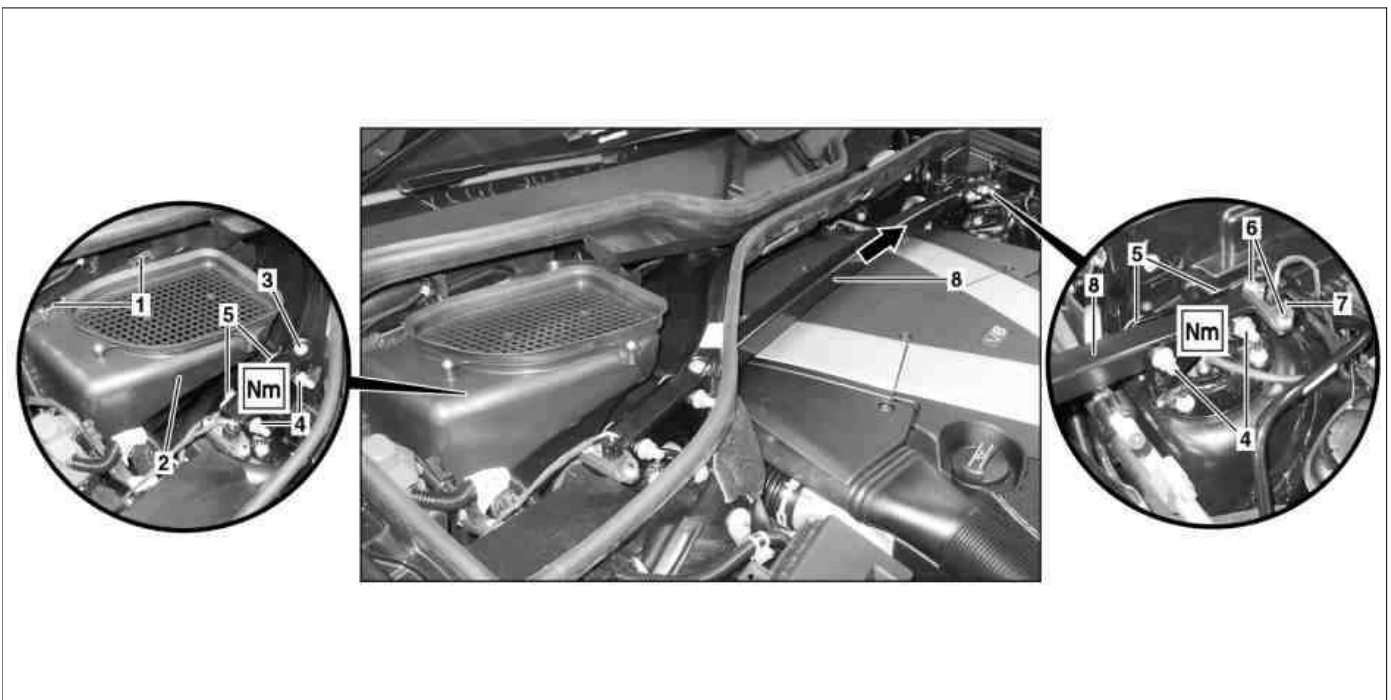
| 1 | Clips | 5 | Bolts |
| 2 | Air conditioning air inlet | 6 | Nuts |
| 3 | Screw | 7 | Left ADS sensor bracket |
| 4 | Nuts | 8 | Strut tower brace |

Remove/install		
1	Open engine hood		AR88.40-P-1000GZ
2	Loosen clamps (1), remove air conditioning air inlet (2) upward	<b>i</b> <b>Installation:</b> Bottom lug on air conditioning air inlet (2) should reach into corresponding guide.	
3	Unscrew nuts (6), place left ADS sensor bracket (7) to one side	<b>i</b> Do not disconnect left ADS sensor (7) electrically.	
4	Remove bolt (3)		
5	Unscrew nuts (4)	<b>Nm</b>	*BA62.30-P-1005-02D
6	Remove bolts (5) toward rear	<b>i</b> <b>Installation:</b> Wax bolted connections.	*BR00.45-Z-1018-05A
7	Slightly raise strut tower brace (8) on left side and remove left toward (arrow)	<b>i</b> <b>Installation:</b> Check whether rubber seal, through which the strut tower brace (8) runs, is correctly seated.	
8	Install in the reverse order
