13.10.09	The installation location of the rear SAM control unit (N10/8) has changed	As of model year 2010	
----------	--	-----------------------	--

Remove/install		
	Information on preventing damage to electronic components due to electrostatic discharge	All models	AH54.00-P-0001-01A
1	Connect STAR DIAGNOSIS and temporarily store basic data from rear SAM control unit (N10/8) in STAR DIAGNOSIS	<p> Only when installing a new rear SAM control unit (N10/8).</p> <p> Installation: Transfer the temporarily stored basic data to the new rear SAM control unit (N10/8).</p>

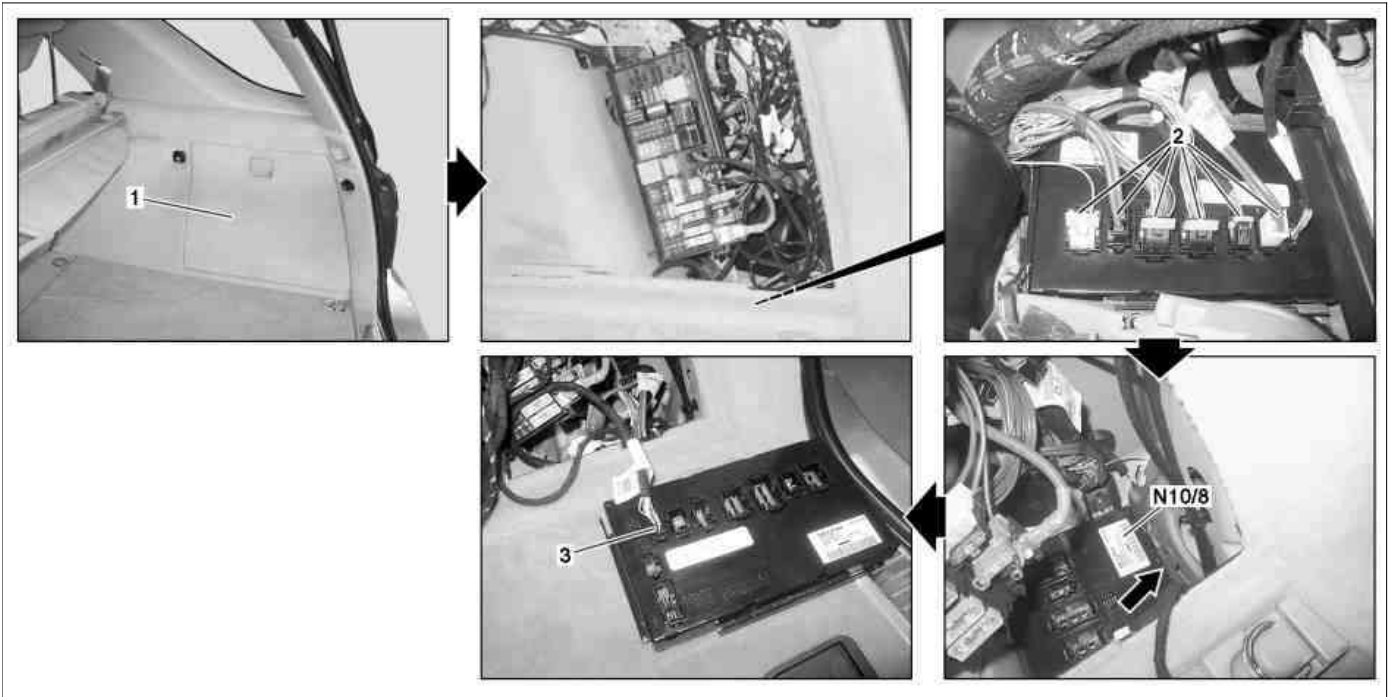
P54.21-2479-09

Shown on model 164.1 up to model year 2010

- 1 Cover
- 2 Electrical connectors

- 3 Electrical connector
- N10/8 Rear SAM control unit

AD	Connect STAR DIAGNOSIS and read out fault memory		AD00.00-P-2000-04A
2.1	Remove cover (1) from load compartment side trim

Only on vehicles as of to model 2010.	
3	Separate electrical connectors (2)		
4	Unclip rear SAM control unit(N10/8) upwards out of the retaining clamps and remove

Installation: Pay attention to line routing.	
5	Disconnect electrical connector (3)		
6	Remove rear SAM control unitN10/8		
7	Install in the reverse order

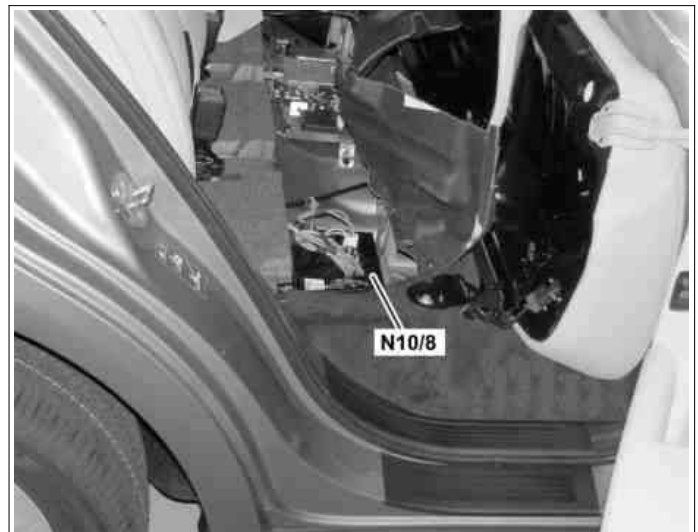
P54.21-3044-11

Shown on model 164.1 as of model year 2010

N10/8 Rear SAM control unit

Only on vehicles up to model 2010.	
2.2	Fold down rear seat on the passenger-side
