AC BLOWER INOPERATIVE DTC 912F87 IN ACC "THE FRONT BLOWER REGULATOR HAS A MALFUNCTION. THE MESSAGE IS MISSING"

DEALER TECH TOPICS; OCTOBER 2014

Reference Number(s): TT 10/14,Â Date of Issue:Â October 2014

MERCEDES-BENZ: Model 166

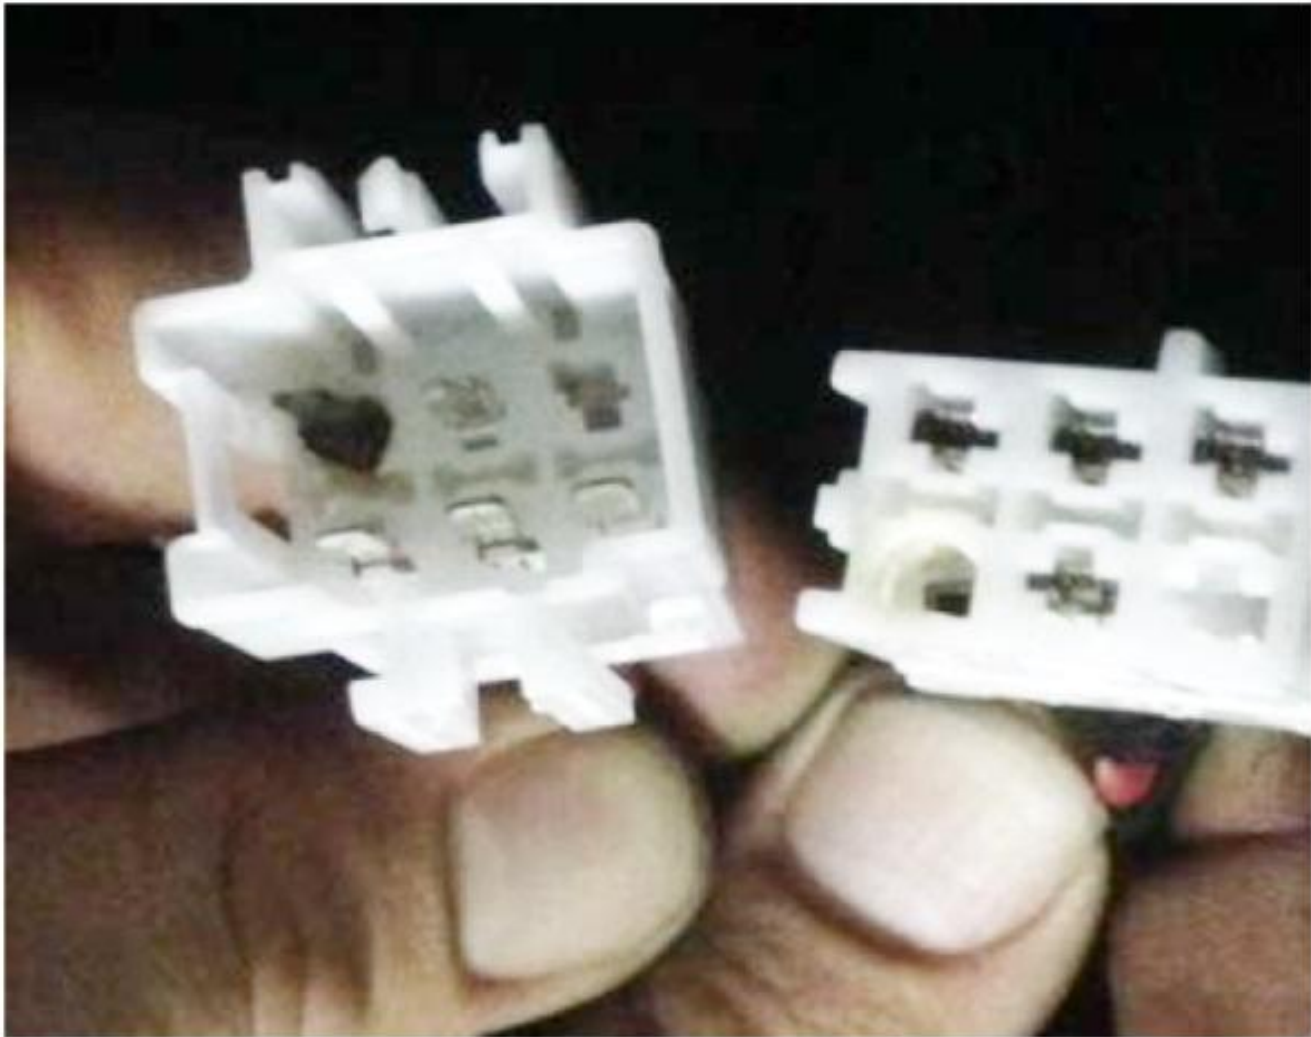
Possible connection failure at connector X18(2) pin 2.

CORRECTION

A0375459428: 6 Pin Housing

A2205456928: 6 Pin Bushing Housing

A0115450726: Female SLK2.8 4.0mm² Pin

A0355457628: Male SLK2.8 4.0mm² Pin

NOTE: If other pins are damaged, refer to wiring diagram for wire size and laminated sheet in Wiring Harness Repair Kit for correct SLK2.8 pins.
