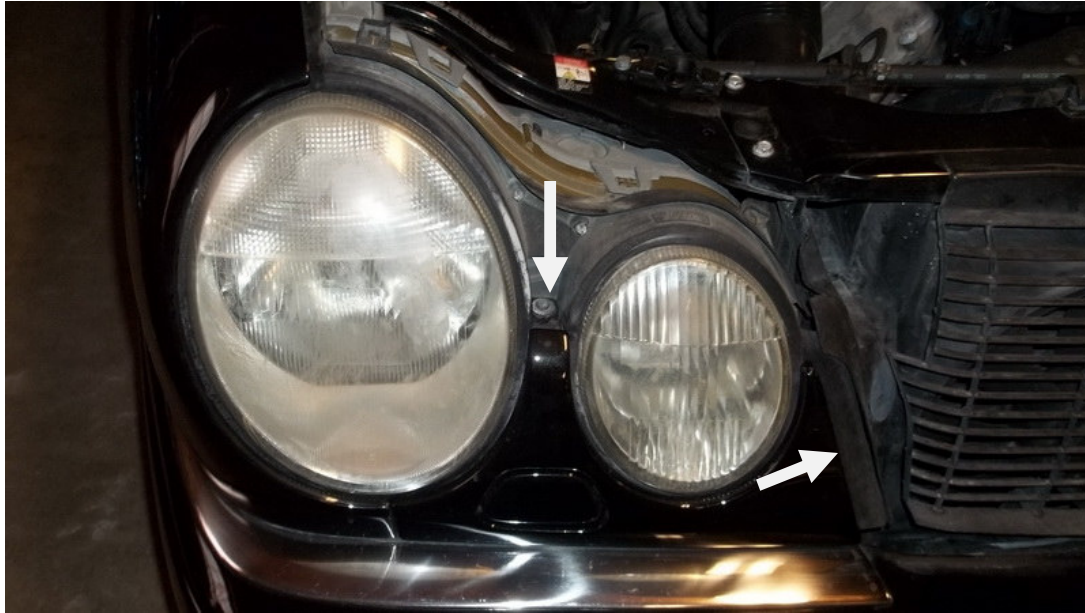
Remove 2 each 8mm hex-head screws. One is hidden under the rubber stripping.

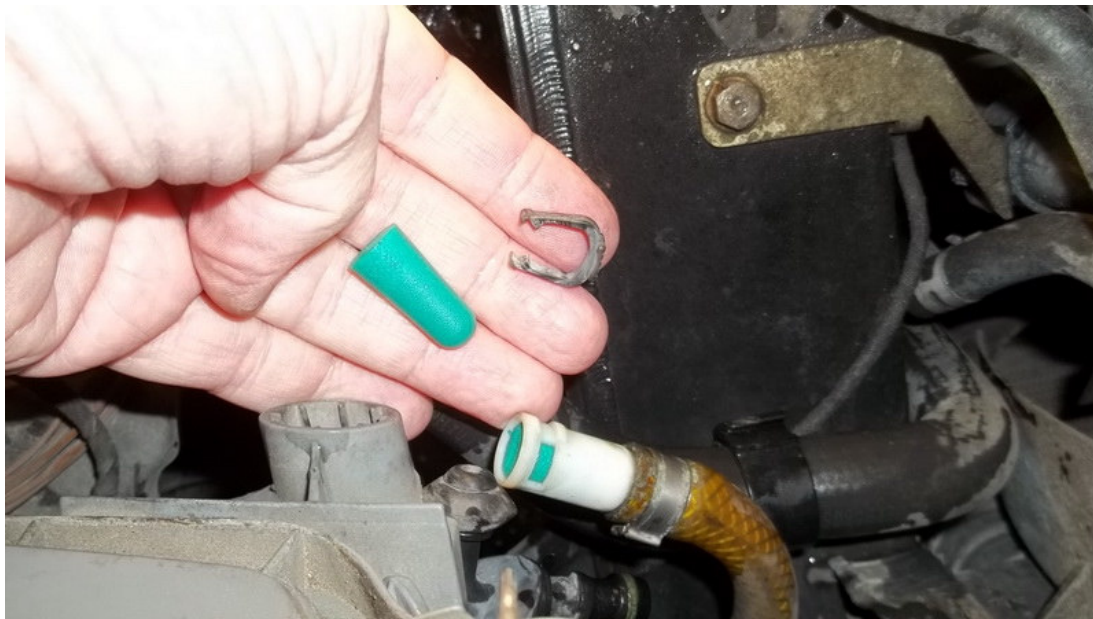
Disconnect washer line at back of assembly. Pull clip, remove line, rapidly plug with foam ear plug (easily removed with small screwdriver when you reconnect the line).

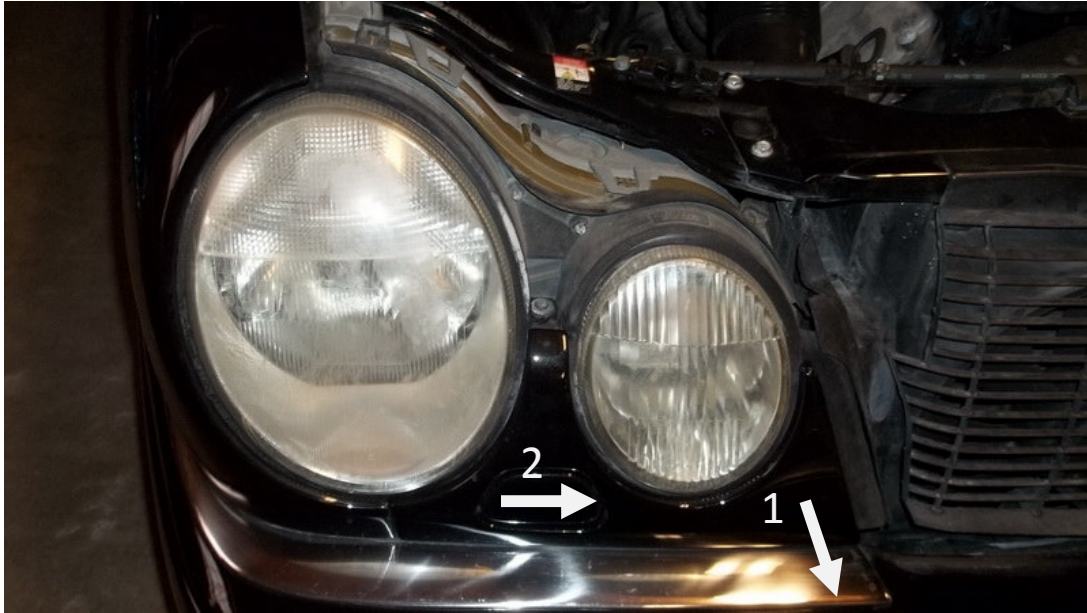
Pull out (1), then over (2), to release tab hidden under headlight. Take your time, the headlight washer gets in the way. Note: the rubber weather-stripping on the bottom of the body work prevents you from removing the piece until the next step!

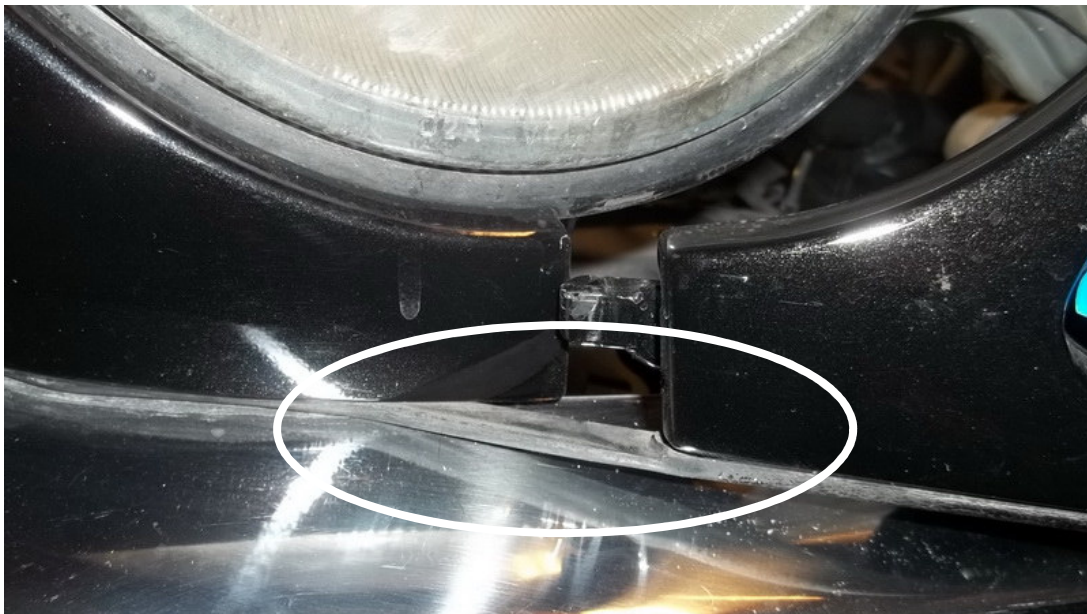
Do not tear the rubber piece  
Holding the body work in place.

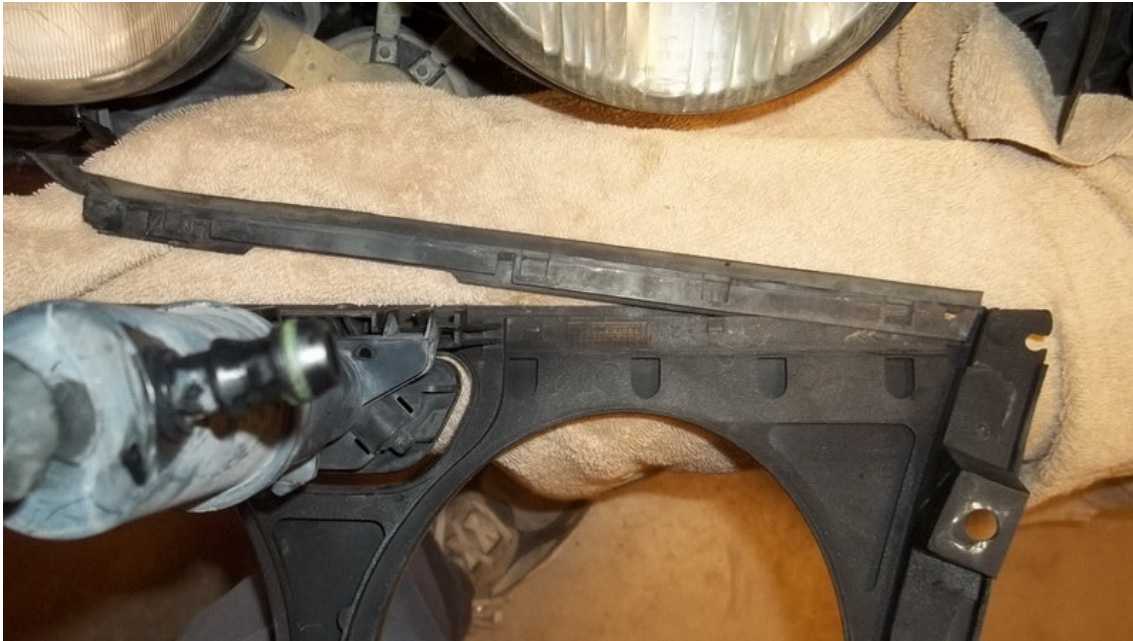
Use towel to protect paint, remove gasket at bottom, set the body piece aside.

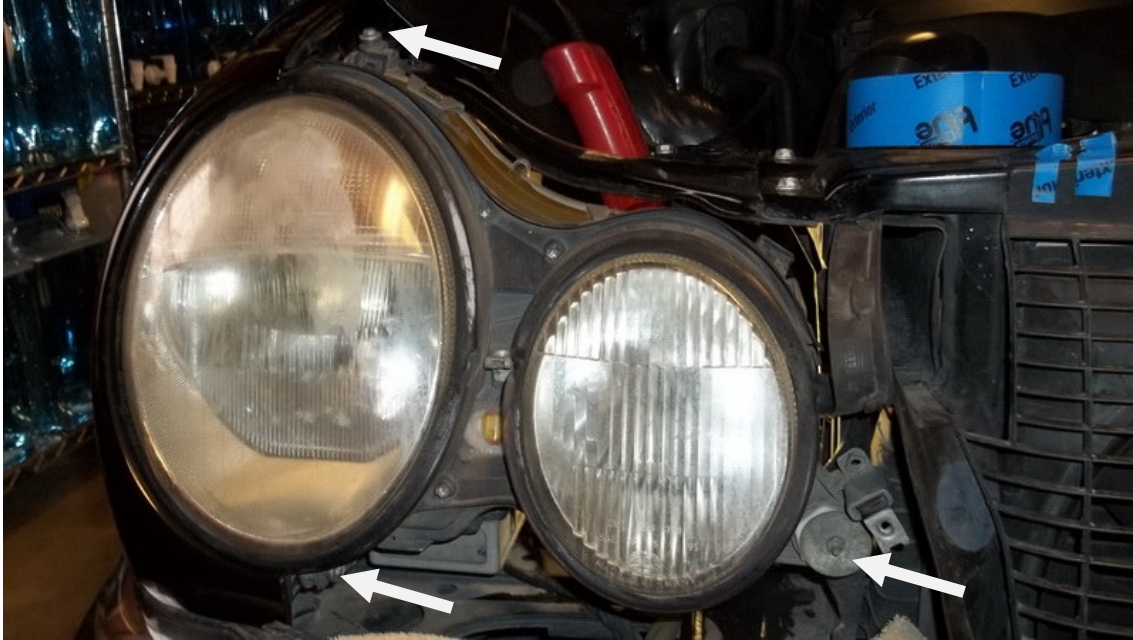
Remove two 8mm hex-head bolts and one 8mm hex-head nut with fender washer.

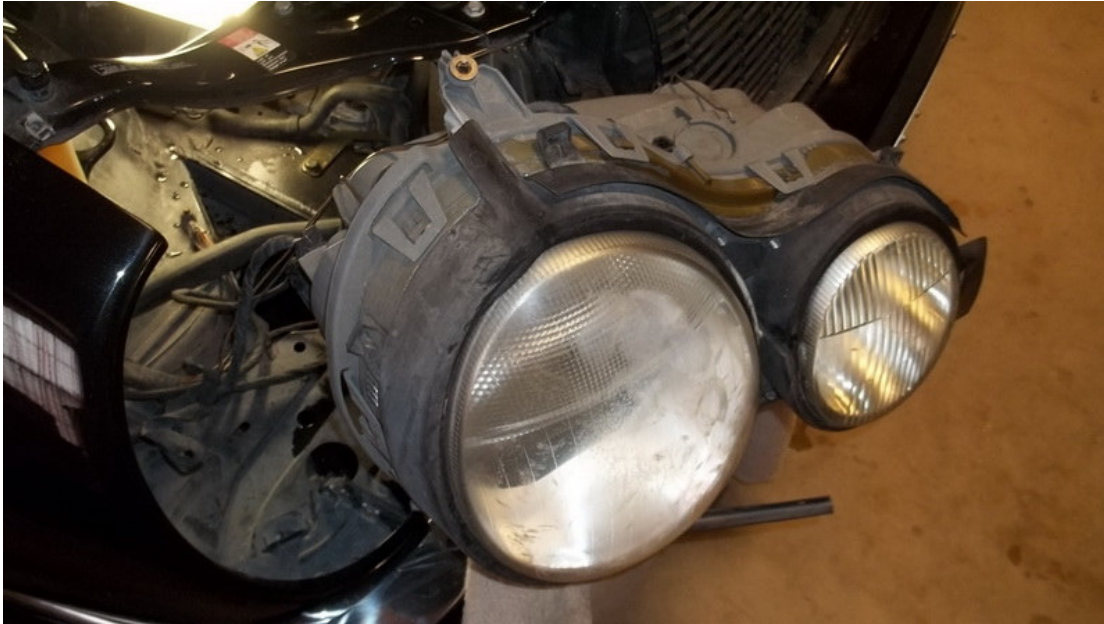
Carefully slide headlight assembly out.

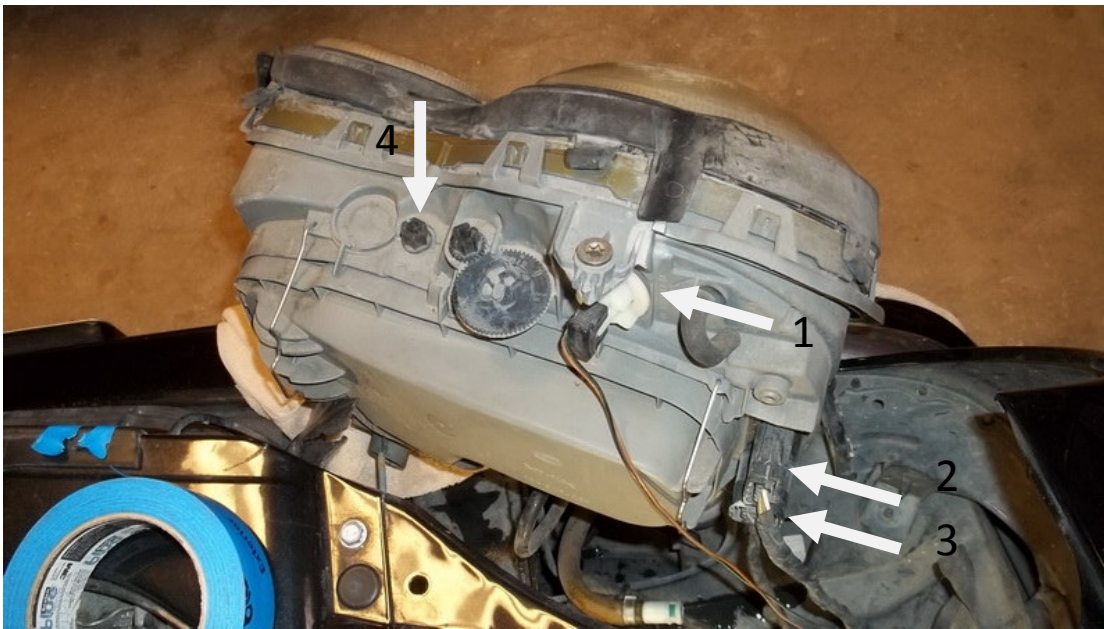
Remove turn signal socket (1), light wiring connector (2), and stepper motor connector(3). (4) points to headlight adjuster that will be used to remove stepper motor.

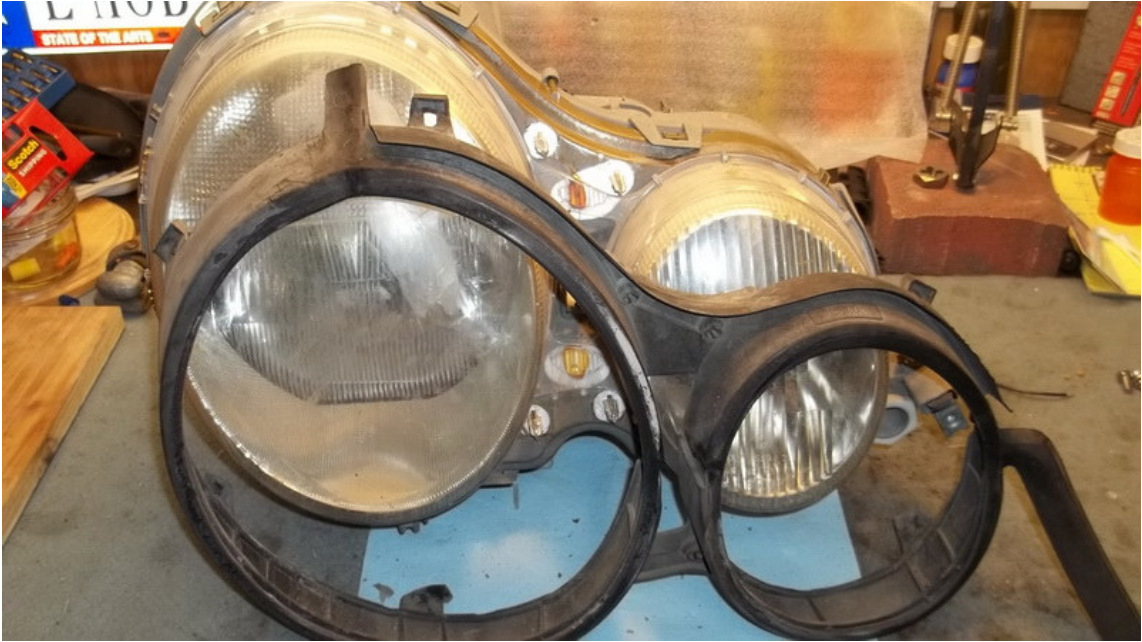
Remove gasket.

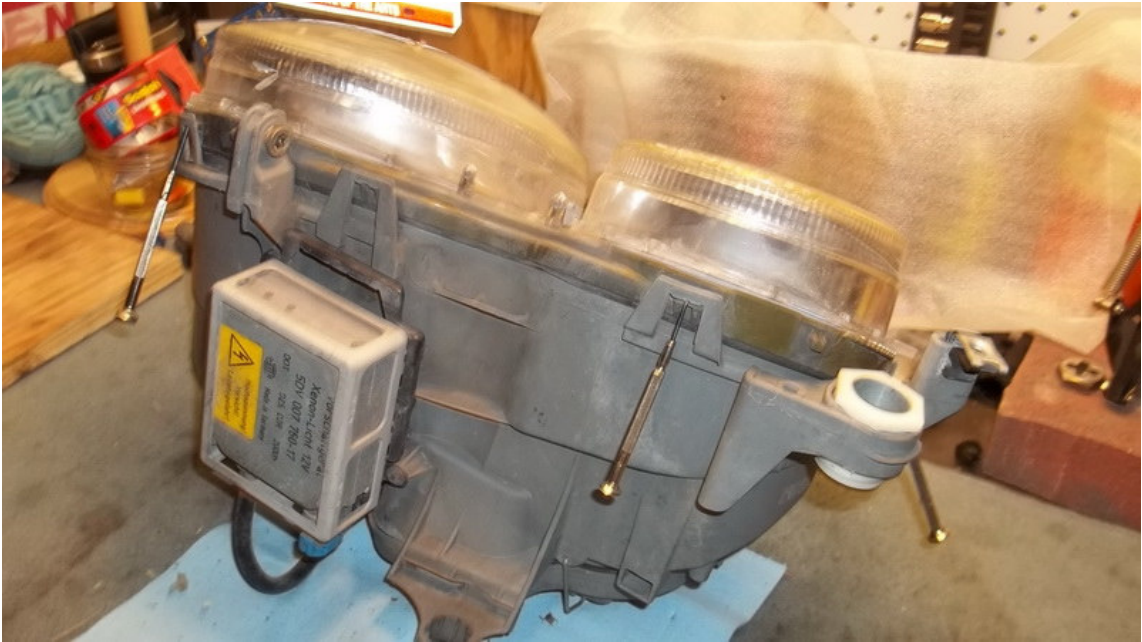
Very carefully release tabs using screwdrivers. Work slowly and, as multiple tabs are released, begin to separate the lens assembly from the housing.

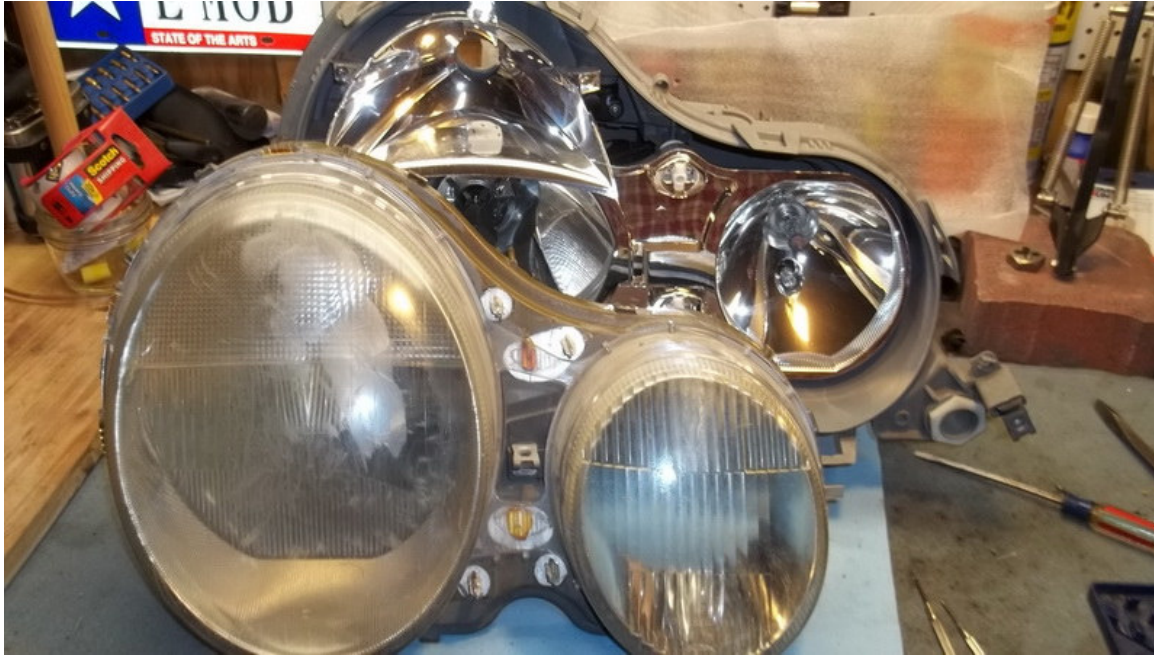
Lens separated at last!

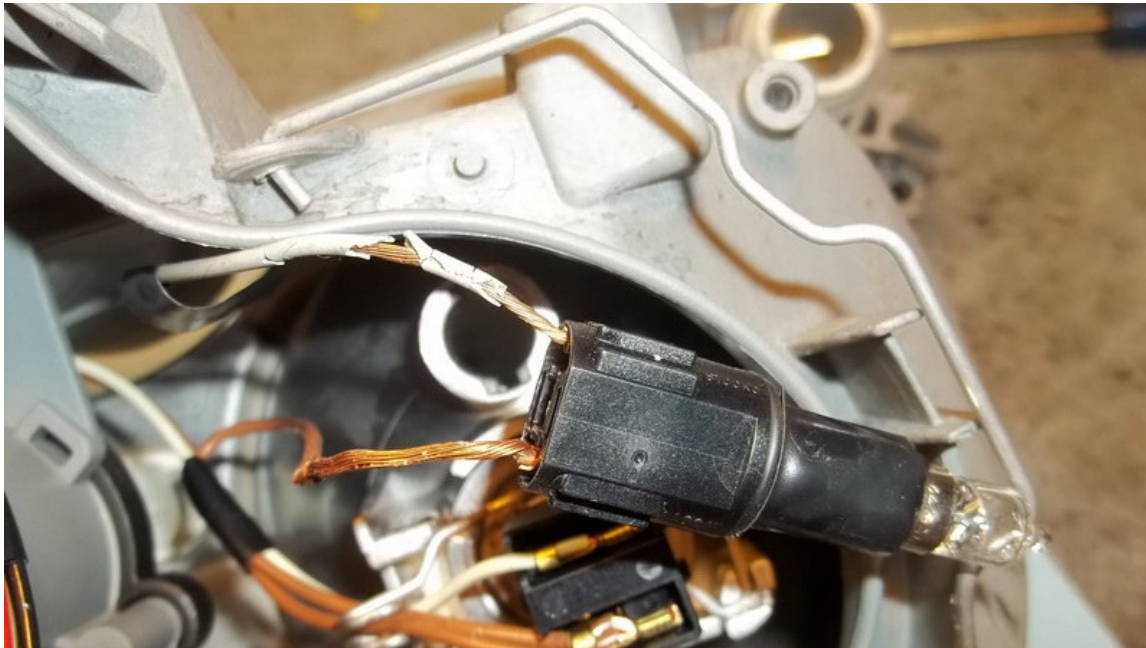
Running light insulation looks very bad. Left over batch from the mid-90's?

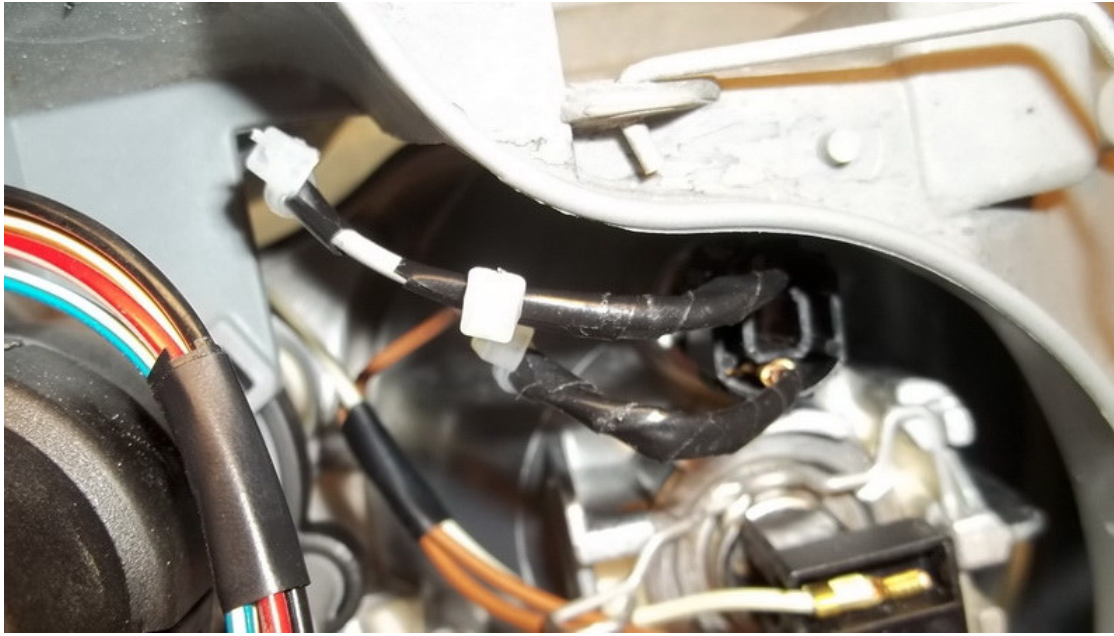
Wires wrapped in electrical tape and tie-wrapped to prevent tape from unraveling.

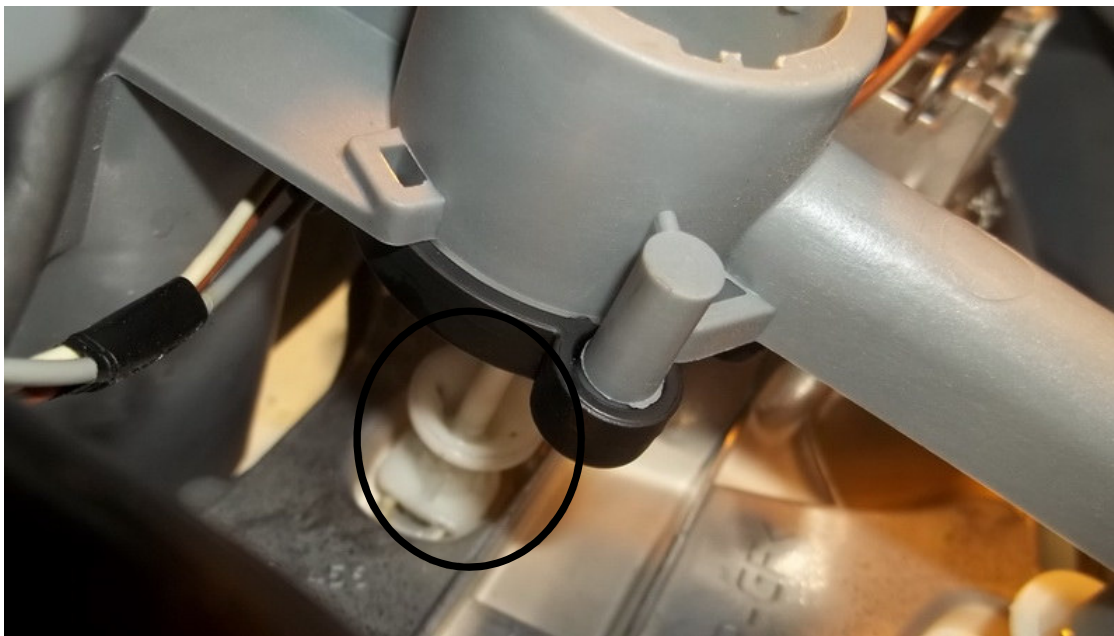
Plastic piece in circle is fixed to reflector, upper end threads into the headlight adjuster stepper motor. It can be removed but should stay in place to remove stepper motor. Note: this photo was taken after the stepper motor was removed. Count visible threads before removal so you can get headlight alignment close on reassembly.

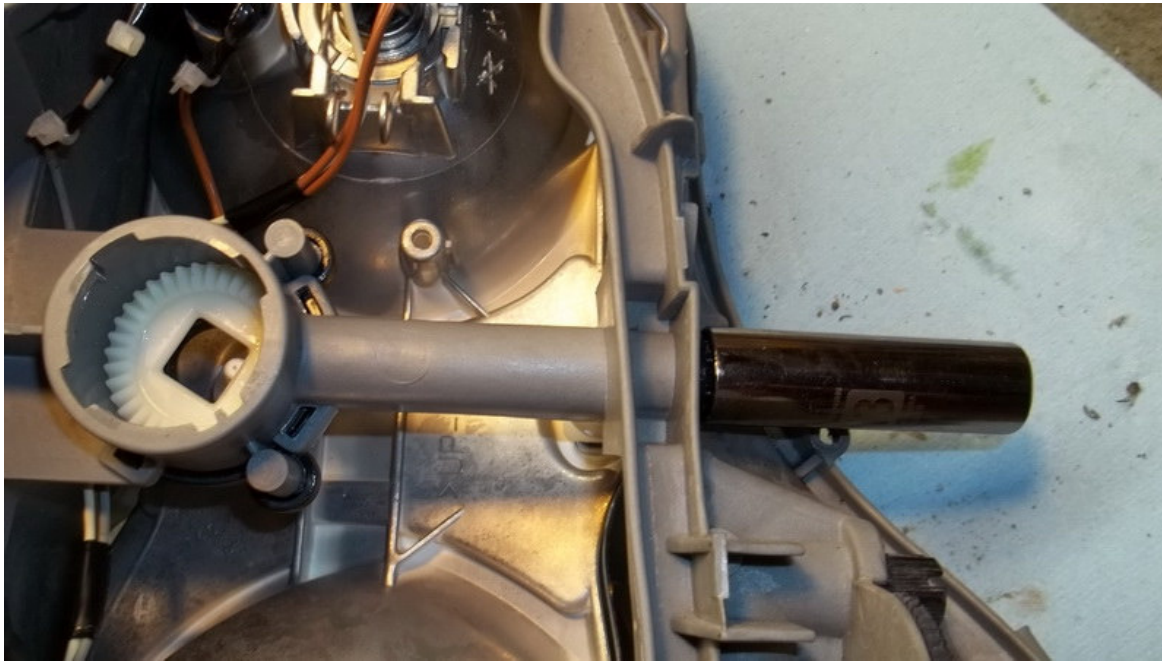
Out of sequence photo: use 13mm socket to rotate adjuster CCW (anti-clockwise) until stepper motor assembly unthreads from the threaded portion of the plastic stud. This photo was taken after the stepper motor was removed.

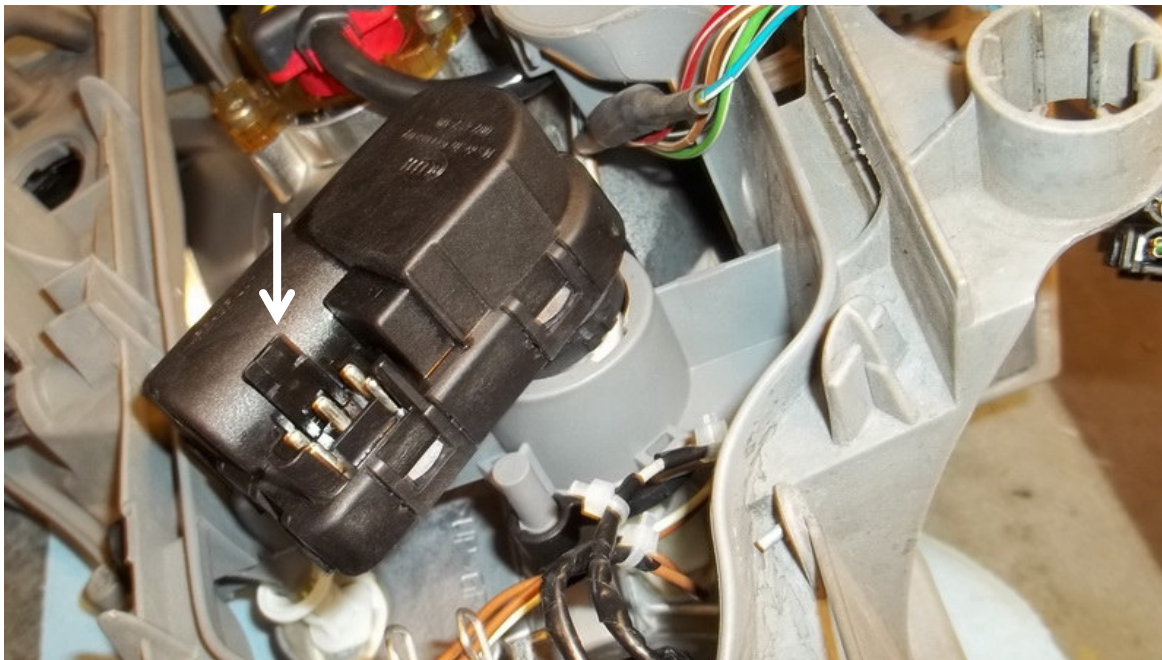
After unthreading the plastic stud from the stepper motor as above, disconnect the harness by pushing tab towards motor body, remove socket, then rotate the stepper motor 1/4 turn CCW, and remove.

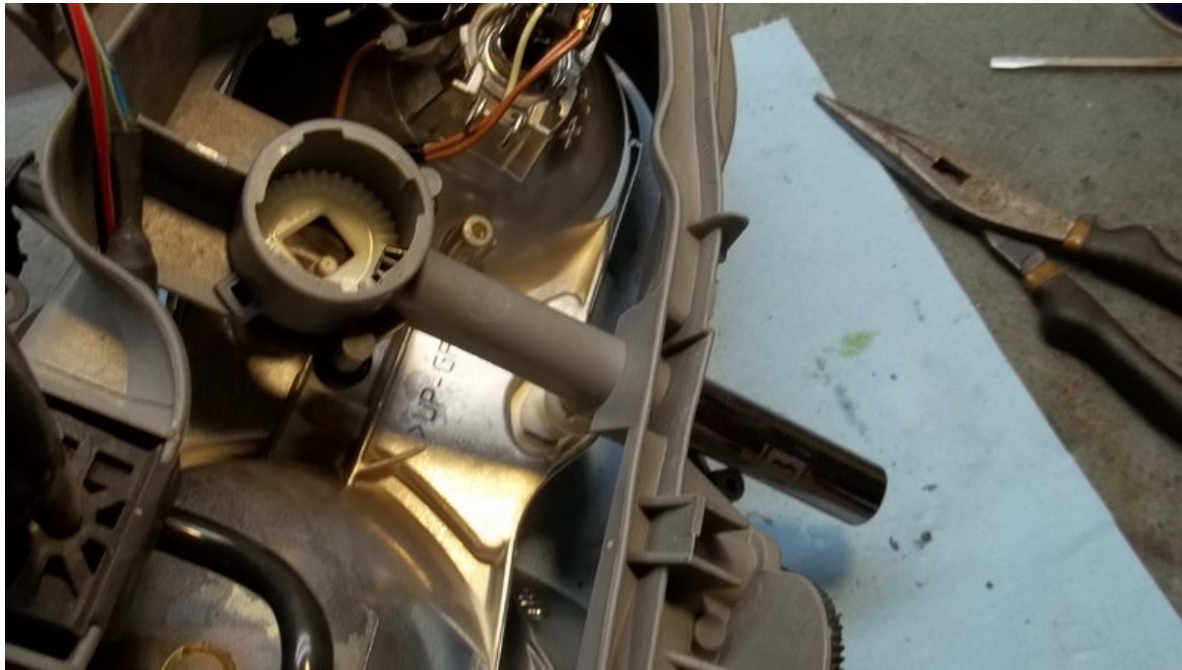
Shaft was very difficult to turn. Lots of CLP (Cleaner-Lubricant-Protector) and much rotation to free the shaft of whatever restricted its movement. This was what was causing the fault code on the diagnostic system.

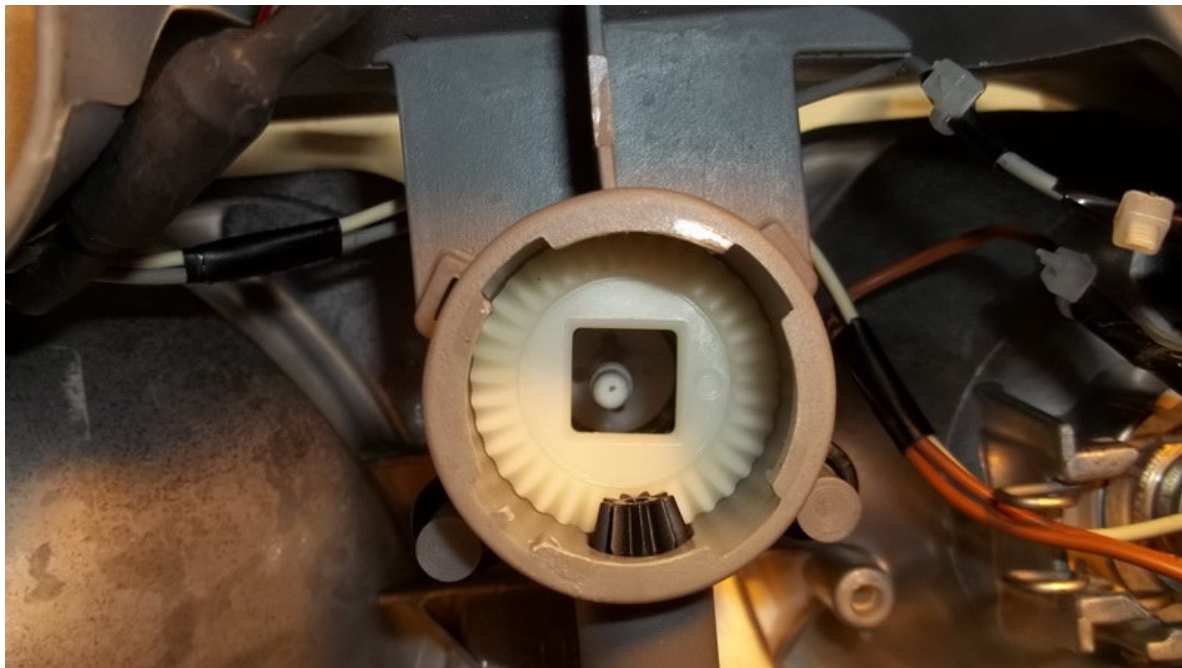
Stepper motor assembly drops through the ring gear. The threaded stud attached to the reflector can be seen in the center. Lube threads lightly. Insert stepper motor, rotate CW  $\frac{1}{4}$  turn, then turn the manual adjuster shaft CW using the 13mm socket to thread the stepper motor assembly onto the plastic stud until the same number of threads are visible as before disassembly.

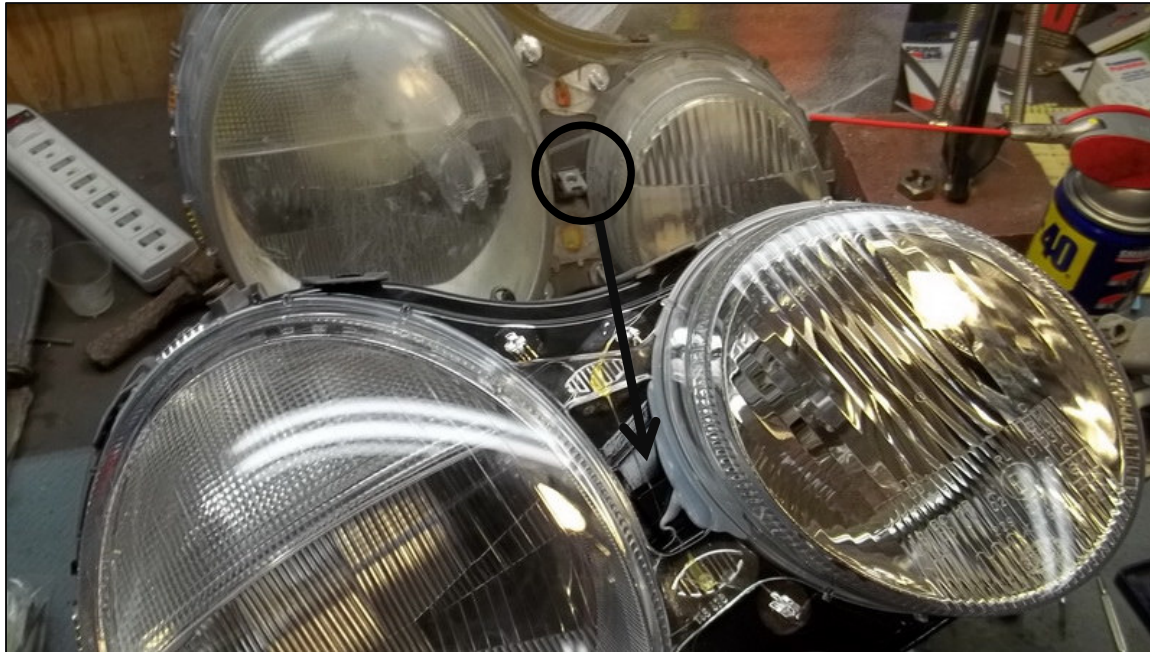
Lens installed on assembly. Don't forget to transfer the bracket (circled) from the old to the new.

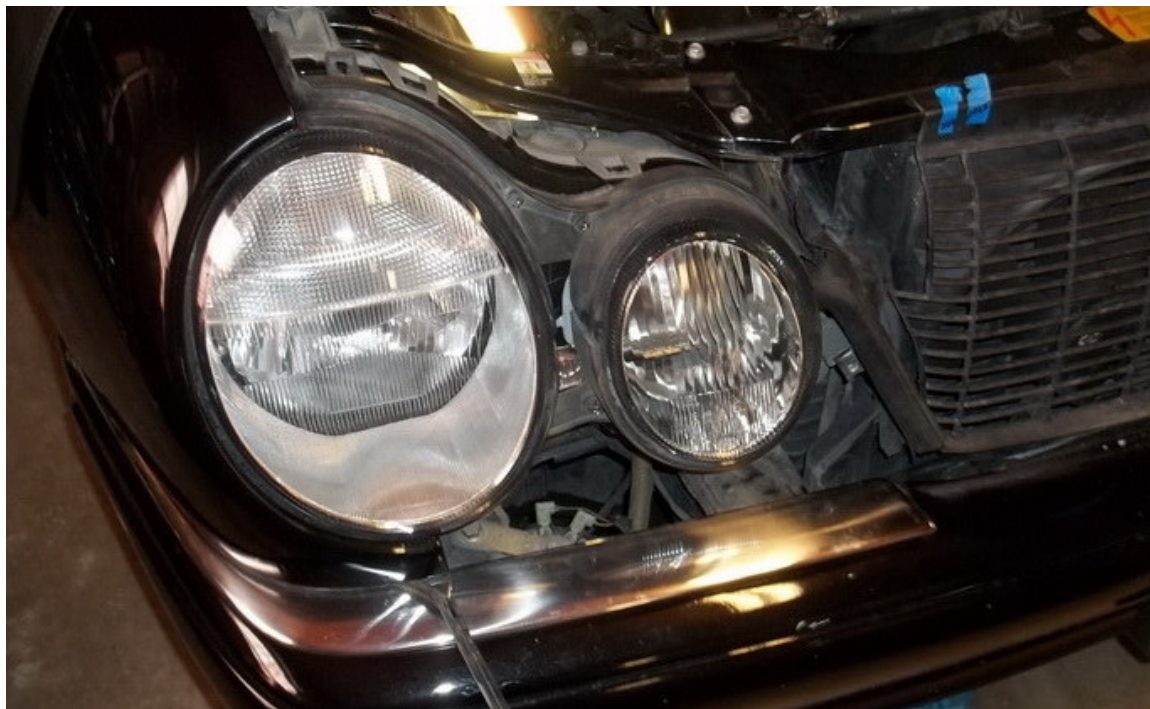
Assembly is reverse of disassembly. I cleaned all connectors with "Safety Wash II", then mated/demated the connectors multiple times to "wipe" the pins and sockets. Followed up with WD-40 to prevent water intrusion and corrosion.

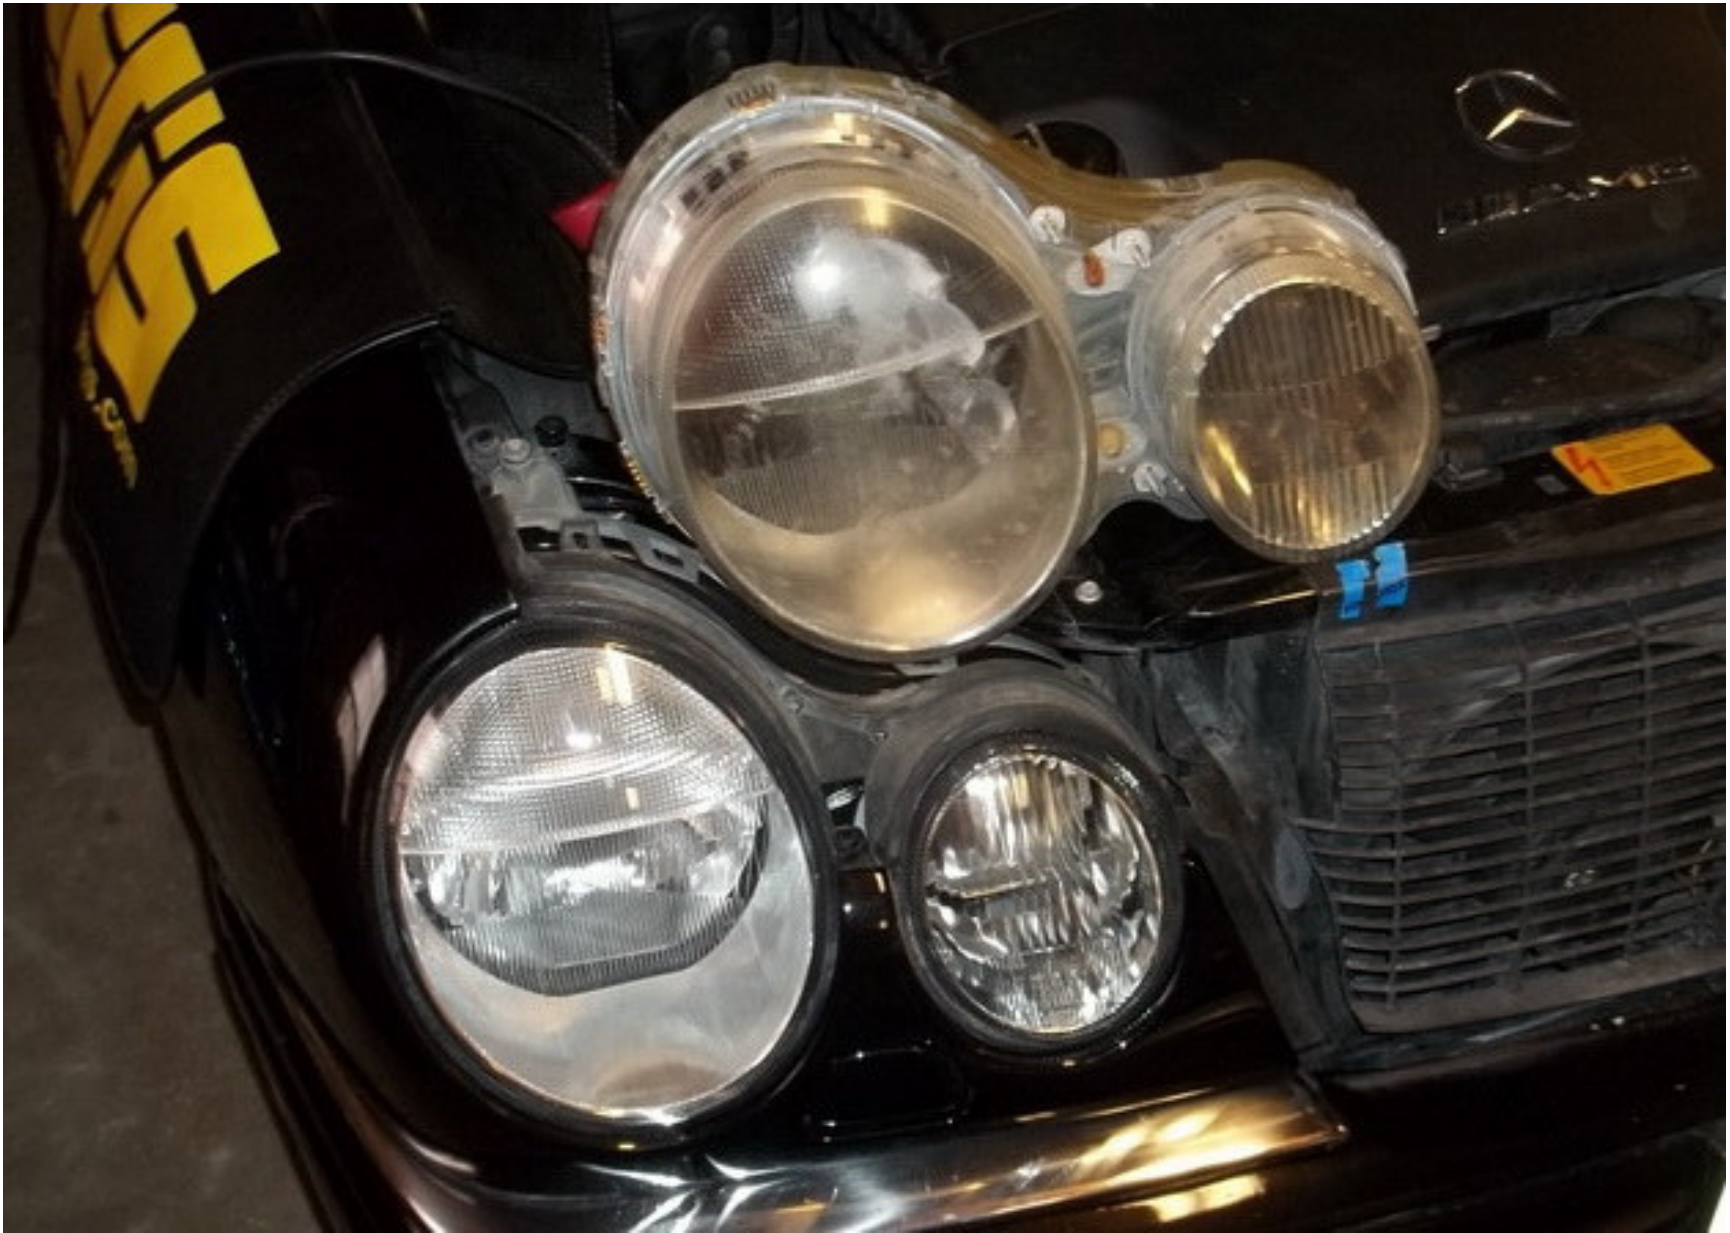
Before and after. Total time: ~ 2 ½ hours.
