30 December 2015, 166,829 kilometers – 1999 E55

VIN: WDBJF74H1XA.....

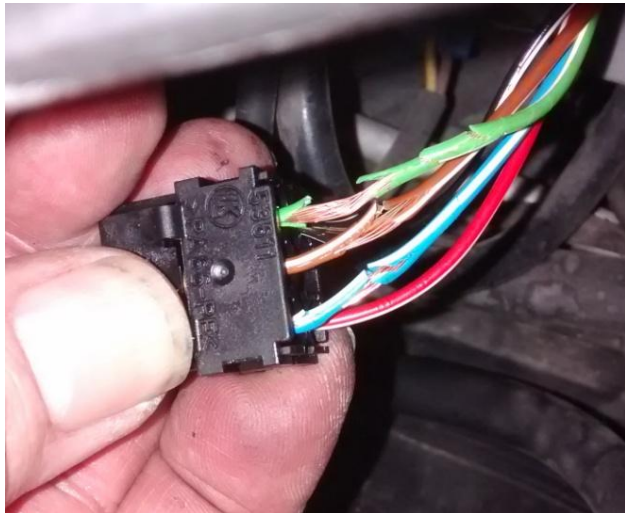
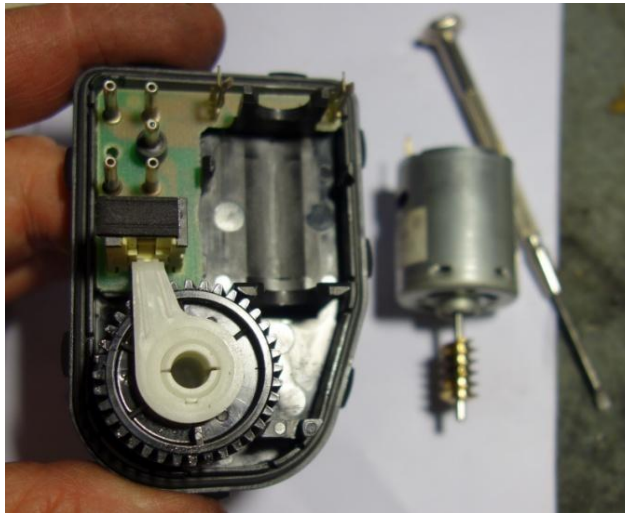
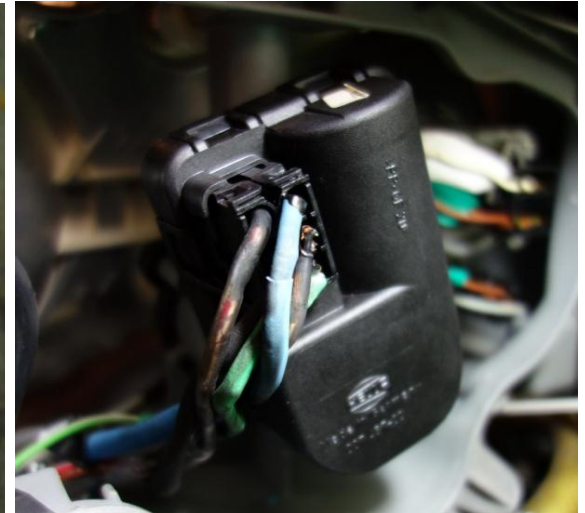
-Left front headlight stepper motor showing error codes; not adjusting even with diagnostic system. Opened both headlights, insulation flaking off of stepper motor wires; will replace wires next summer, for now just lifted tabs on side of connectors, opened front and rear of connector, and slipped shrink tubing over the wires.

-Final diagnosis, oxidized connectors on stepper motor prevented reliable operation. Removed motor; burnished connector and motor contacts on circuit board with brass brush. System operated normally after this.

-Reinstall: reach under stepper motor and guide reflector's threaded rod into stepper motor threaded socket while holding reflector to rear. Simultaneously use 13mm socket to rotate headlight alignment vertical aim point knob to thread stepper motor threaded socket onto threaded rod

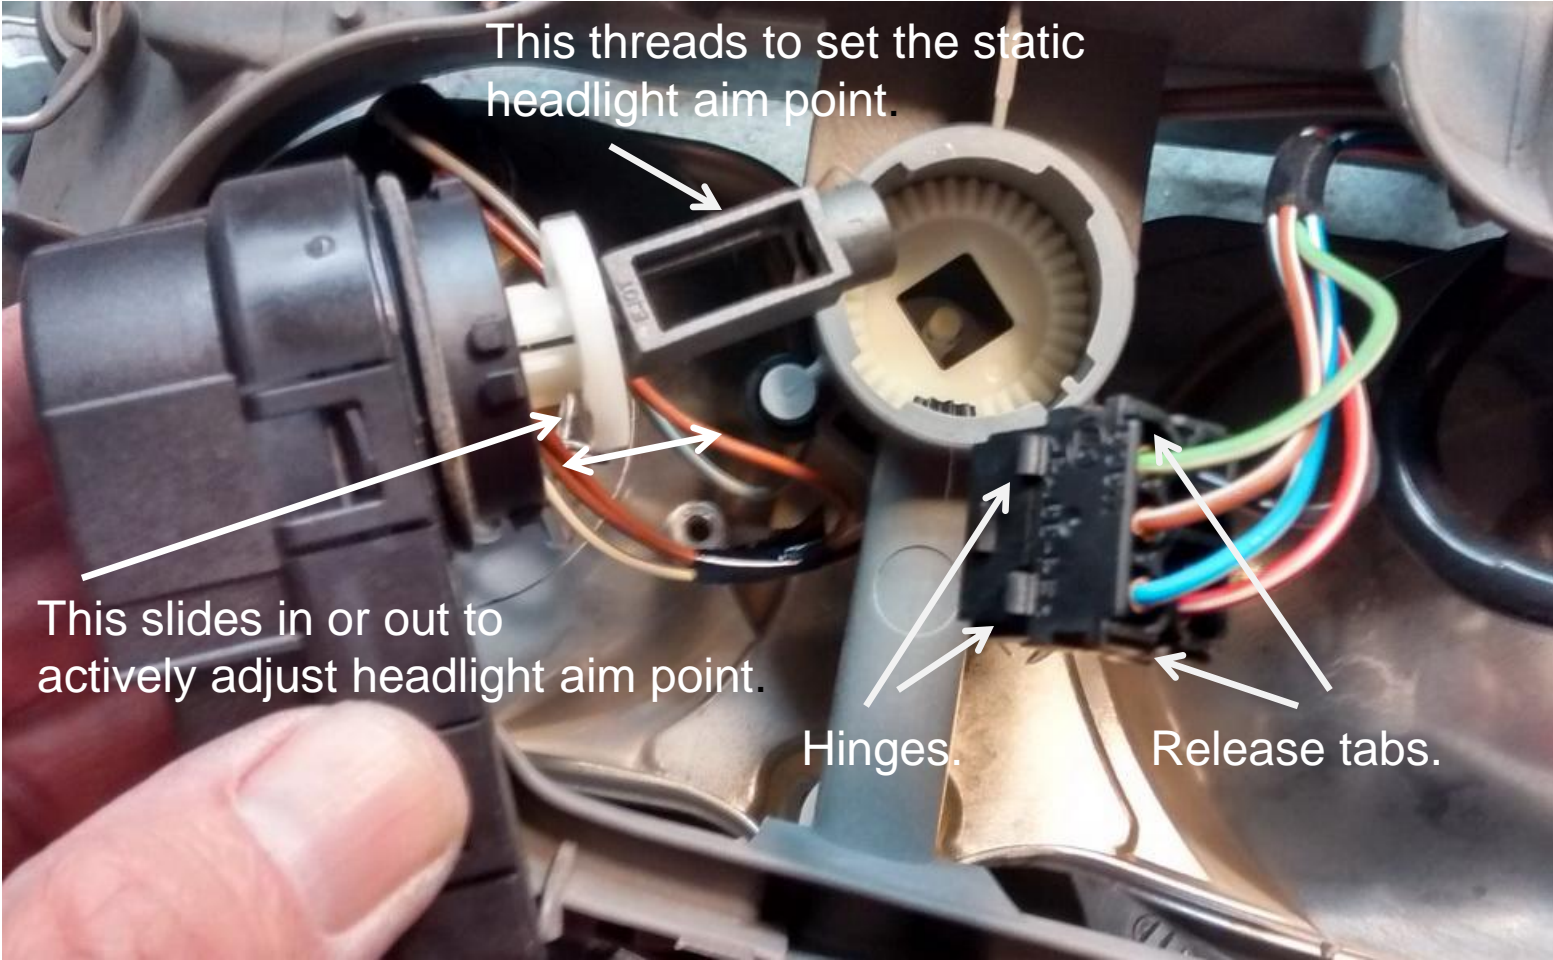
This threads to set the static headlight aim point.

This slides in or out to actively adjust headlight aim point.

Hinges.

Release tabs.
