General information

Seat cover components (model 211)

Comfort systems

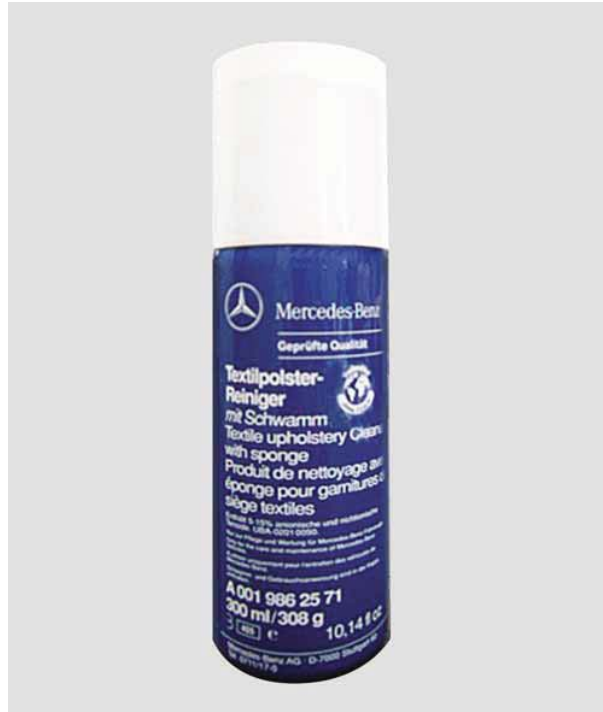
P91.00-2238-00

Textile upholstery cleaner

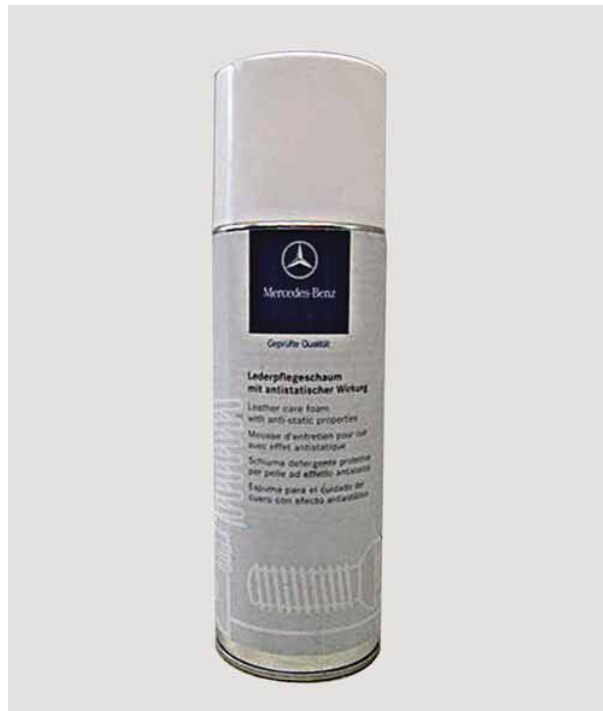
P91.00-2239-00

Leather care foam

To remove any residual soiling, apply Mercedes-Benz leather care foam to the entire seat and then work it in gently after it has dried.

Leather can become electrostatically charged. To prevent this, it is necessary to treat it regularly with Mercedes-Benz leather care foam.

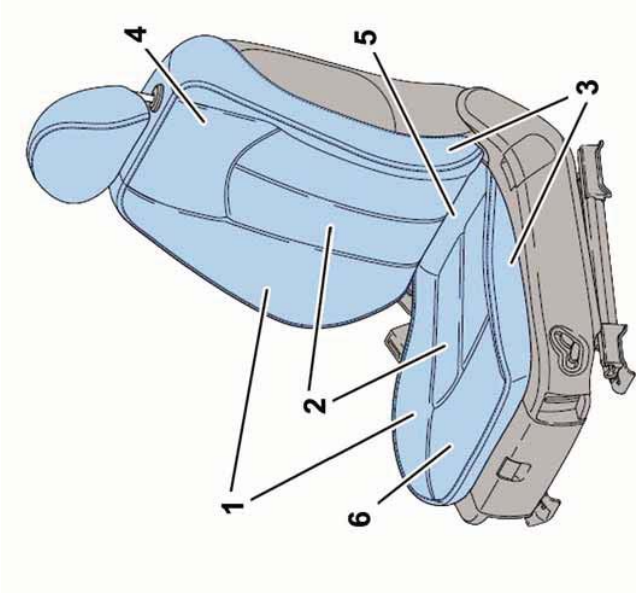
P91.10-3212-00

- 1 Side bolsters
- 2 Seat center panels
- 3 Seat rims
- 4 Upper beaded section
- 5 Rear beaded section
- 6 Front beaded section

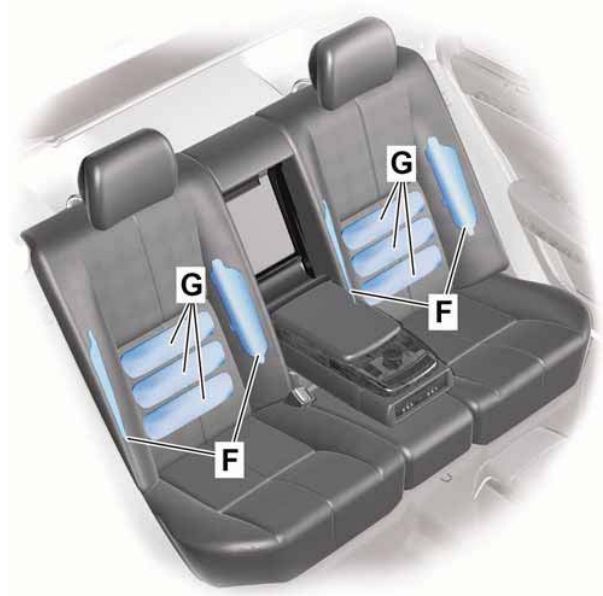
P91.12-3150-00

Location of rear seat air cushions

- F Side area of backrest
- G Lumbar area of backrest

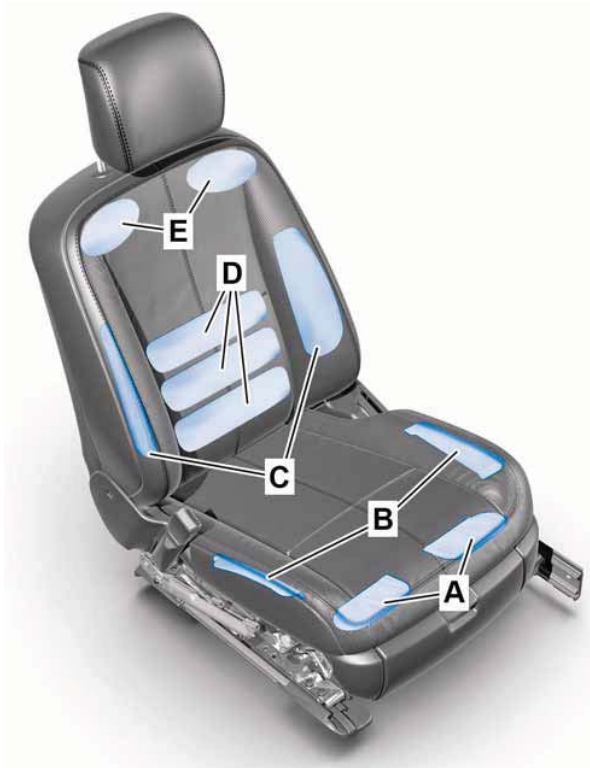
P91.10-3213-00

Location of front seat air cushions

- A Upper leg area of seat cushion (up to 12/2006)
- B Side area of seat cushion
- C Side area of backrest
- D Lumbar area
- E Shoulder area of backrest

The air cushions are located in the upper leg area, in the side areas of the seat cushion and in the shoulder area, lumbar area and side area of the backrest. Air cushion adjustment requests are read by a control unit and are then implemented in the air cushions by means of pneumatic valves. Compressed air is supplied by a pneumatic pump located in the trunk or load compartment of the vehicle. On vehicles without an automatic readjustment function for the compressed air supply, the air pressure must be manually readjusted by the customer.

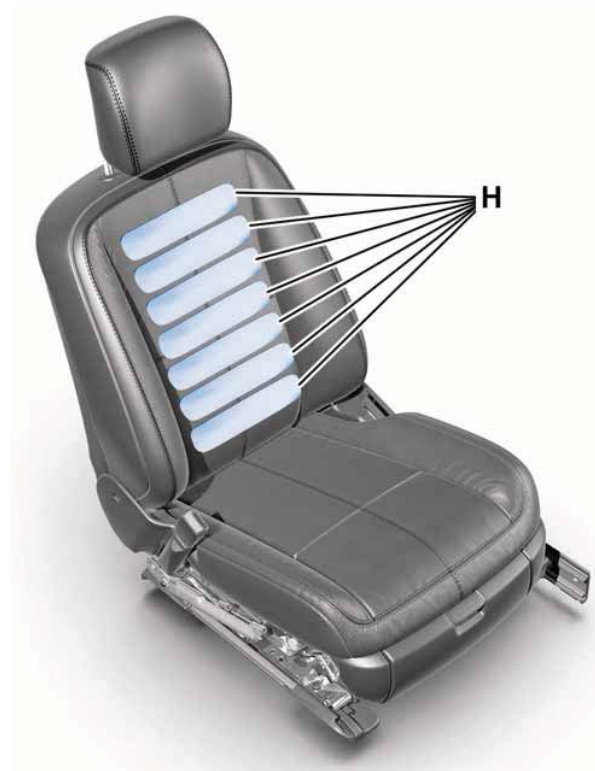
P91.10-3214-00

Location of front seat massage inserts

The massage function operates using seven air cush-ions positioned one above the other. These cushions are successively filled with air which is held in the respective cushions for a period of time and then released.

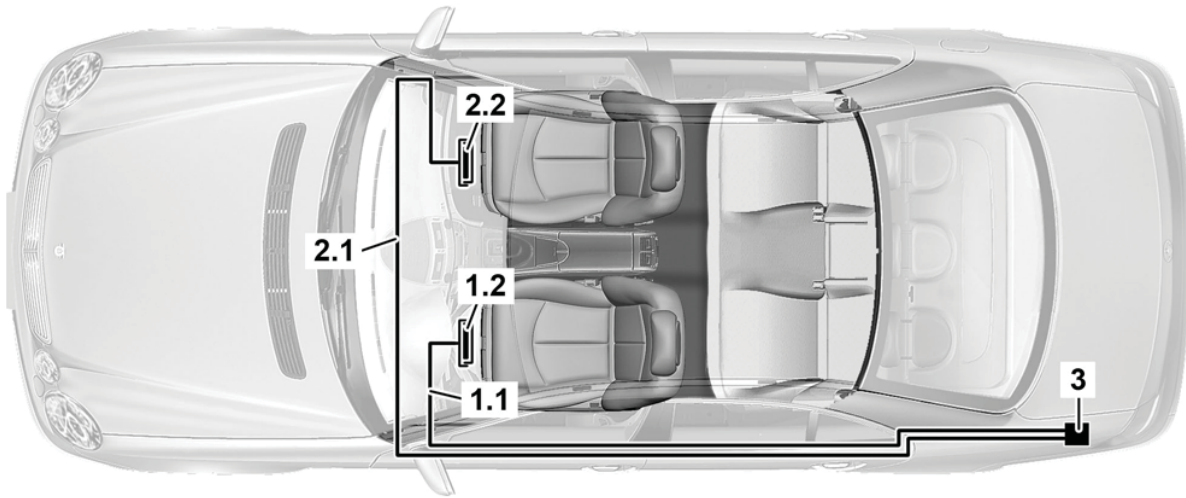
P91.00-2240-00

Location of components for multicontour seat (MCS) in model series 211 and 219 (with code 404, 405)

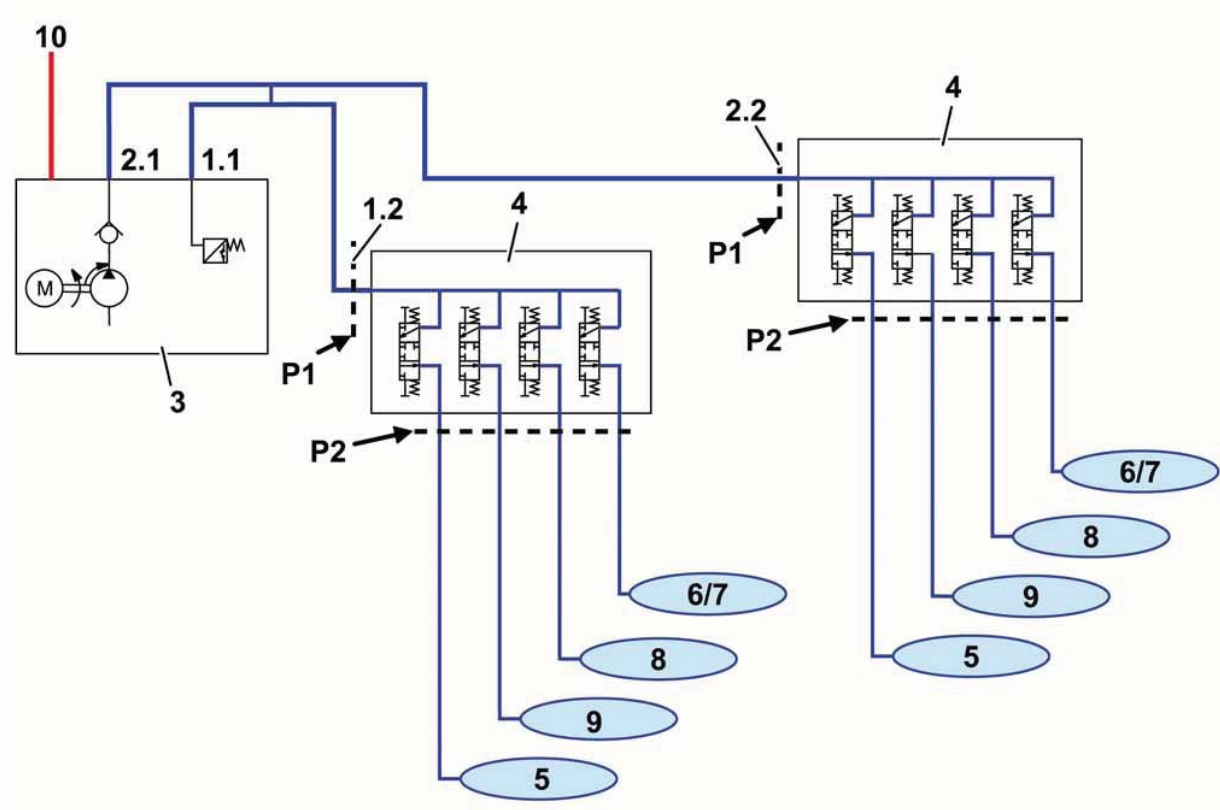
P91.10-3217-00

Pneumatic diagram for multicontour seat (MCS) in model series 211 and 219 (with code 404, 405)

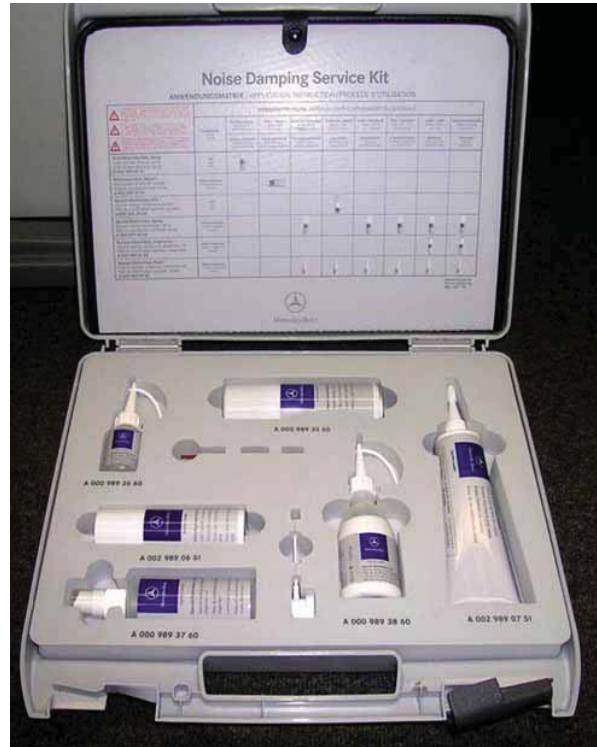
P58.00-2086-00

Noise kit

The Mercedes-Benz "Noise kit" has been developed especially for Mercedes-Benz workshops and is intended to effectively eliminate creaking, squeaking and cracking noises.

The lubricants were created especially for Mercedes-Benz vehicles and offer the following advantages over conventional lubricants:

- Usage temperature from -40°C to +140°C
- Compatible with all "interior" materials (e.g. plastics, seals, (non-ferrous) metals, leather)
- Optimal long-term lubrication
- Resistant to other environmental influences (dirt, moisture, dust, etc.)
- Non-toxic
- Lubricants available worldwide

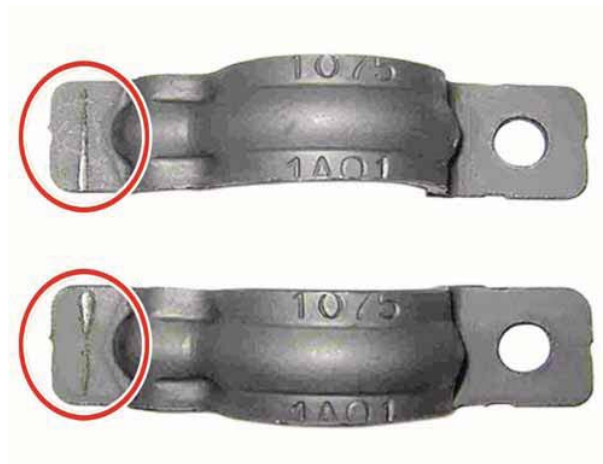
P91.10-3231-00

The cushion frame brackets in vehicles produced before 31.06.06 develop a burr as the vehicle mileage increases which can cause the described noise complaint (see picture).

Cushion frame bracket with signs of wear

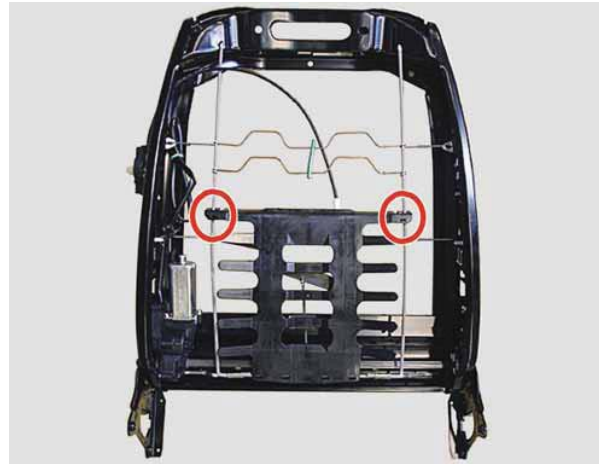
P91.00-2241-00

Interface between guide wires and lumbar support frame

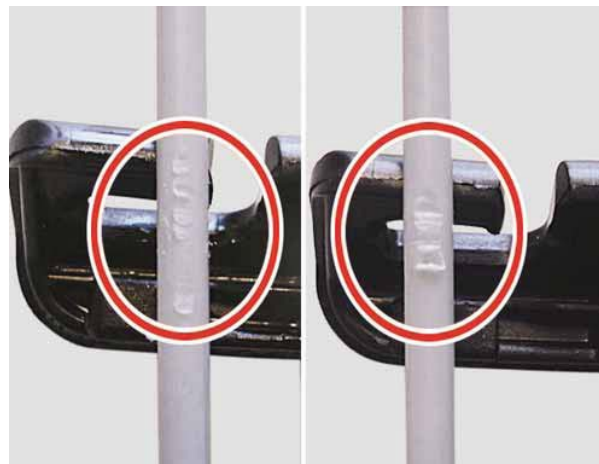
P91.00-2242-00

- At low temperatures, natural vibrations of the lumbar support frame can result in damage to the guide wire when a person sits down in the seat.
- On vehicles produced up to 09.2005, the Pulmaflex mat rubs against the attachment points on the backrest frame. There are two attachment points on both the left and right side of the backrest frame.
- On model 203.7 and 209, relative movements can result in noise complaints from the lower area of the backrest.

Damaged guide wires

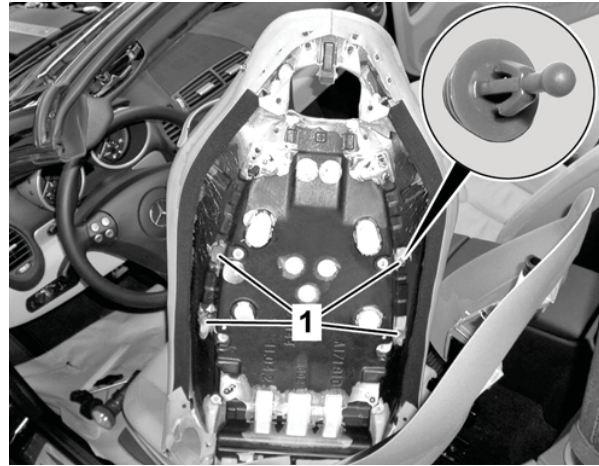
P91.10-3219-00

The red side attachment clips between the padding carrier and the backrest frame are broken. As a result, the side bolsters of the padding carrier are no longer fixed to the backrest frame.

1 Position of clips

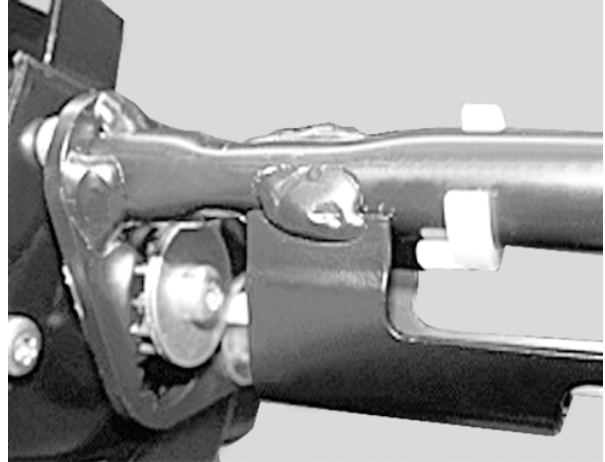
P91.10-3220-00

Relative movements can lead to noises and play.

Installed clip spacer ring

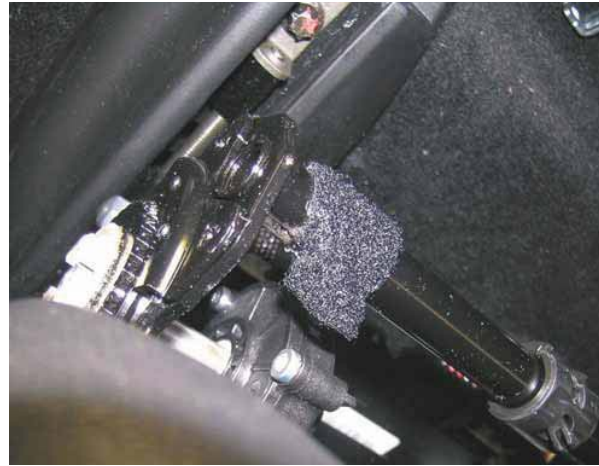
P91.10-3221-00

Inaccurate positioning of the felt on the transverse pipe (door side).

Transverse pipe

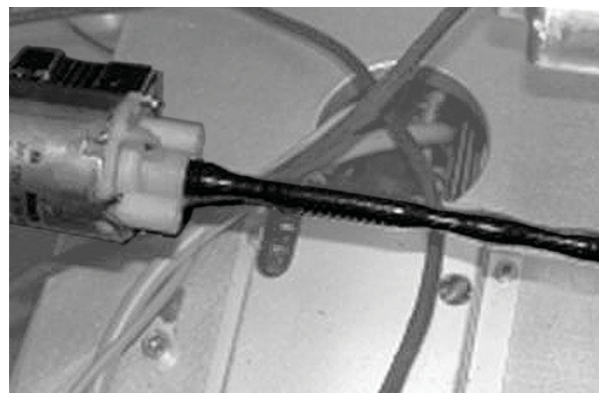
P91.10-3222-00

Damage to flexible shaft between motor and transmission of seat fore/aft adjuster.

Flexible shaft at motor end

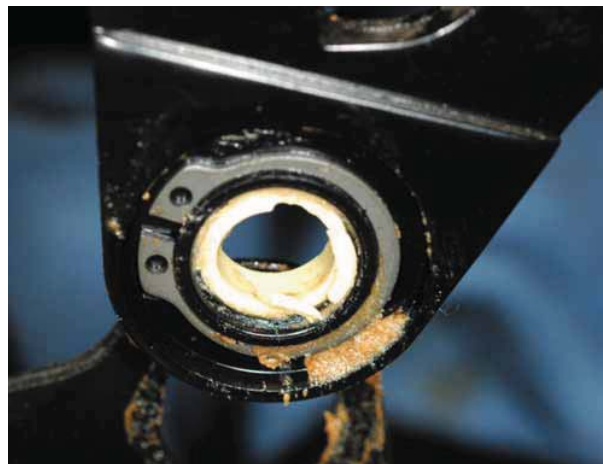
P91.10-3223-00

- Broken or damaged bushing in seat adjuster causes play or noises during load change.

- Broken or damaged bushing in seat adjuster causes play and possibly an SRS fault message.
- Various fault codes

Damaged bushing

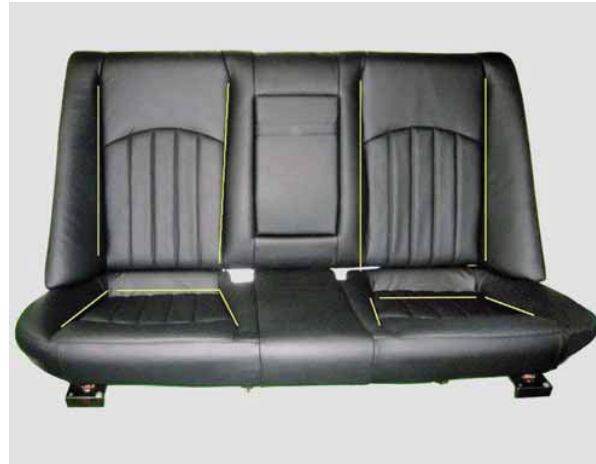
P91.12-3151-00

Deviations in tolerance when sewing covers.

Location of wire pockets in rear bench seat

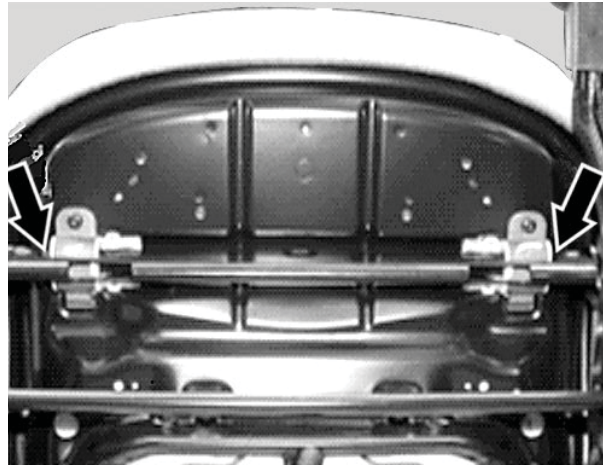
P91.10-3225-00

The front bearing shells (cam clips) of the seat cushion shell allow the seat cushion a certain amount of play. The cracking noise occurs between the plastic bearing and cross-connection pipe.

Position of cam clips

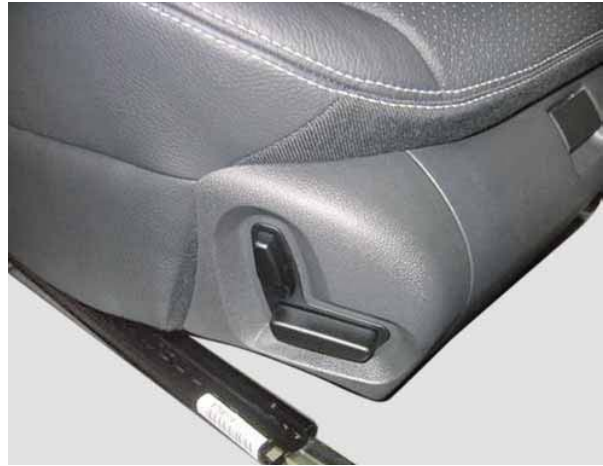
P91.10-3228-00

Damage to switch. Accidentally kicking the switch can cause it to break e.g. when loading roof box or attaching bicycle carrier with driver door open and feet on rocker panel.

Partially electric seat adjustment switch

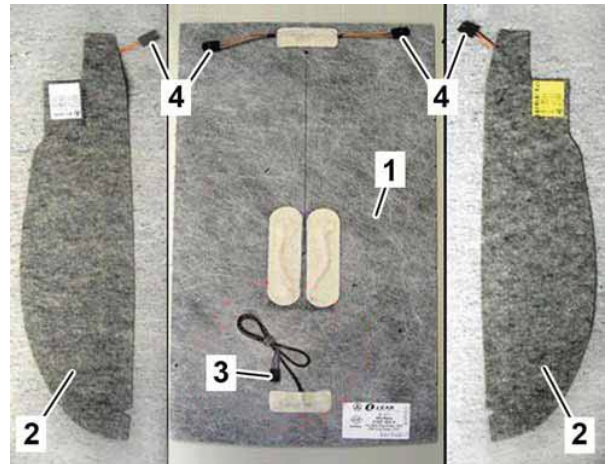
P91.10-3229-00

The seat heating leads at the door side of the seat cushion break as a result of frequent entry/exit.

- 1 Seat cushion center panel heating element
- 2 Seat cushion side panel heating element
- 3 Main connector
- 4 Secondary connector

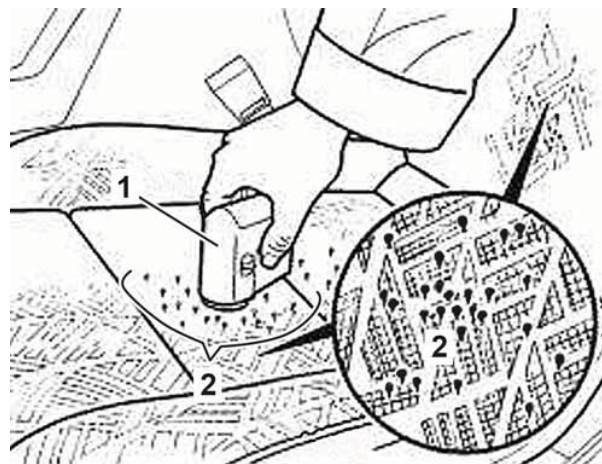
P91.00-2243-00

Fibers detach from the clothing of passengers (external-source pilling) and/or from the fabric of the seat cover (inherent pilling) and form small fiber burls on the surface as a result of sliding motion.

- 1 Wool razor
- 2 Fiber burls

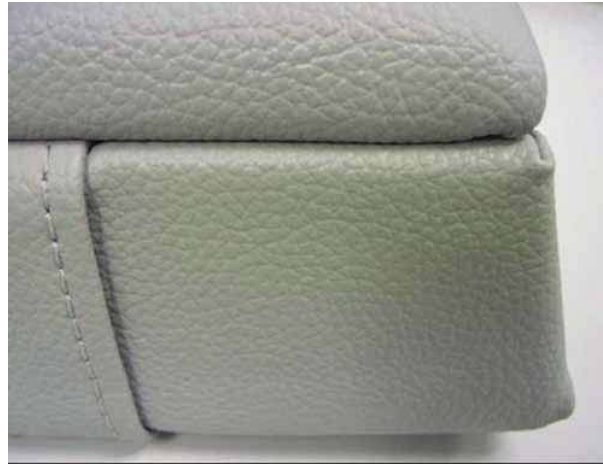
P91.12-3154-00

Amines diffuse out of the foam padding, e.g. through seams, and cause a reaction with the upper paint layer of the PVC of adjacent components (e.g. armrest). This causes yellowing. This reaction only occurs in the dark.

Armrest yellowing

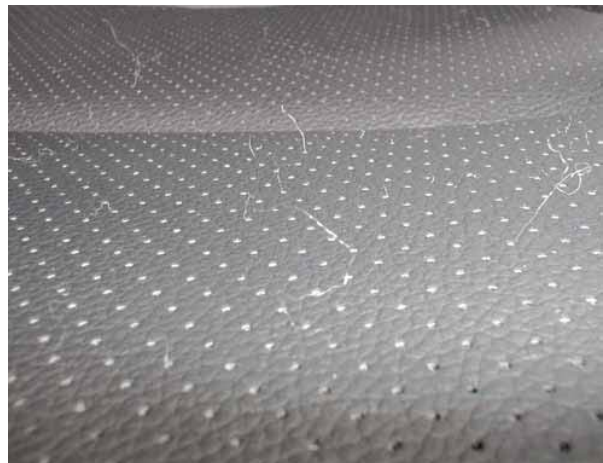
P91.00-2244-00

- A change of material for the inlays in the rear seat covers leads to loose threads.
- A change in the diameter of the perforations in the imitation leather cover material leads to loose threads.

Thread formation
