# Passenger Car Seats

## Design • Function • Care • Complaints

Service Technology Guide

Mercedes-Benz

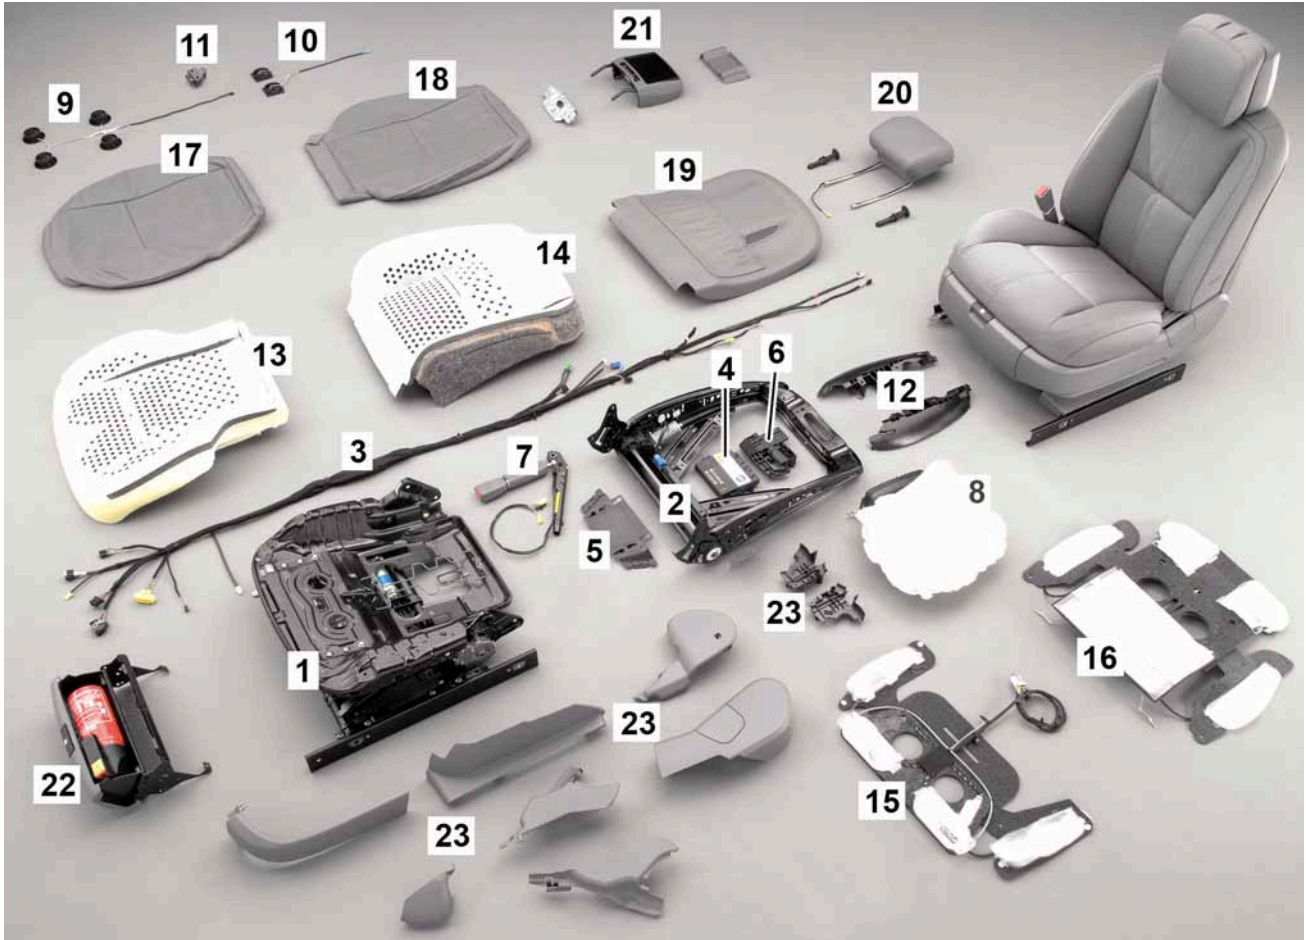
P91.10-3209-00

The picture below provides an overview of the many components incorporated in a modern seat from Mercedes-Benz (example shows a dynamic seat from model 221).

**Design of dynamic seat (driver seat, model 221)**

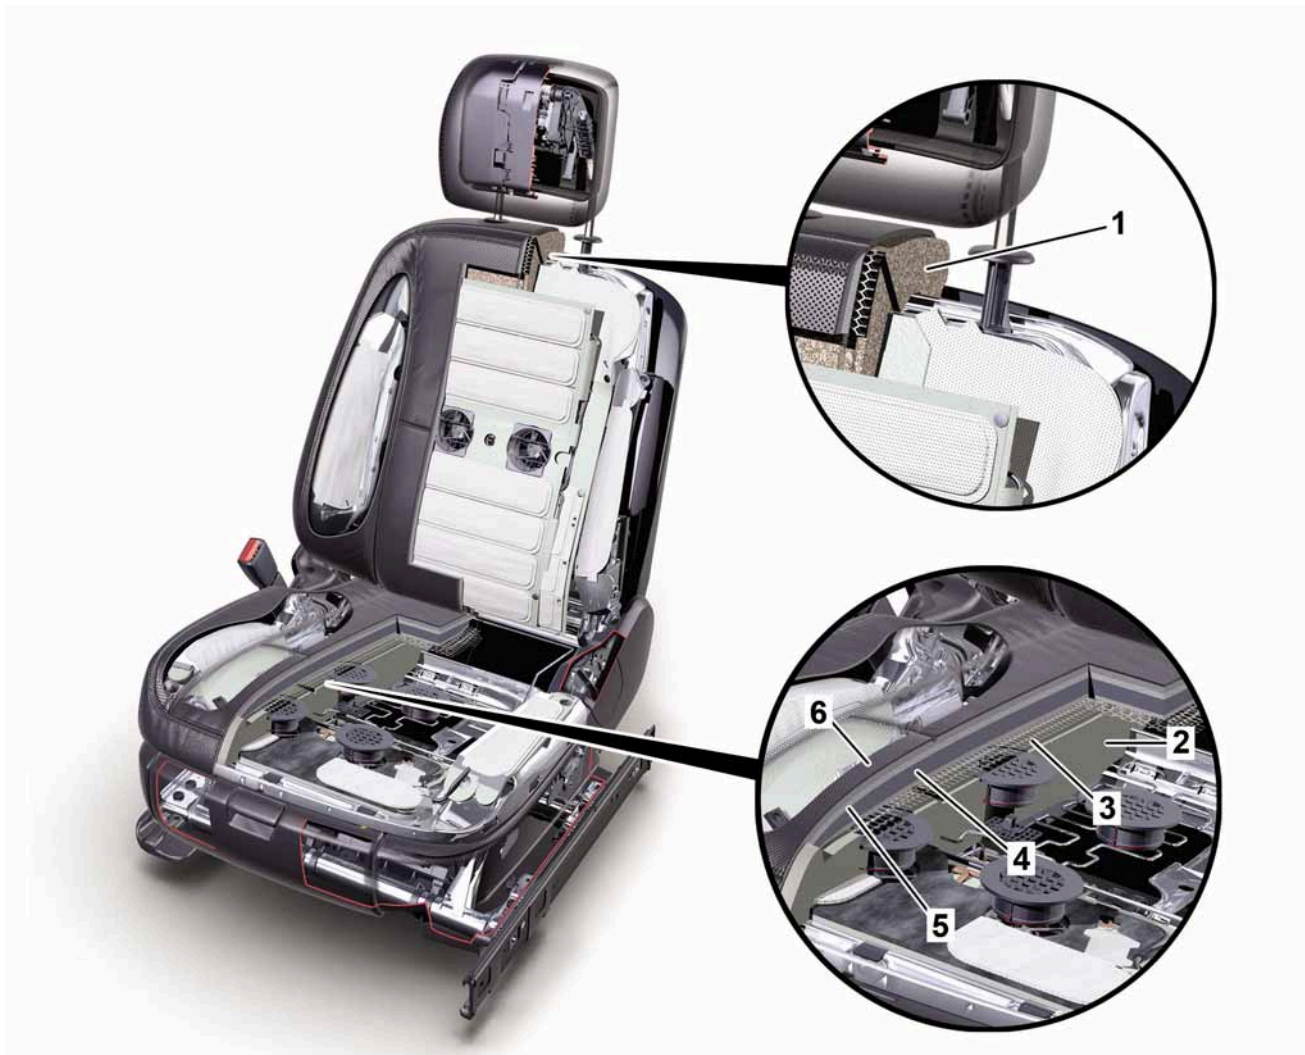
P91.10-3210-00

- The backrest padding and seat cushion padding serve to pad and shape the seat and also act as an intermediate seat layer to improve seat comfort. The spacer fabric ensures that the air circulates properly on vehicles with active ventilation.
- The cut foam primarily serves to improve both the break-in characteristics and surface softness of the seat.
- The PES non-woven cloth also provides added softness and break-in comfort.
- The cushion cover is the final layer of the upholstery structure and serves as a design element.

**Dynamic seat (model 221)**

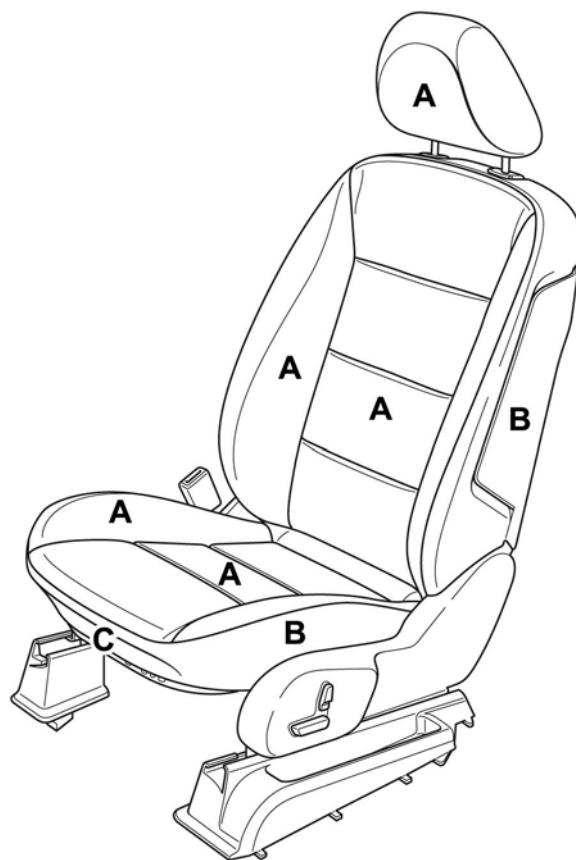
P91.10-3232-00

These are the areas which are not directly visible.

**Seat quality zones**

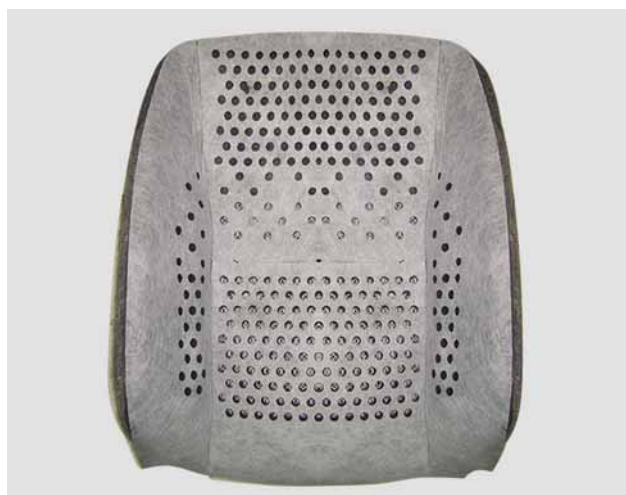
P91.00-2237-00

The cut foam is a layer of padding of approx. 1 to 2 cm thickness which is additionally placed on the backrest or seat cushion padding.

**Cut foam**

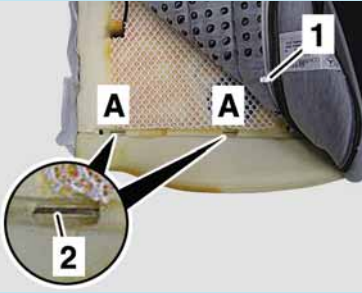
<p><b>Special case, model 209, 219</b></p> <p>On these model series, the upholstery wires are embedded in the backrest foam and the upholstery clips are attached to the seat cover. The seat cover must be attached at the points where the wire in the padding is visible.</p>

<p>A Attachment point</p> <p>1 Clip</p> <p>2 Upholstery wire</p>

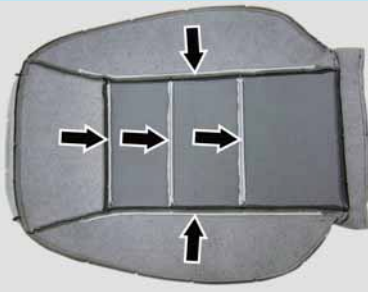
<p>Picture shows reverse of seat cover. Upholstery wires (arrows)</p>
<p><b>Special case, model 169/245</b> The clips are embedded into the backrest on both of these vehicle models.</p>

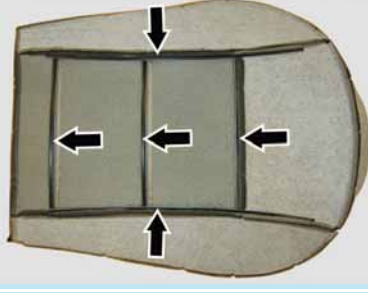
<p>Upholstery rails (arrows)</p>
<p>Plastic rails for attachment</p>

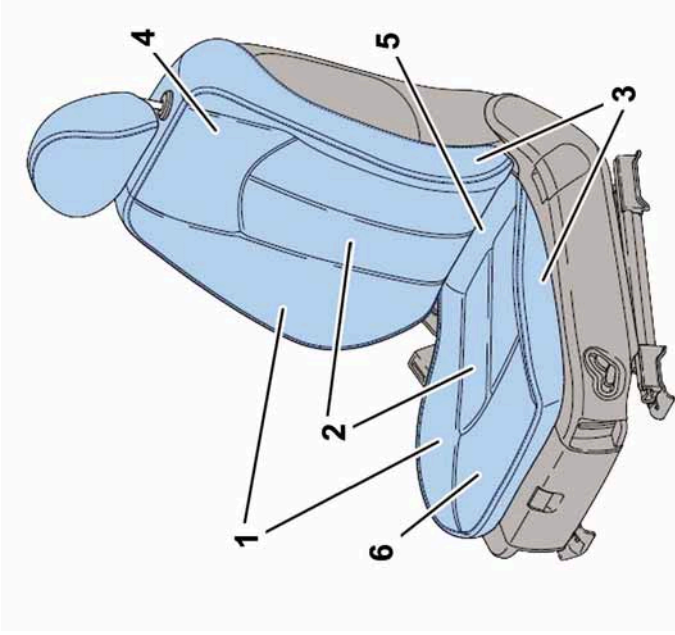
P91\_10-3212-00

**Seat cover components (model 211)**

- 1 Side bolsters
- 2 Seat center panels
- 3 Seat rims
- 4 Upper beaded section
- 5 Rear beaded section
- 6 Front beaded section

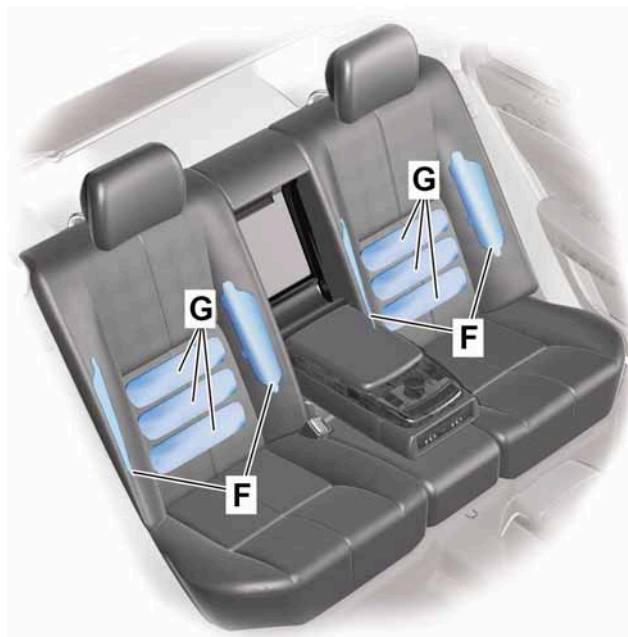
P91.12-3150-00

#### Location of rear seat air cushions

- F Side area of backrest
- G Lumbar area of backrest

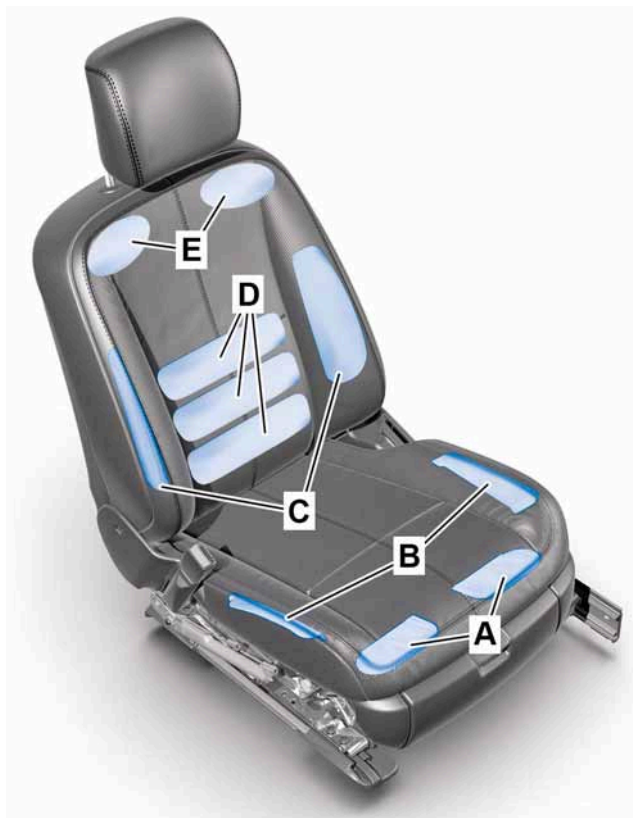
P91.10-3213-00

#### Location of front seat air cushions

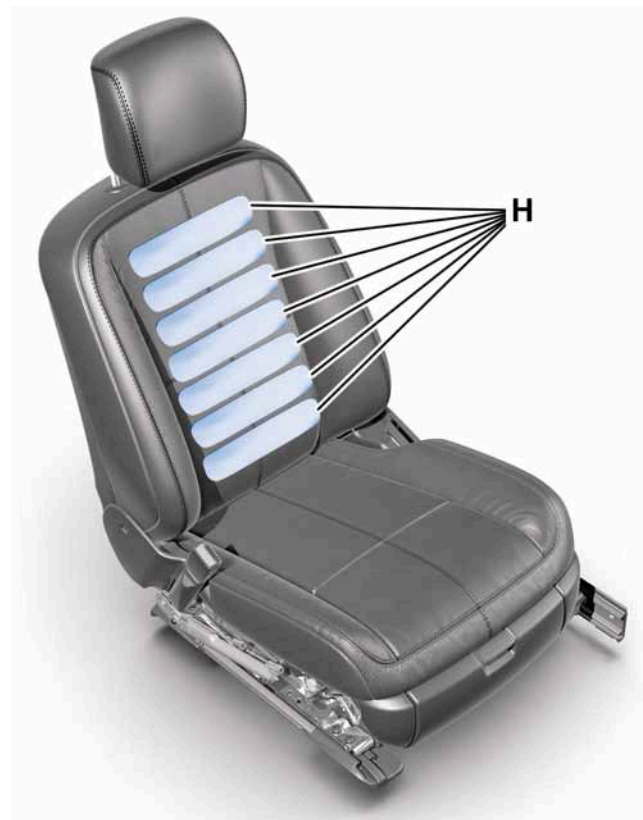
P91.10-3214-00

On the front seats, two massage programs are avail-able. It is also possible to select between two levels of intensity for each program.

**Location of front seat massage inserts**

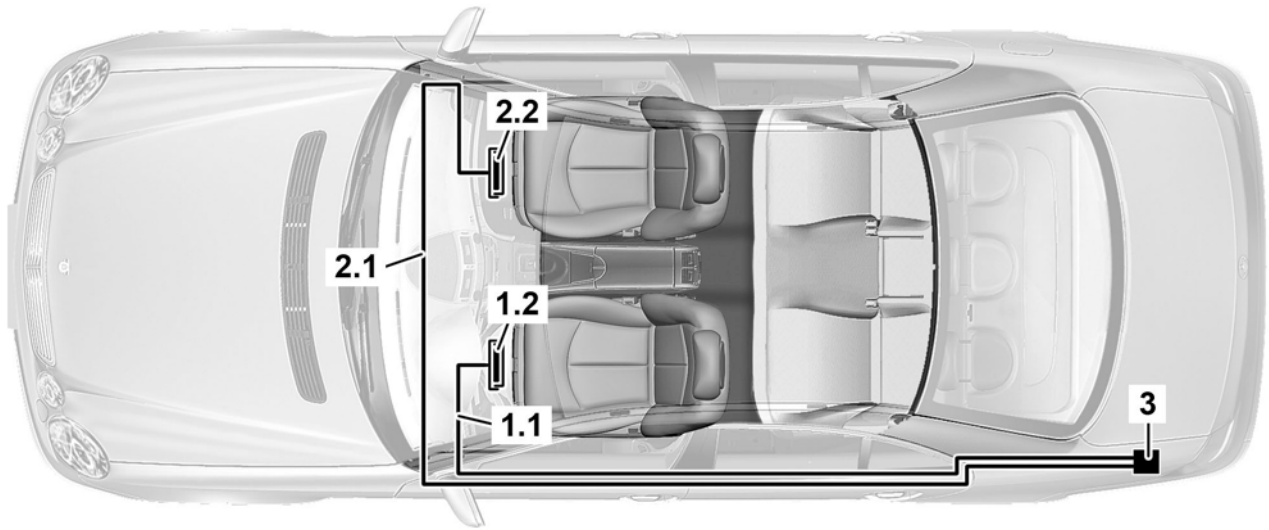
P91.00-2240-00

### Location of components for pneumatic comfort system in seat

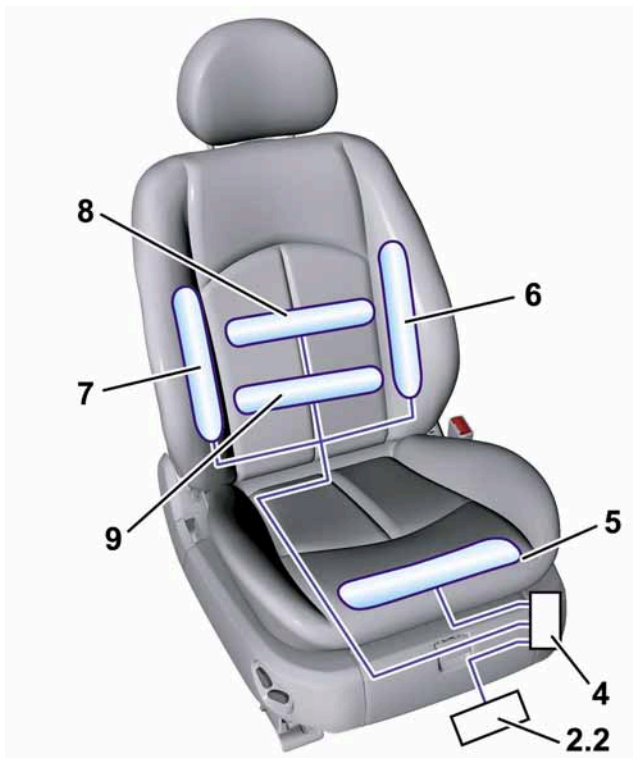
P91.10-3215-00

### Location of components for multicontour seat (MCS) in model series 211 and 219 (with code 404, 405)

**Front passenger seat (MCS)**

- 5 Front air cushion insert
- 6 Left air cushion insert
- 7 Right air cushion insert
- 8 Upper center air cushion insert
- 9 Lower center air cushion insert

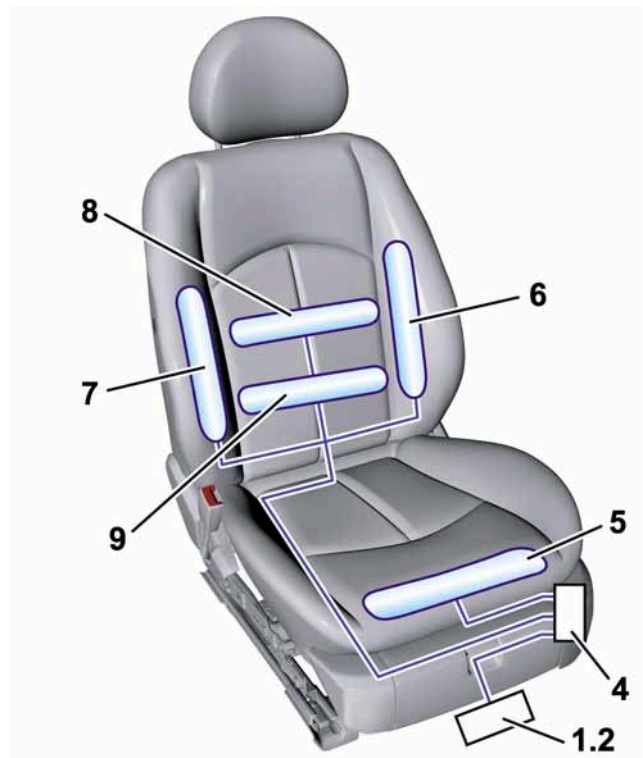
P91.10-3216-00

**Driver seat (MCS)**

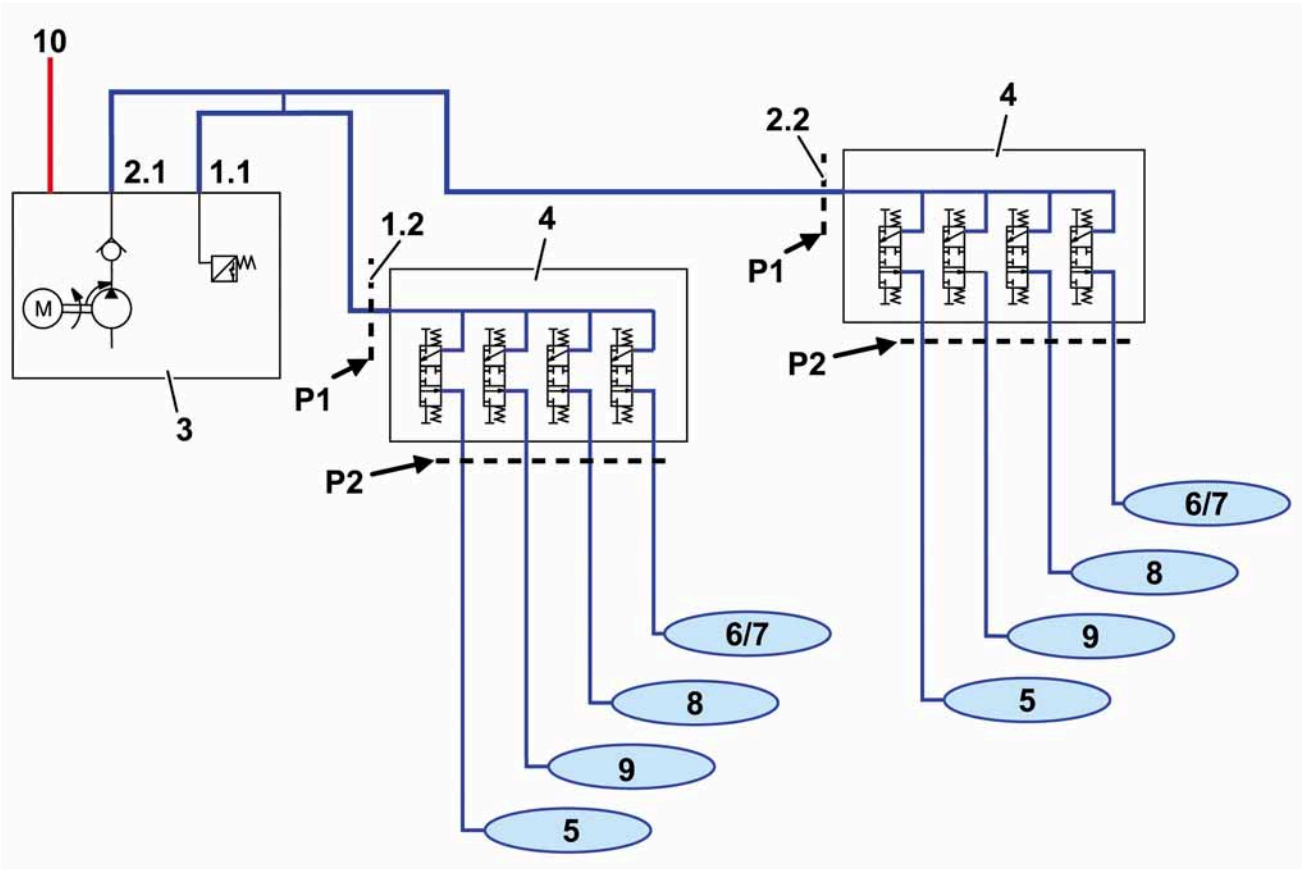
P91.10-3217-00

**Pneumatic diagram for multicontour seat (MCS) in model series 211 and 219 (with code 404, 405)**

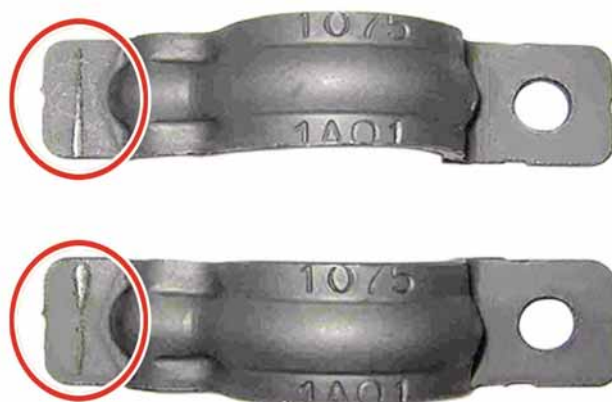
P91.10-3231-00

The cushion frame brackets in vehicles produced before 31.06.06 develop a burr as the vehicle mileage increases which can cause the described noise complaint (see picture).

**Cushion frame bracket with signs of wear**

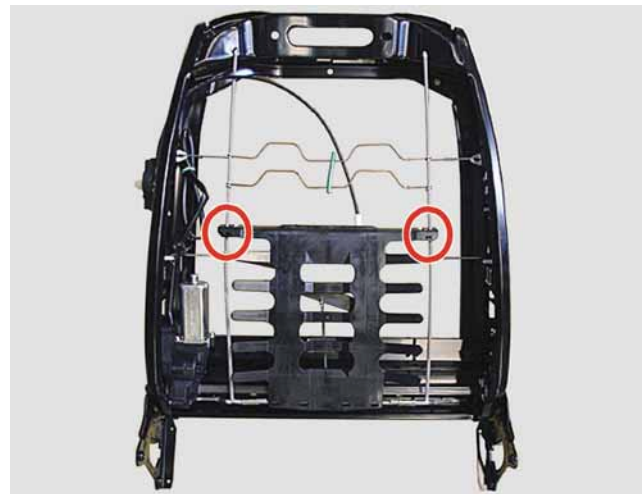
P91.00-2241-00

**Interface between guide wires and lumbar support frame**

- At low temperatures, natural vibrations of the lumbar support frame can result in damage to the guide wire when a person sits down in the seat.
- On vehicles produced up to 09.2005, the Pulmaflex mat rubs against the attachment points on the backrest frame. There are two attachment points on both the left and right side of the backrest frame.
- On model 203.7 and 209, relative movements can result in noise complaints from the lower area of the backrest.

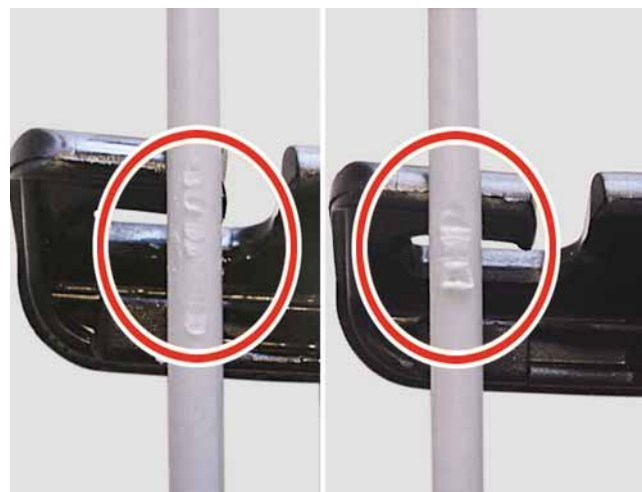
P91.00-2242-00

**Damaged guide wires**

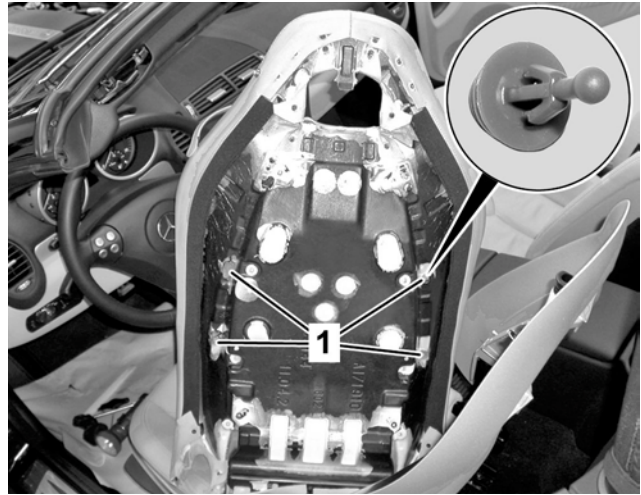
P91.10-3219-00

The red side attachment clips between the padding carrier and the backrest frame are broken. As a result, the side bolsters of the padding carrier are no longer fixed to the backrest frame.

1 Position of clips

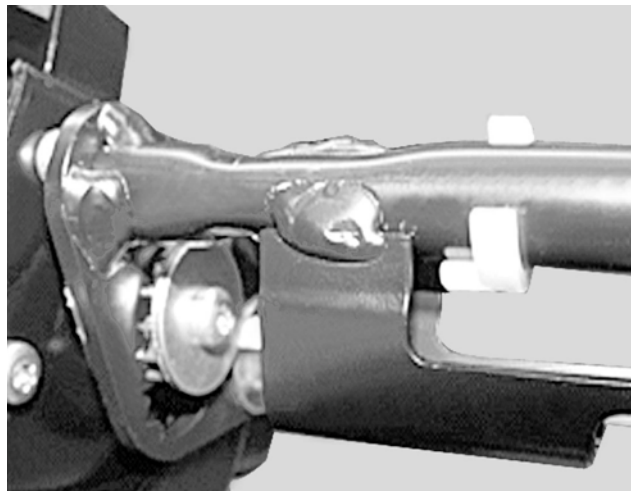
P91.10-3220-00

Relative movements can lead to noises and play.

*Installed clip spacer ring*

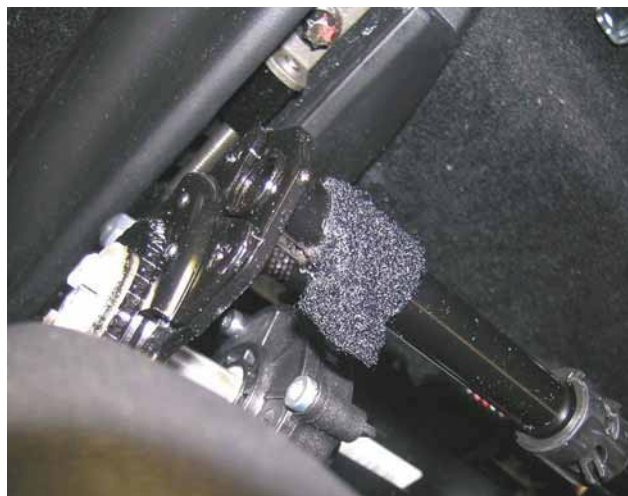
P91.10-3221-00

Inaccurate positioning of the felt on the transverse pipe (door side).

*Transverse pipe*

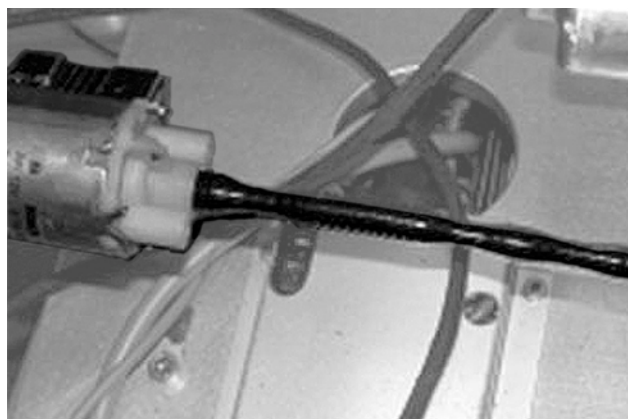
P91.10-3222-00

Damage to flexible shaft between motor and transmission of seat fore/aft adjuster.

*Flexible shaft at motor end*

Generally, the electric seat adjuster does not need to be replaced due to this complaint. This measure must only be implemented if the flexible shaft between motor and transmission is visibly deformed and still engaged on both sides (the seat has **not** been moved on one side only).

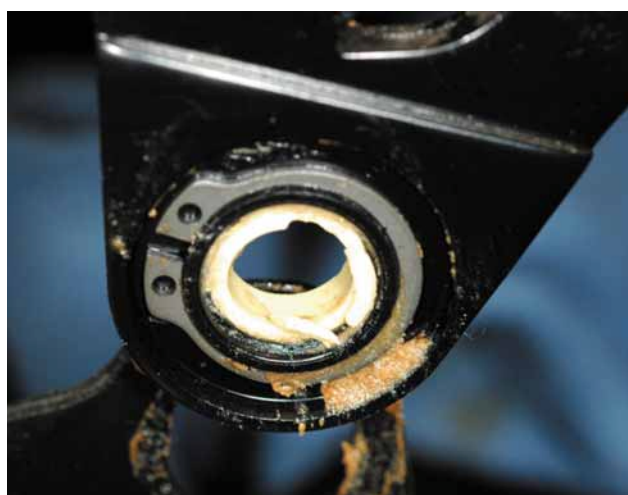
P91.10-3223-00

- Broken or damaged bushing in seat adjuster causes play or noises during load change.

- Broken or damaged bushing in seat adjuster causes play and possibly an SRS fault message.
- Various fault codes

*Damaged bushing*

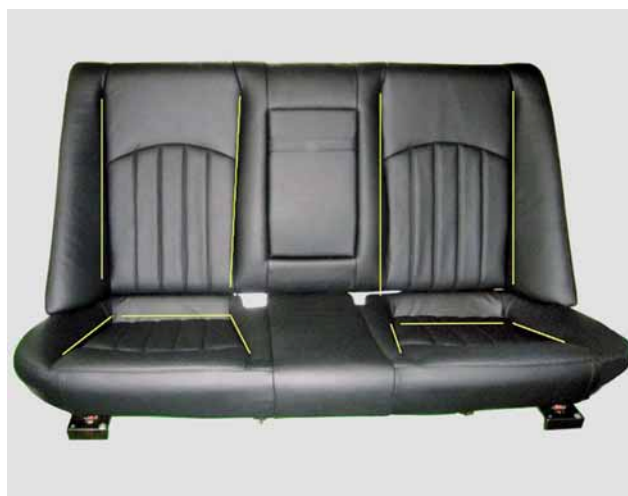
P91.12-3151-00

Deviations in tolerance when sewing covers.

*Location of wire pockets in rear bench seat*

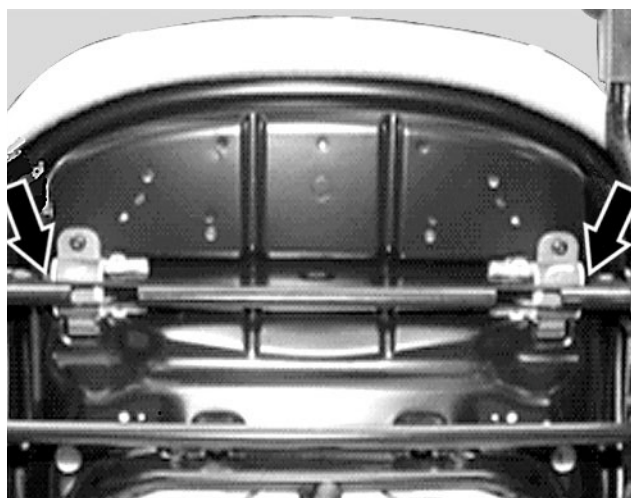
P91.10-3225-00

The front bearing shells (cam clips) of the seat cushion shell allow the seat cushion a certain amount of play. The cracking noise occurs between the plastic bearing and cross-connection pipe.

*Position of cam clips*

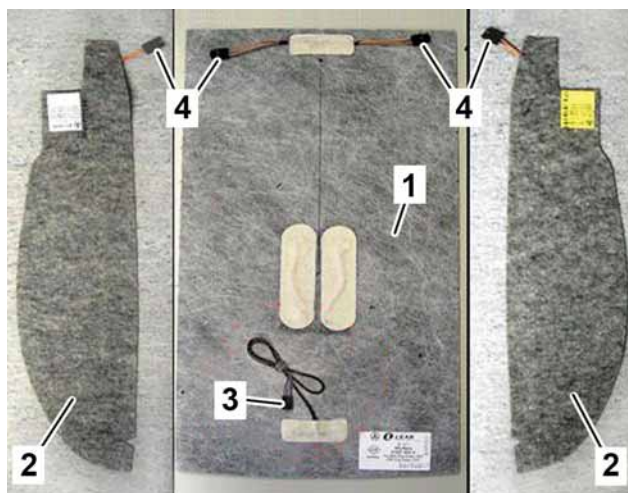
P91.10-3229-00

The seat heating leads at the door side of the seat cushion break as a result of frequent entry/exit.

- 1 Seat cushion center panel heating element
- 2 Seat cushion side panel heating element
- 3 Main connector
- 4 Secondary connector

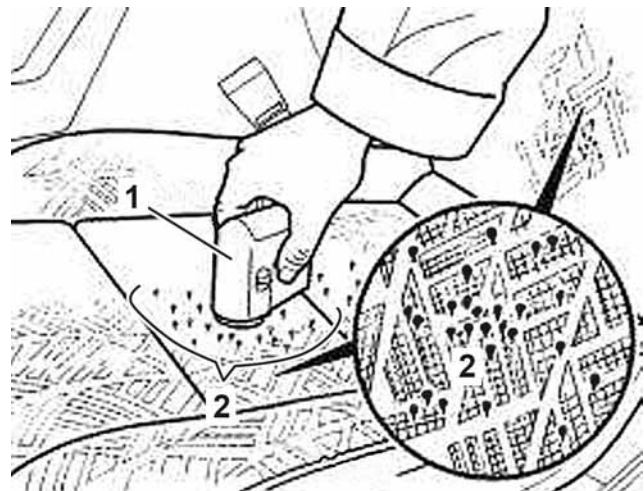
P91.00-2243-00

Fibers detach from the clothing of passengers (external-source pilling) and/or from the fabric of the seat cover (inherent pilling) and form small fiber burls on the surface as a result of sliding motion.

- 1 Wool razor
- 2 Fiber burls

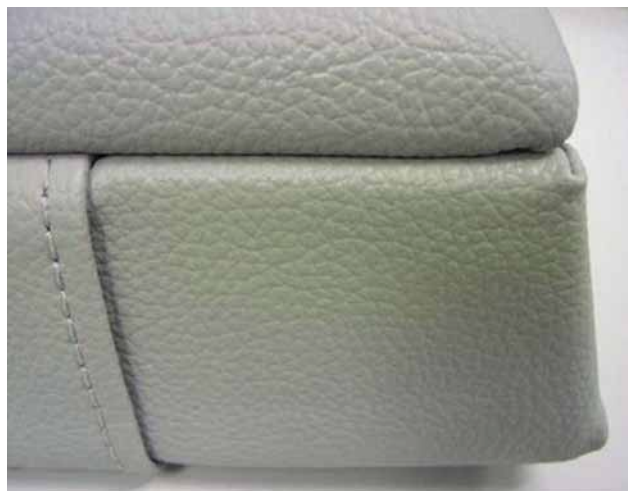
P91.12-3154-00

Amines diffuse out of the foam padding, e.g. through seams, and cause a reaction with the upper paint layer of the PVC of adjacent components (e.g. armrest). This causes yellowing. This reaction only occurs in the dark.

**Armrest yellowing**

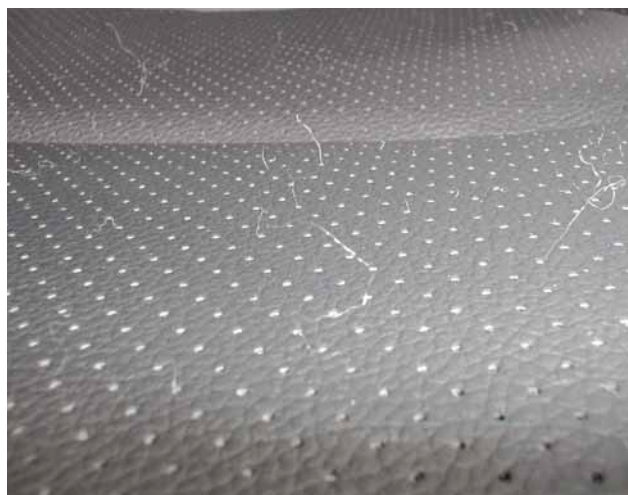
P91.00-2244-00

- A change of material for the inlays in the rear seat covers leads to loose threads.
- A change in the diameter of the perforations in the imitation leather cover material leads to loose threads.

**Thread formation**

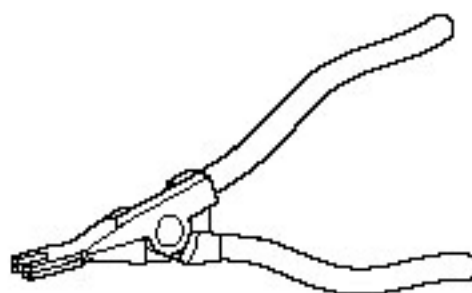
### Pliers

<b>Valid for</b>	Models 211, 219
<b>Use</b>	Pliers to separate the pneumatic line connections.
<b>DC number</b>	W000 589 04 37 00
<b>FG</b>	91
<b>Set</b>	B
