The \$700+ Rear View Mirror

I needed to work on my rear view mirror on my 2007 Benz R320CDI but couldn't find much info on how to get inside of it. I needed to fix the "ball joint" of my mirror because it got loose in late 2012 (it slips down when you drive). From what I could tell, it wasn't fixable so I had the unfortunate opportunity to replace it. Dealer wanted \$705 MSRP (\$564 wholesale) just for the part (no error on the decimal there – SEVEN HUNDRED FIVE dollars), but I replaced it with one from a junker on ebay (\$200). I went ahead and pulled apart the old one and thought I'd share what I found. Looking back, I wrote a bunch below about this stupid mirror, but I guess it helps make me feel better that I paid for a car that has a \$705 mirror.

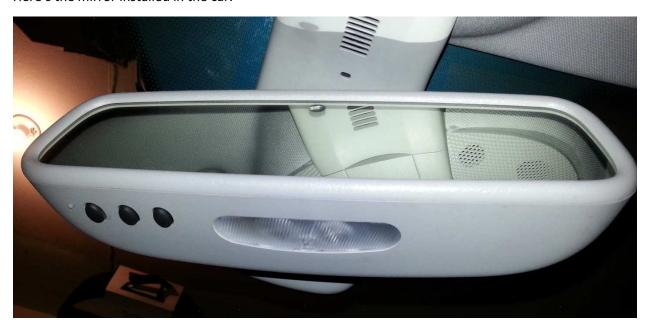
For the record, this mirror has the following features: auto-dimming; integrated garage door remote; built-in down-facing lights; and some sort of sensor that faces forward (for auto-dimming headlights?). Here's the mirror installed in the car:

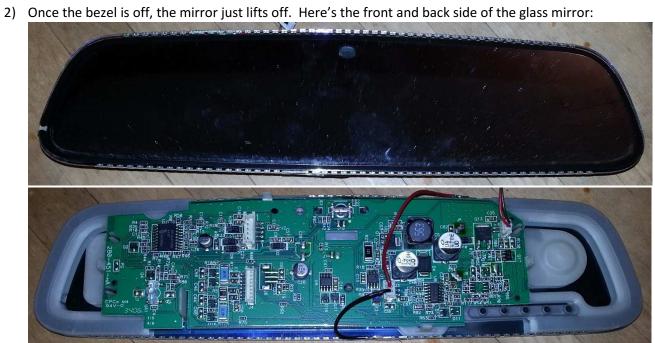
1) Opening it – the bezel along the front edge does just pop off. I didn't care about damaging the plastic so I didn't worry about it. However, the plastic is pretty soft so you want to be careful. Here's the front bezel, removed, showing all of the "click-in" points. All are shown – there aren't any along the ends.

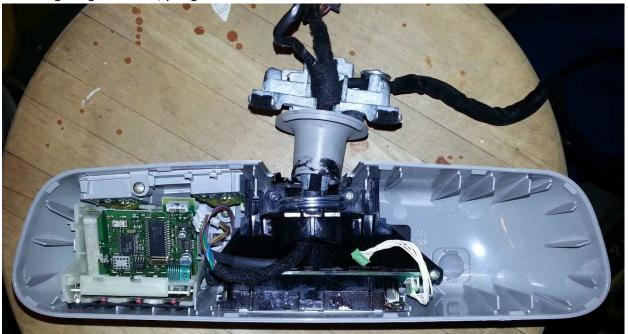
3) Removing the glass mirror, you get:

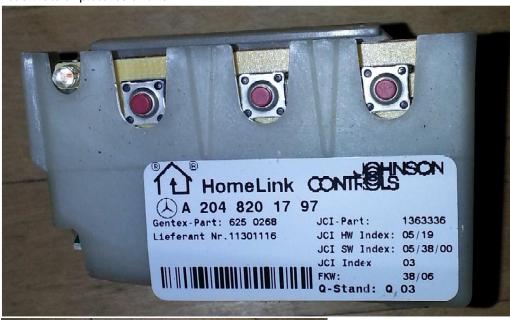
4) The circuit board on the left is the garage door opener from Johnson Controls. For some reason I took lots of pictures of this:

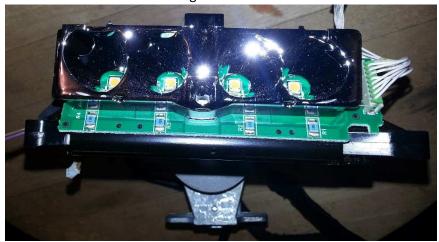
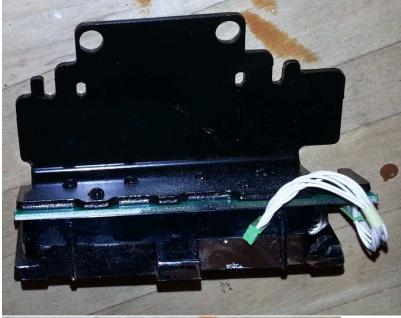
5) The lights on the bottom of the mirror are LED's. They are removed with the ball-joint assembly and can then be detached from the ball joint once removed. Again, more pictures than really needed... but I took 'em so I might as well share them.

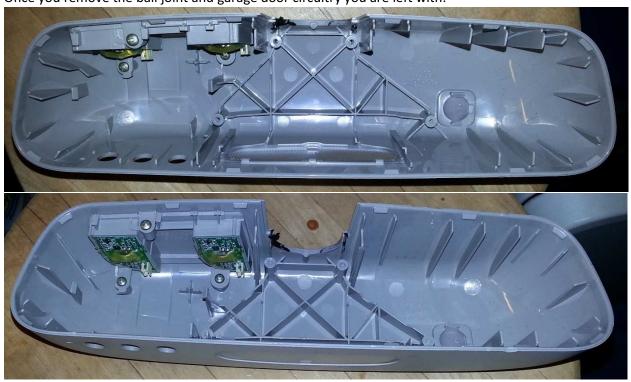
6) Once you remove the ball joint and garage door circuitry you are left with:

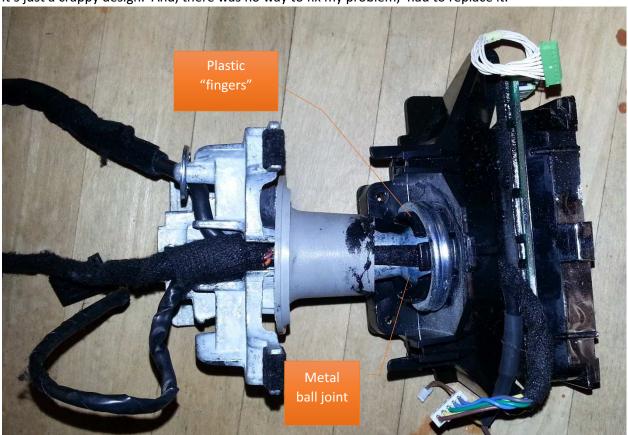
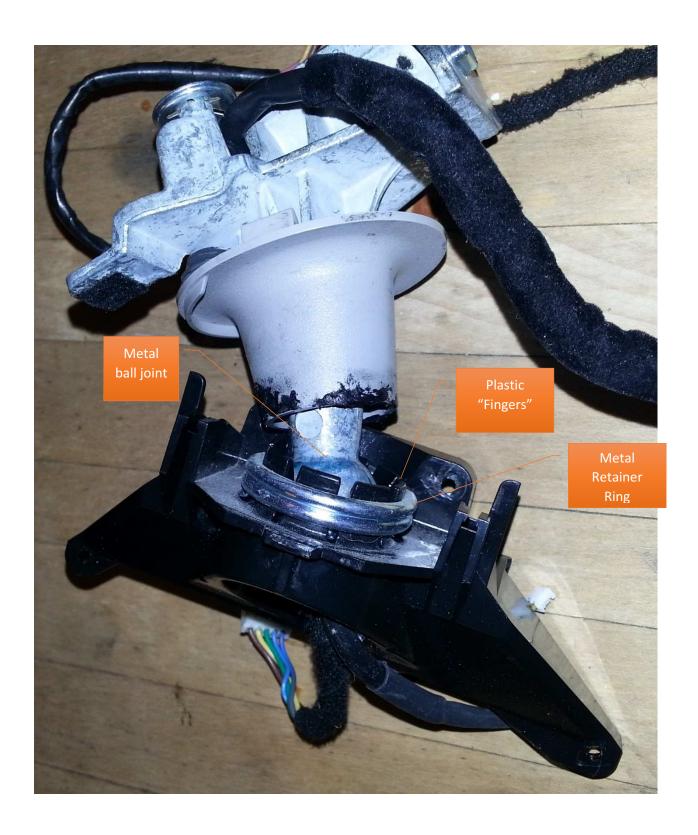
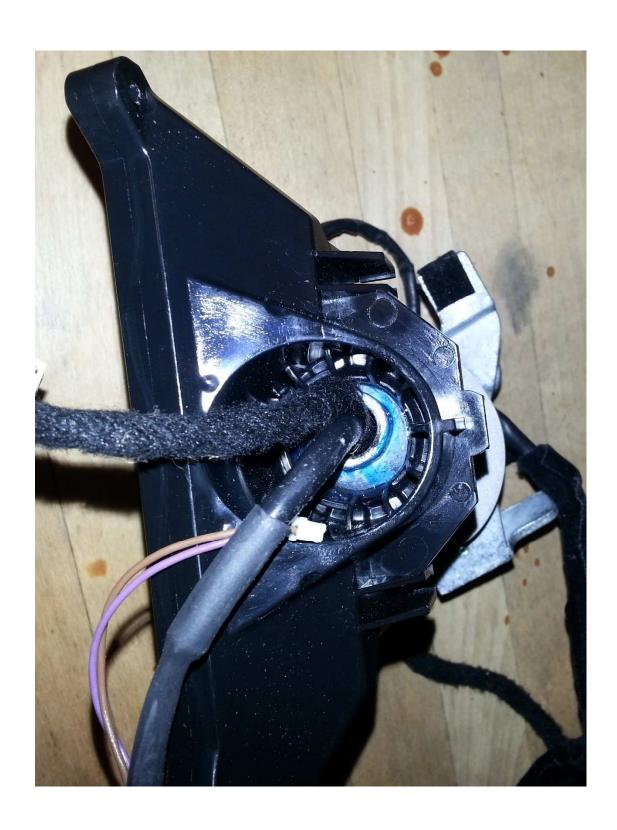
7) Now for the piece of #\$%@& that forced me to replace the mirror to begin with: the ball joint. You'll see the only thing creating the grip on the ball joint are plastic "fingers" that are held in place by a metal retainer ring. My guess is either the metal ring loosened (unlikely) or the plastic fingers just wore out. I know, you're thinking I must've moved it a bunch to get the plastic to wear out, and I'm just as surprised as you are – it wasn't moved that much. Frankly, it's just a crappy design. And, there was no way to fix my problem, 'had to replace it.
