MODEL 217, 222.0/1/9

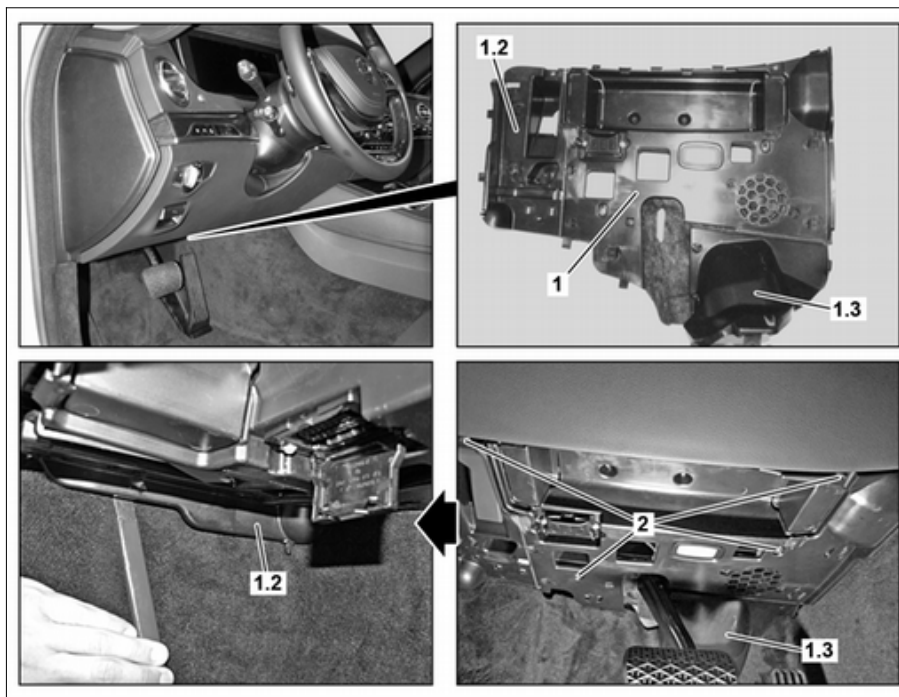
P68.20-4624-06

Shown on model 222

- 1 Cover
- 1.2 Left partial cover
- 1.3 Rear partial cover
- 2 Bolts

Remove/install		
1	Move driver seat to end position toward rear		
2	Switch off ignition and remove transmitter key		
3	Remove driver kneebag	MODEL 217 MODEL 222.0/1/9 with CODE 294 (Kneebag)	AR91.60-P-0200LF
4	Remove bolts (2)		
5	Fold left partial cover (1.2) down with suitable tool		
6	Pull left partial cover (1.3) down in direction of arrow

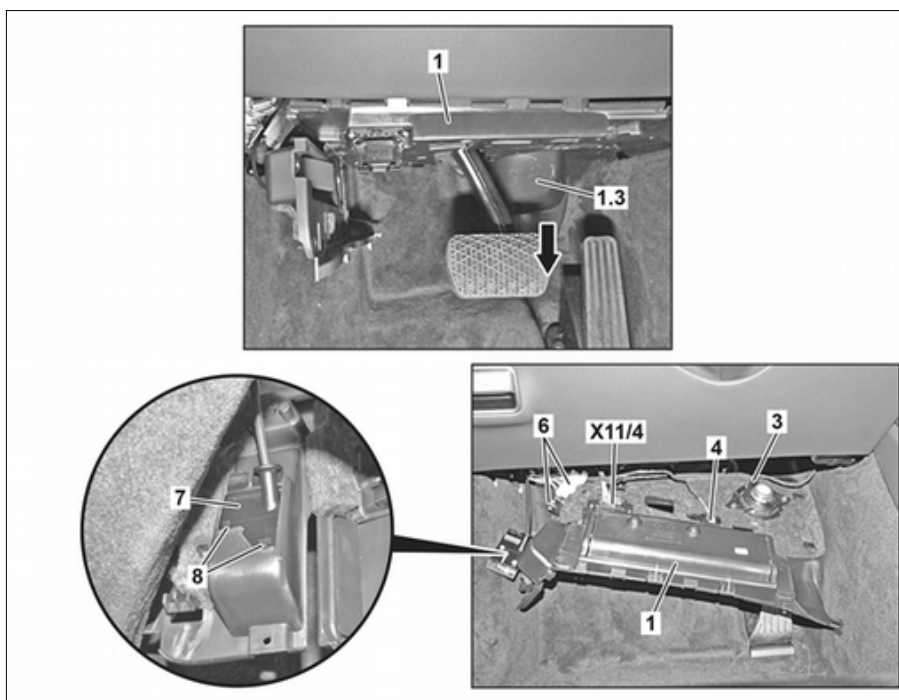
P68.20-4623-06

Shown on model 222

- 1 Cover
- 1.3 Rear partial cover
- 3 Electrical connector
- 4 Electrical connector
- 6 CAN hub
- 7 Engine hood cable release handle
- 8 Engine hood release handle catch tab
- X11/4 Diagnostic connector

7	Push cover (1) in direction of travel and lower	i Lower cover (1) downward only until engine hood cable release handle (7), electrical connectors (3, 4), CAN hub (6) and data link connector (X11/4) are accessible.	
8	Unlock diagnostic connector (X11/4) and remove from cover (1)		
9	Detach electrical connections (3, 4)		
10	Unclip CAN distributor (6)		
11	Detach engine hood cable release handle catch tab (8) and guide engine hood cable release handle (7) toward inside through cover (1)		
12	Remove cover (1) from footwell		
13	Transfer speaker and footwell lamp	When replacing cover (1)	
14	Install in the reverse order
