#### MODEL 217

# © Mercedes-Benz AG, 7/13/21, X/07/21, ar83.30-p-8086lc, Remove/install outside air temperature sensor MODEL 217

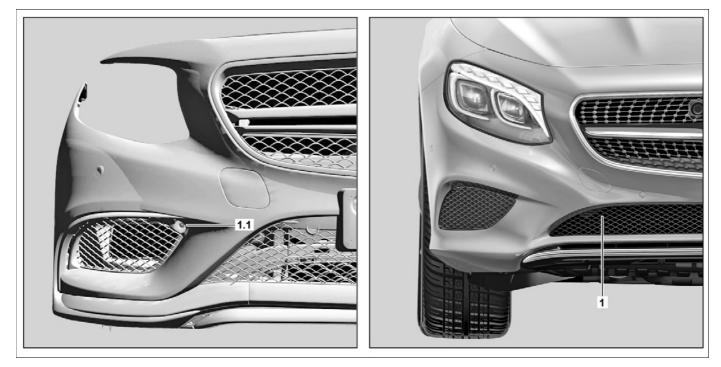
P83.30-4969-09

## 1 Outside temperature sensor (standard)

1	Outside temperature sensor (standard)
---	---------------------------------------

2 Electrical connector

XX	Remove/install		
1	Detach lower engine compartment paneling		AR61.20-P-1105LF
2.1	Unclip outside temperature sensor (1) from right radiator shroud (4)	MODEL 217 without CODE 772 (AMG bodystyling)	
2.2	Unclip outside temperature sensor (1.1) from right air duct segment (3) at bumper	MODEL 217 with CODE 772 (AMG bodystyling)	
3	Disconnect electrical connector (2)		
4	Install in the reverse order

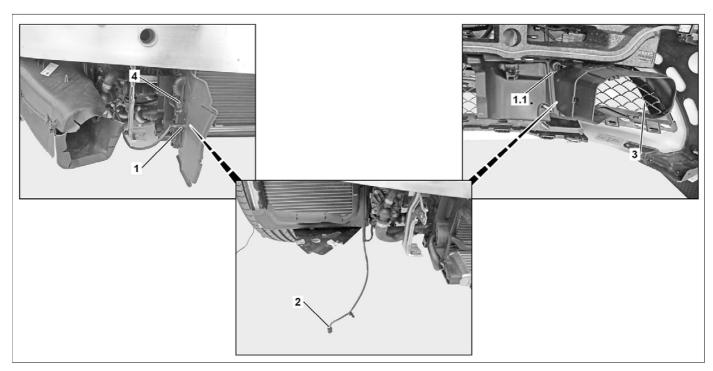
P83.30-4965-09

## 1.1 Outside temperature sensor (AMG)

Air duct segment

Radiator shroud

#### Shown with removed bumper

1.1 Outside temperature sensor (AMG)
