Model 217
with code 308 (Refrigerated compartment in rear passenger compartment)

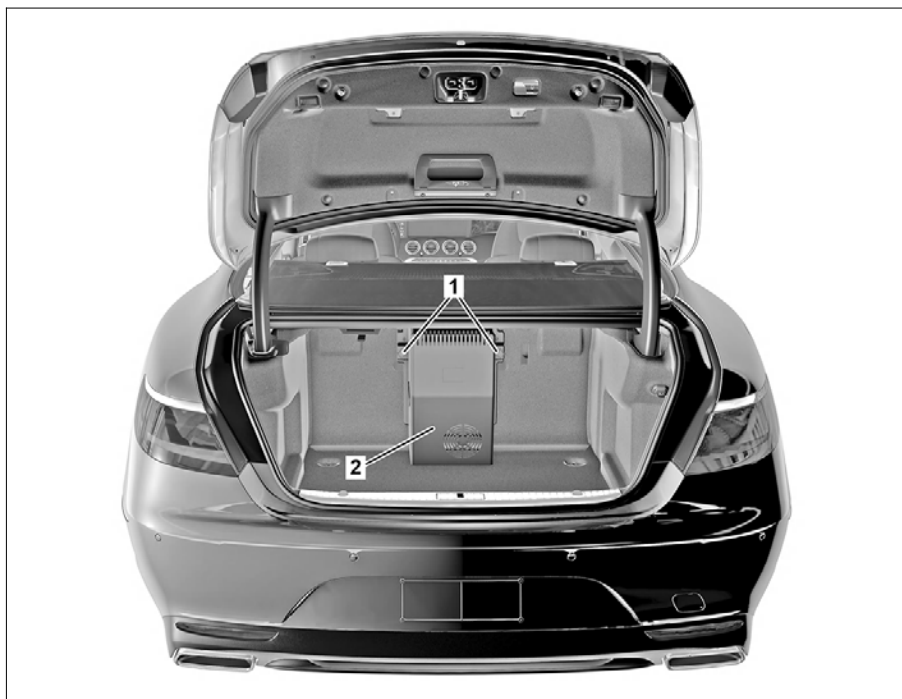
P86.61-2076-06

- 1 Phillips screws
- 2 Open refrigeration compartment

Warning	Risk of injury caused by fingers being jammed or pinched when removing, installing or aligning hoods, doors, trunk lid/rear-end door or sliding roof.	No parts of the body or limbs should be within the operating area when the components are moving.	AS00.00-Z-0011-01A
	Remove/install		
1	Open luggage compartment lid		
2	Remove Phillips screws (1)		
3	Disconnect electrical connector from refrigeration compartment (2)		
4	Remove refrigeration compartment (2)		
5	Install in the reverse order
