Service Campaign Bulletin

Campaign No. 2020110015, May 2021

SUBJECT: **Model E-Class, S-Class Coupe/Convertible, S-Class, AMG GT 4-Door Coupe, GLS-Class, and G-Class (213, 217, 222, 290, 167 and 463 platform) Model Year 2019-2020**

Check high-pressure lines at high-pressure fuel pumps, replace if necessary

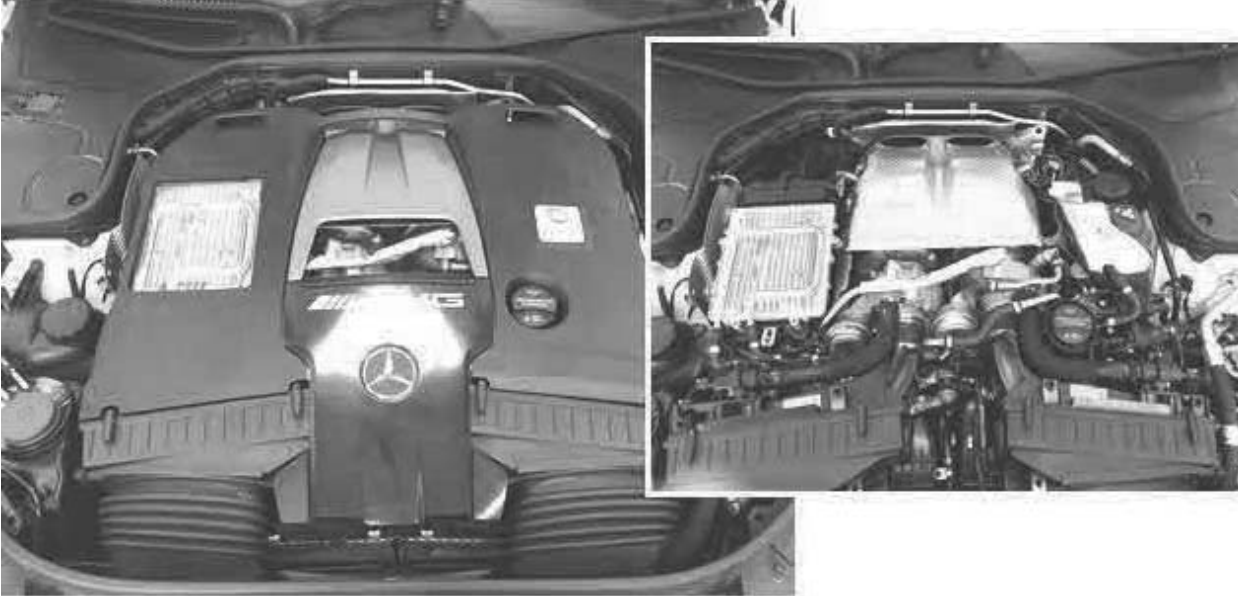
Figure 1

1. Remove engine design cover.

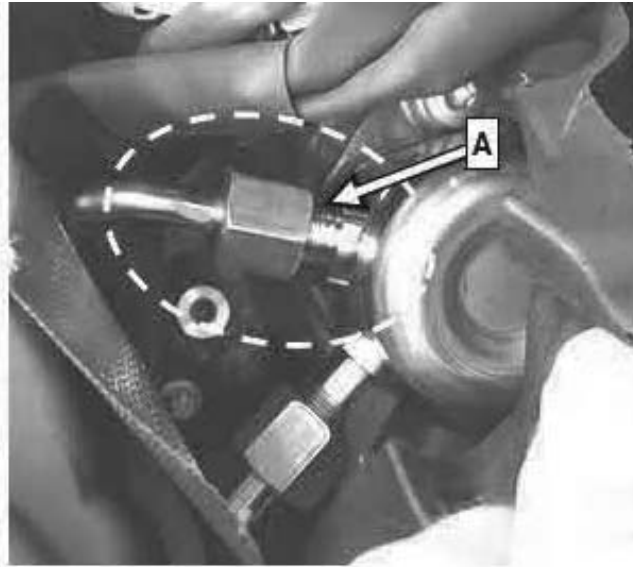
2. Lift left and right soundproofing covers of high-pressure fuel pump.
 - i** Lift until high-pressure fuel line connection (**A**, **Figures 2 and 3**) to high-pressure fuel pump is easily visible.
 - i** The soundproofing cover does not need to be removed completely to perform the check.

Figure 3, OK View of left
