All you need to know for pre-facelift W221 S350 lumbar support leaks

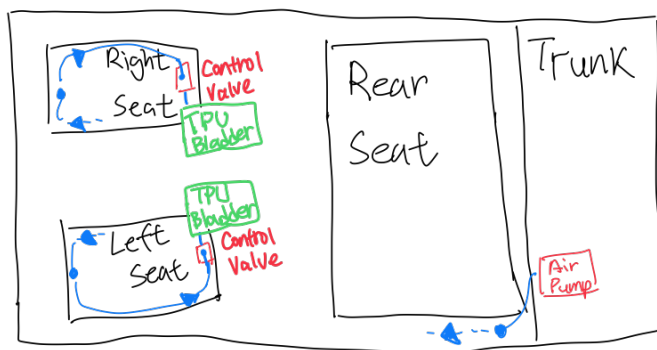
Please note, I only disassembled the sections I needed to fix. The pneumatic system is perhaps much more complicated. The blue dots are the connectors that can be disconnected by pulling the connectors upwards by hand. There are two air inlets underneath the left and right seats to the control valves behind the seats.

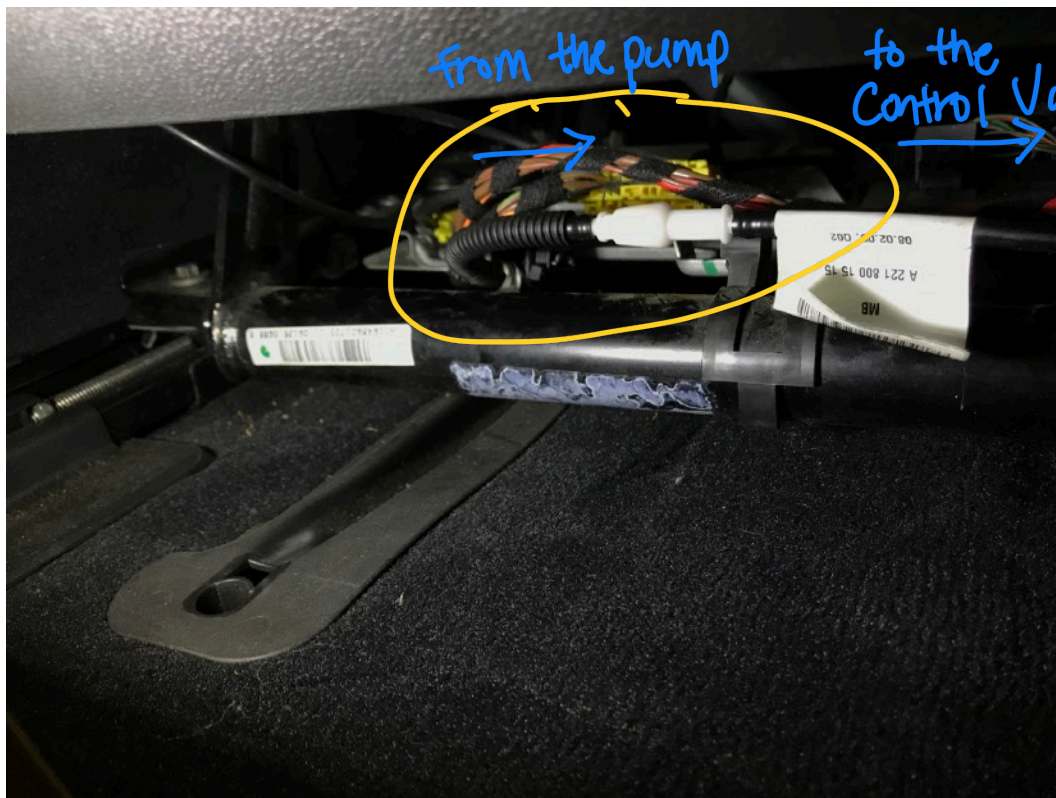
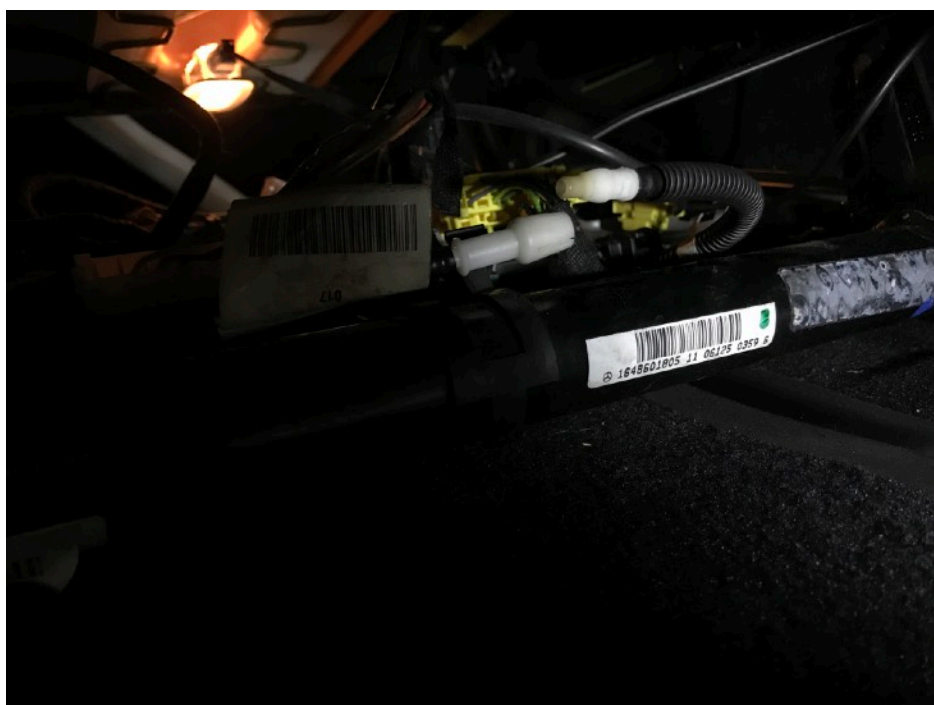
Move the seat all the way up. Disconnect the interconnect connector underneath the seat by starting the vehicle and check if there is any air coming out. Do this before the pump timeout. If no air or weak air is coming out then you probably have a bad pump or the pneumatic line is cracked between the pump and this connector. The pneumatic line is very brittle due to aging. Be very gentle.

In my case, I had air coming out. Next step is to check the bladders behind the seats.

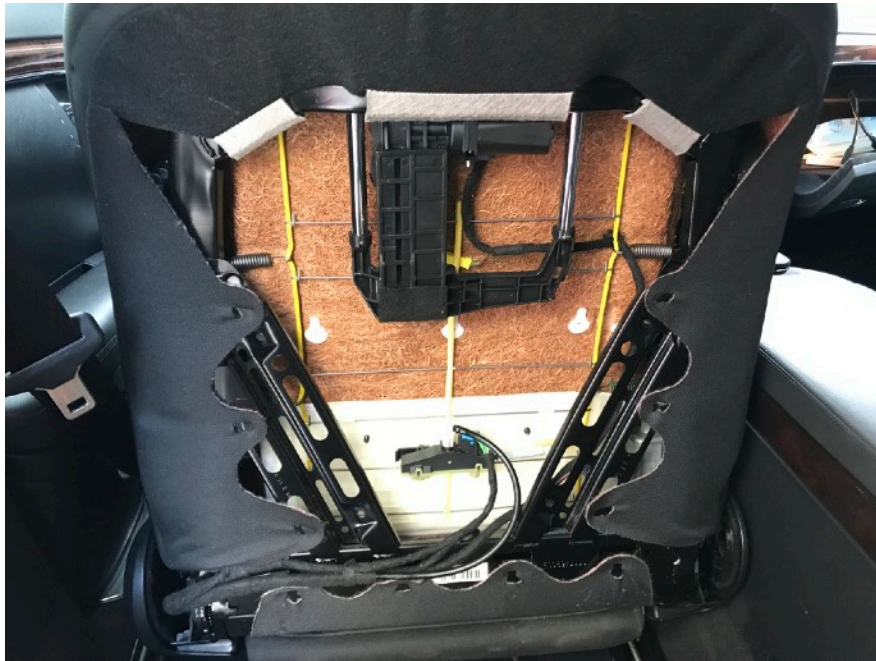
Once the panel is off you will be able to see the air bladders and have access to the control valve. If you have the fancy dynamic seat from S550 then it will look very different, however I would think the troubleshooting is similar.

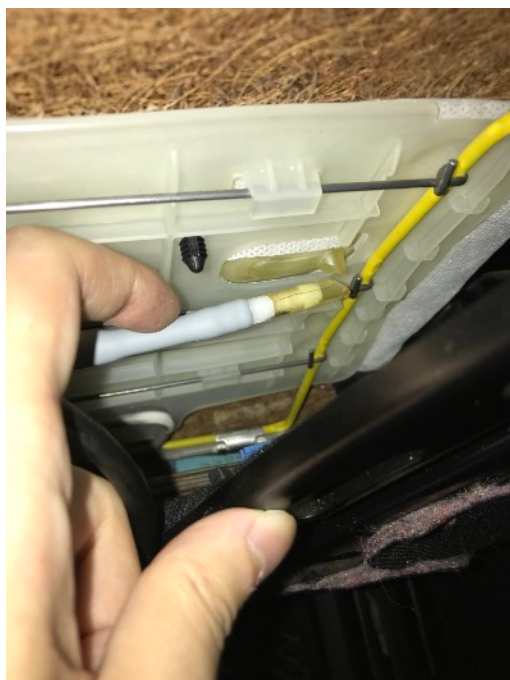
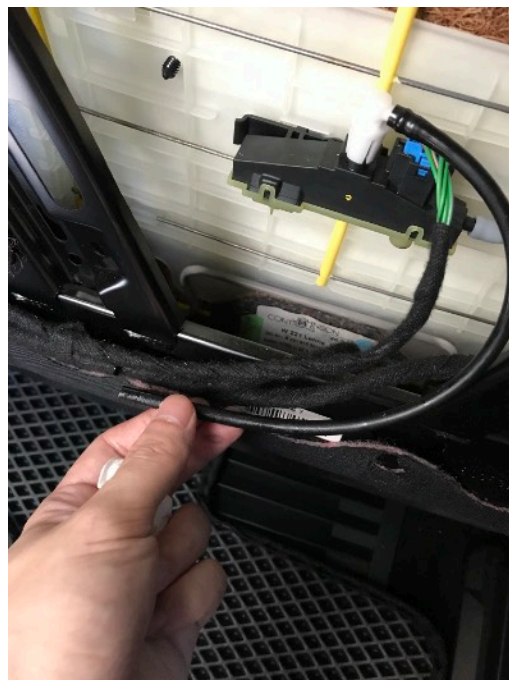
In my case, I had a broken connector on the TPU bladder and cracked pneumatic line.

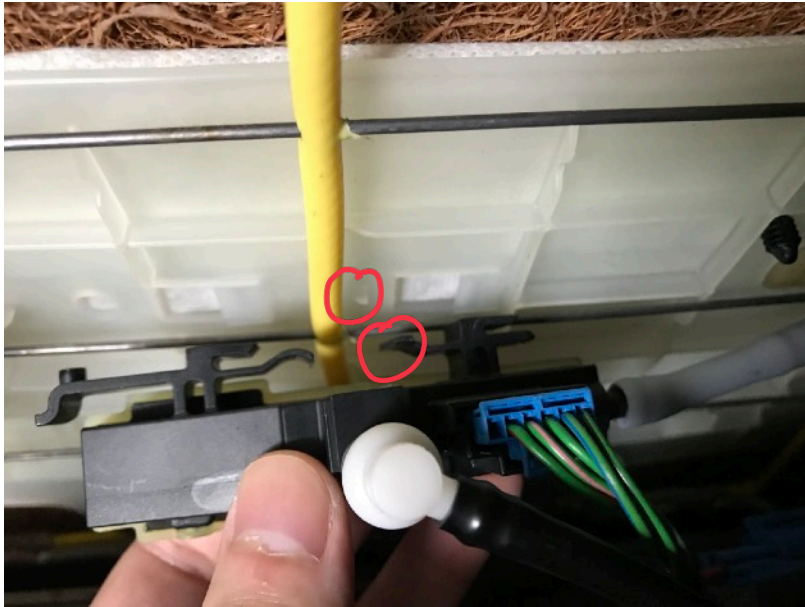
Remove the control valve by using a flat screwdriver to lift up the clip to slid through the “stopper”.

I believe this is a solenoid valve and without electrical signal, the valve will always hold the air inside the bladder (normally close solenoid valve) and air can only be released by disconnecting the top white connector. So if your bladders are not deflating properly then the it should be solenoid valve related.

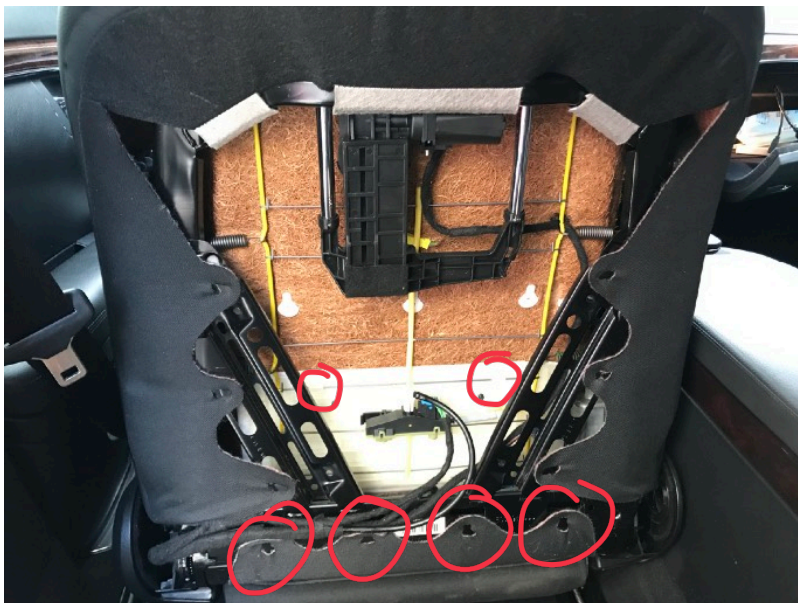
Remove the bottom fabrics fasten to the metal clips. Remove the lumbar support holder off the metal frame.

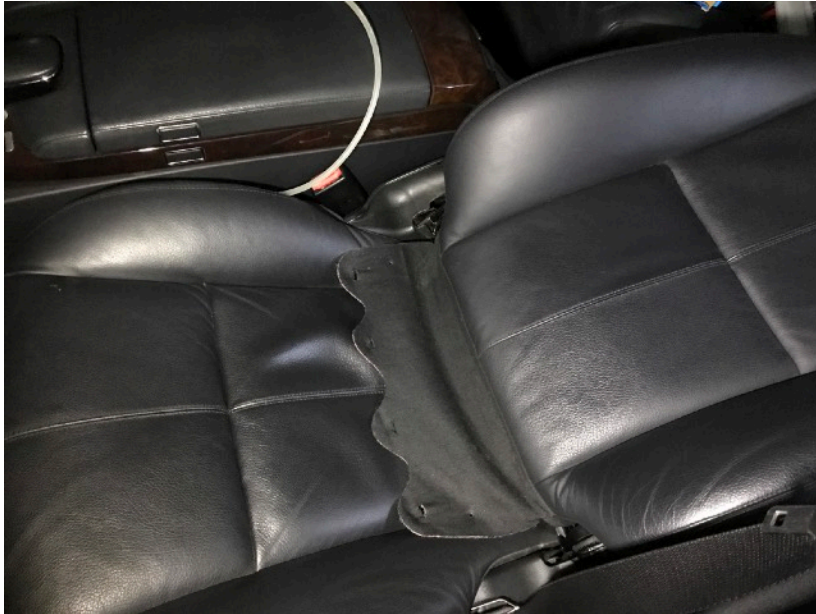
Recline the seat all the way backward, move the front section of the bottom seat upward will open up space to pull out the fabrics.

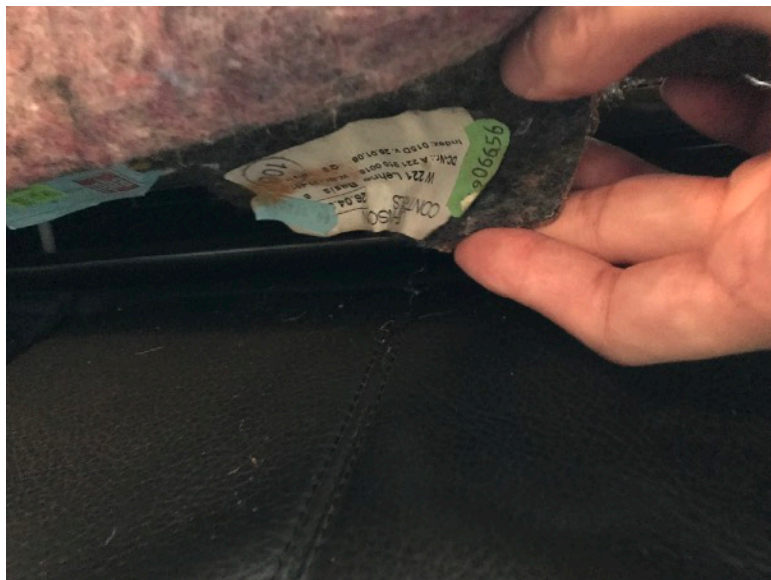
Lift this fabric up, now you can slide your hand between the metal frame to pull out the lumbar support bladder. There are seat air bags near the shoulder area so make sure to remove everything gently.

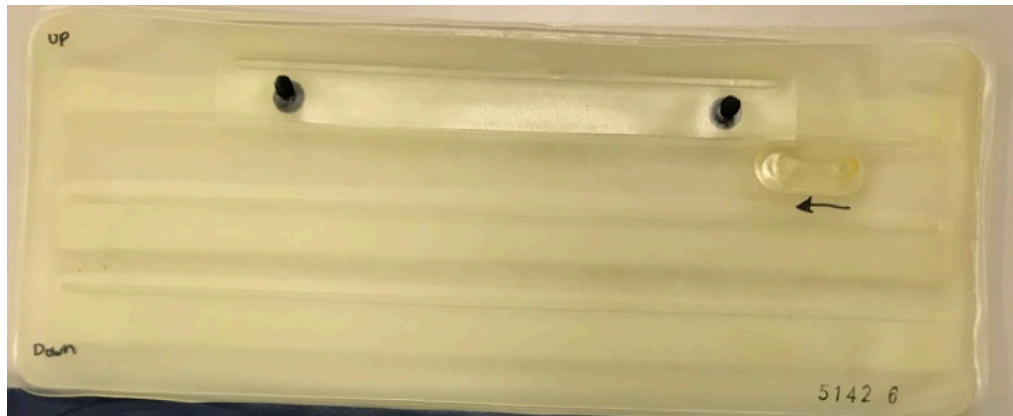
This bladder is made of TPU (Thermoplastic Polyurethane). It is not made with vinyl such as PVC. The only way to properly seal this up is using high frequency welding (RF welding) which the material itself creates heat by friction from dipole polarization. You can buy these used from eBay but I do not recommend it because it will most likely fail again very soon. A brand new bladder is recommended.

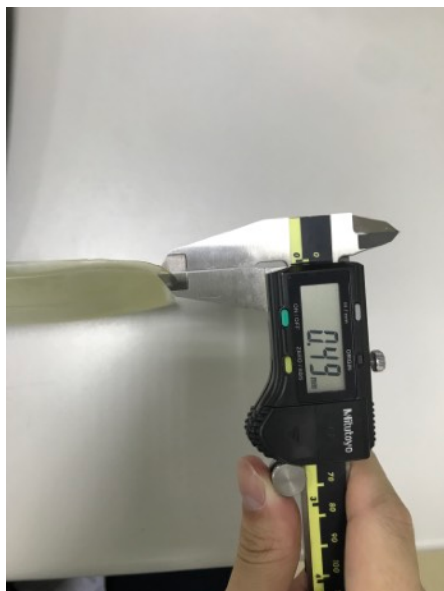
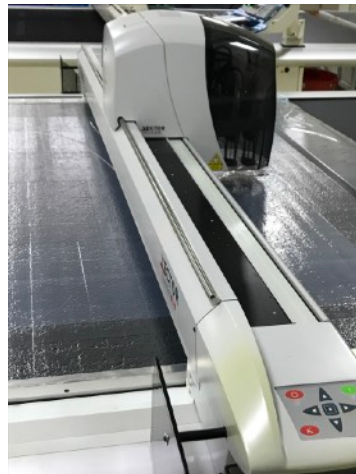
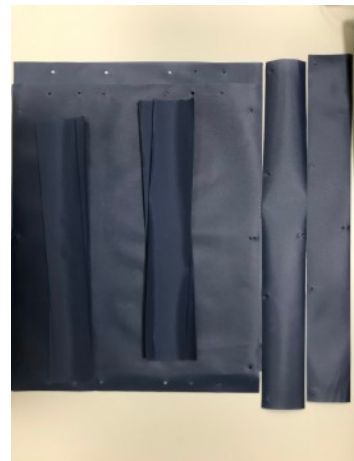
The original TPU bladder is 0.5mm which is very thick. So I decided to use a nylon reinforced TPU.

With some luck, I have the suitable machines and parts for this project (this part can be skipped. Just buy a new bladder):

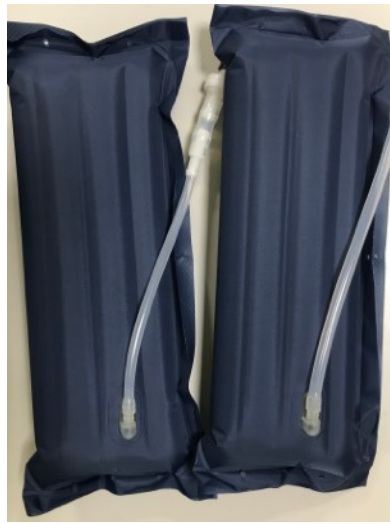
Weld the fabrics

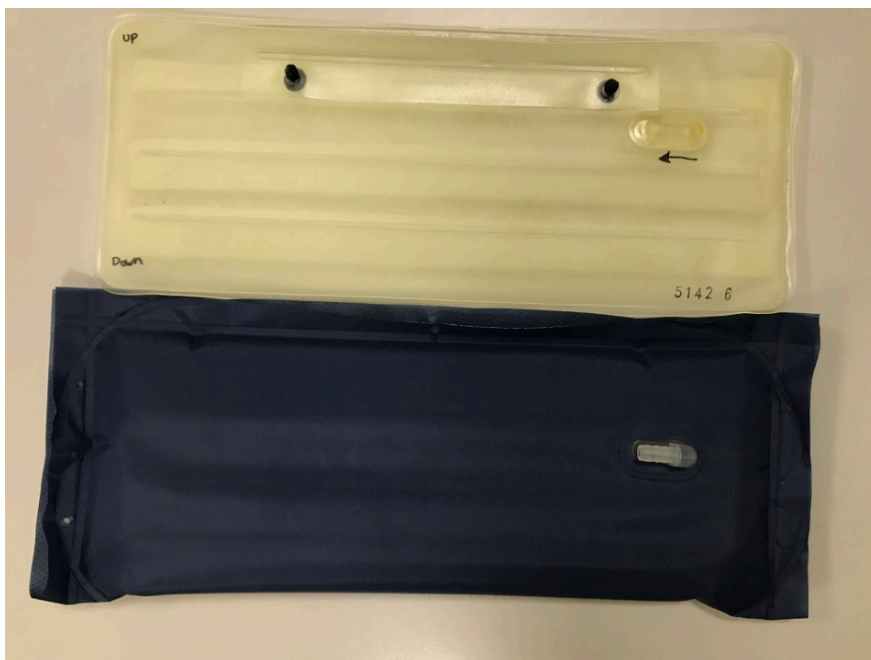
Leaking test

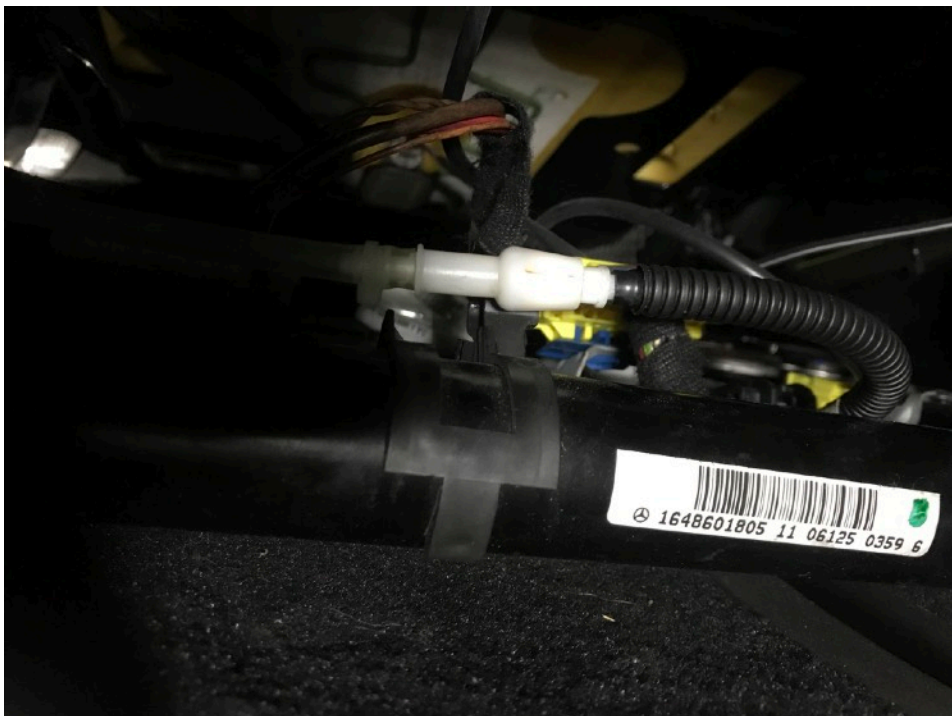
Now put everything back together. Make sure bladder is deflated when fasten the bottom fabrics.

In my case, there were additional leaks between the inlet underneath to the control valve. Instead of unwrapping all the sticky wire coiler and removing the seat I just use a PVC tube to direct the air from the air inlet to the control valve.

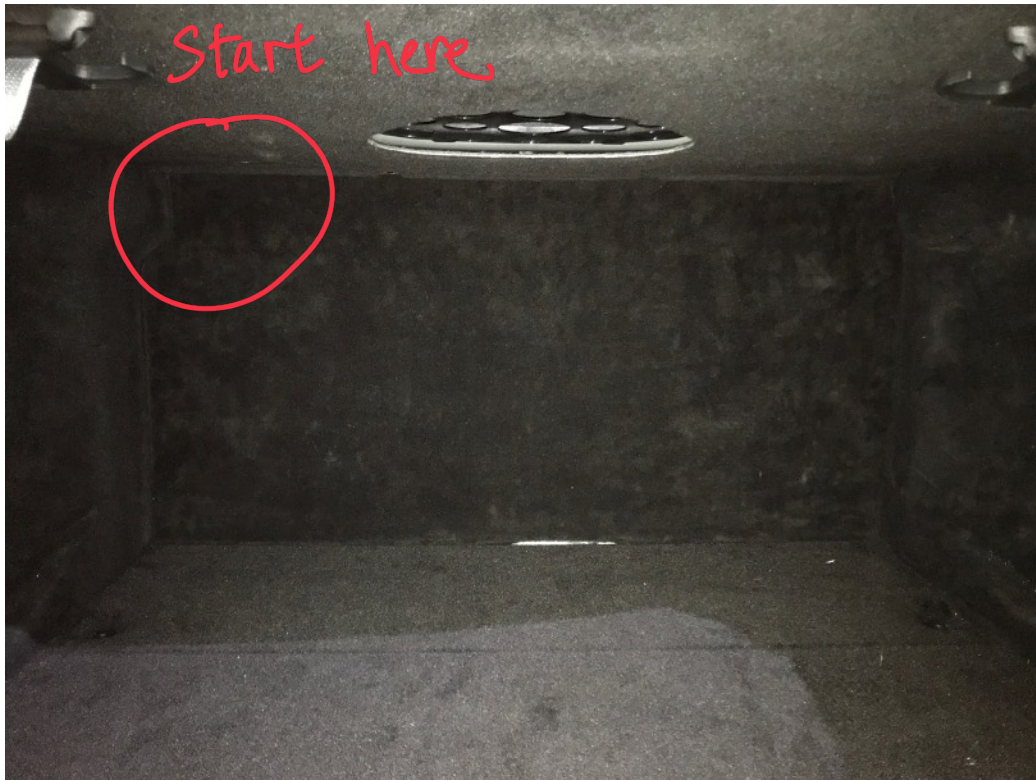
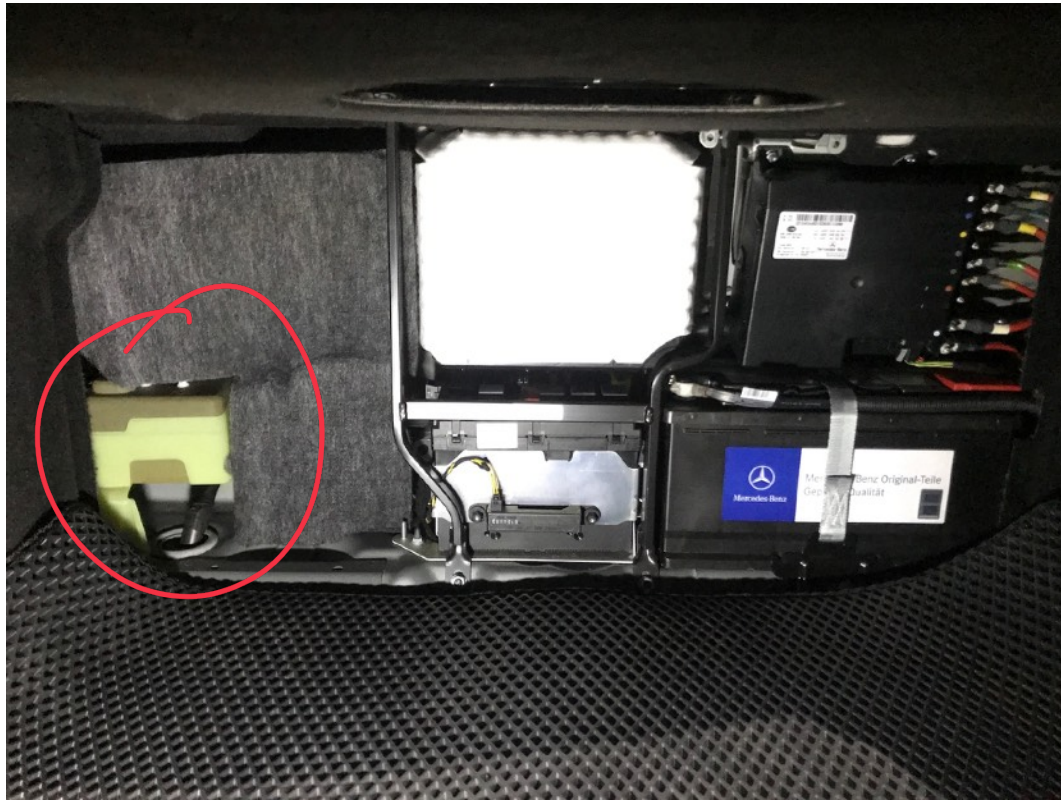
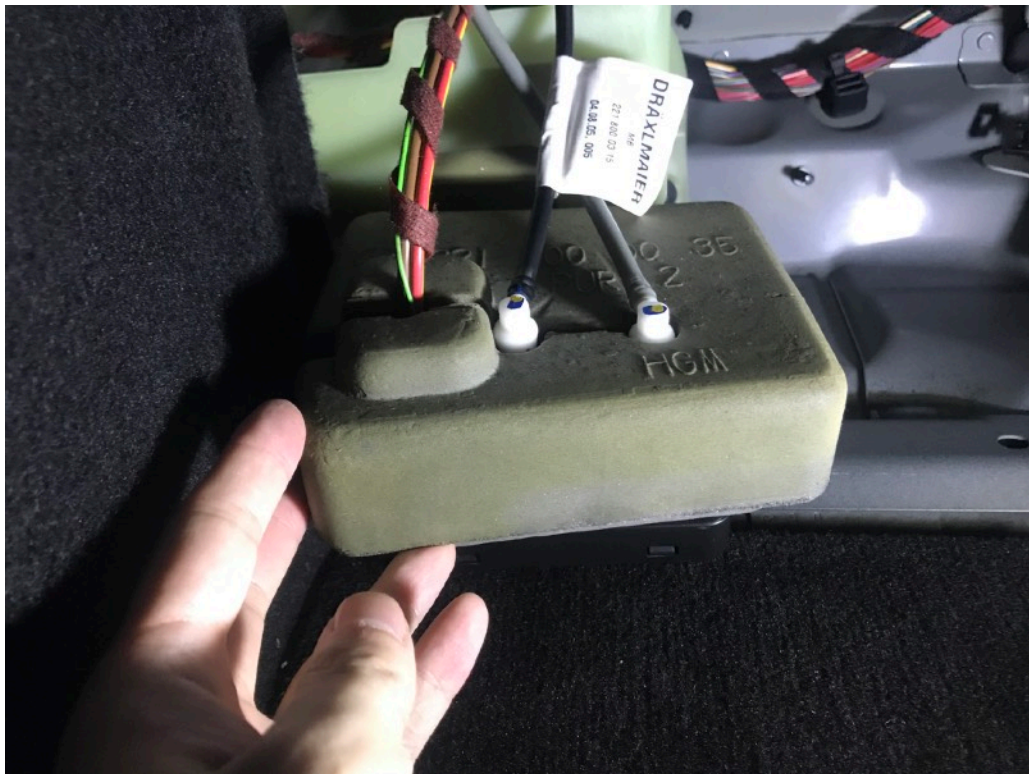
First remove the panel in the trunk to get access to the pump. If find this very difficult in the beginning but eventually pulled the panel off from the top left corner with some force.

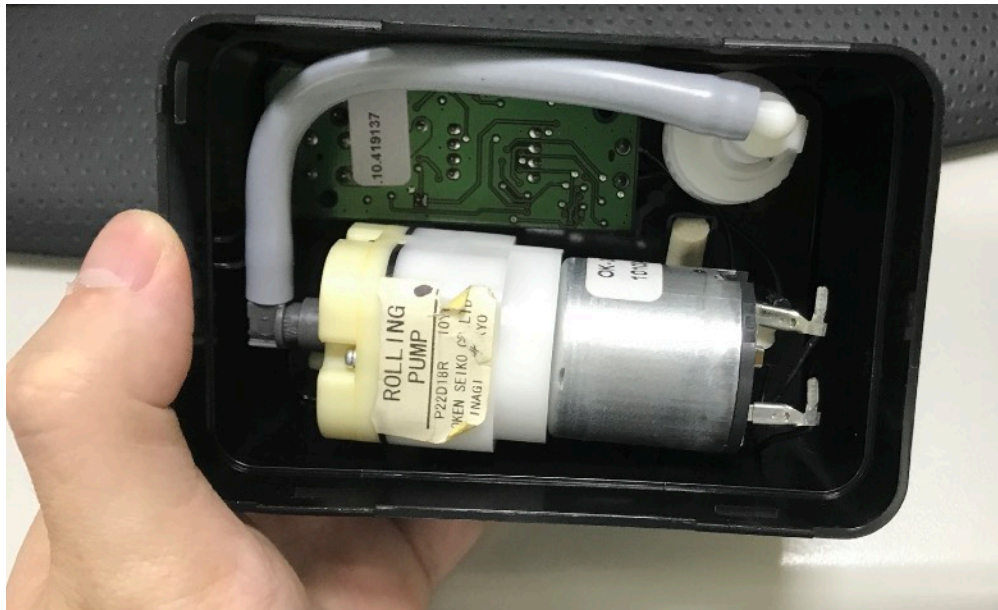
Remove the insulation and take out the compressor pump.

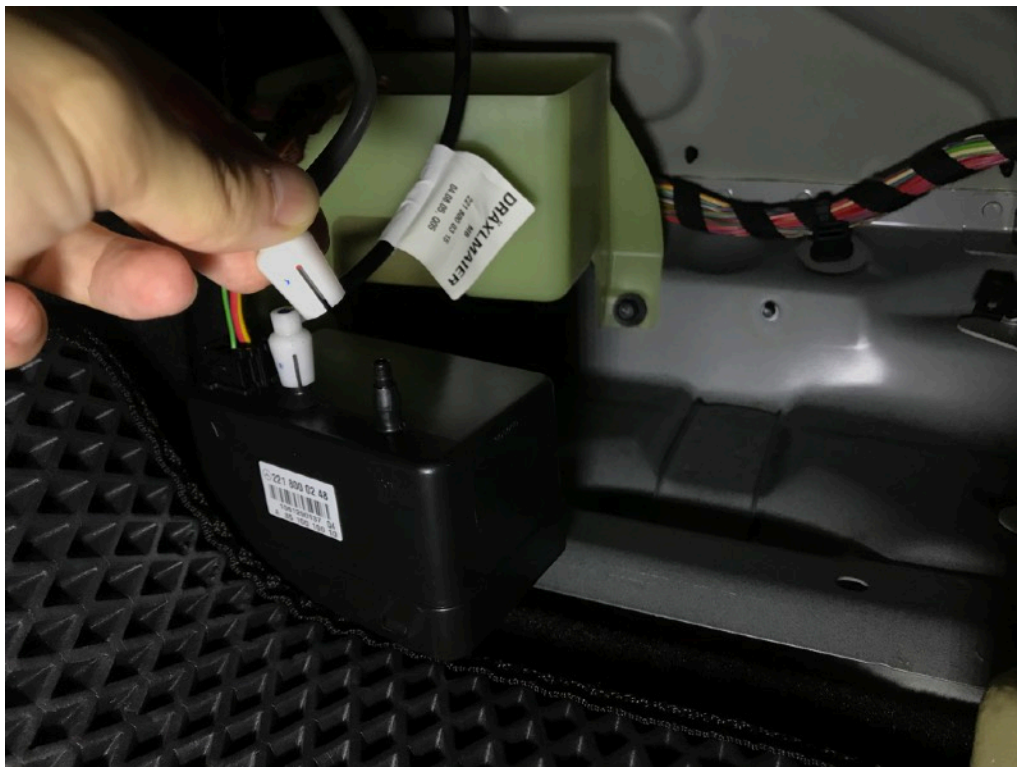
Open up the pump we can clearly see one outlet is for air and the outlet closer to the cables is the pressure transducer.

Disconnect the connector further away to the electrical cable and you should be able to feel strong air coming out or you can measure the pressure and if I remember it correctly it was somewhere above 150mmHg. If you are not getting 0mmHg then the pump is probably good. For mine it was a gray tube which is a different color than the pneumatic line found under and behind the seat.
