## Cracking/grunting noises from area of front axle when driving over large road undulations

Topic number	LI32.35-P-047253
Version	1
Design group	32.35 Stabilizer
Date	07-07-2009
Validity	Model series 221 with SA code 489 (Air suspension)
Reason for change	Supersedes DTB P-B-32.20/47c
Reason for block

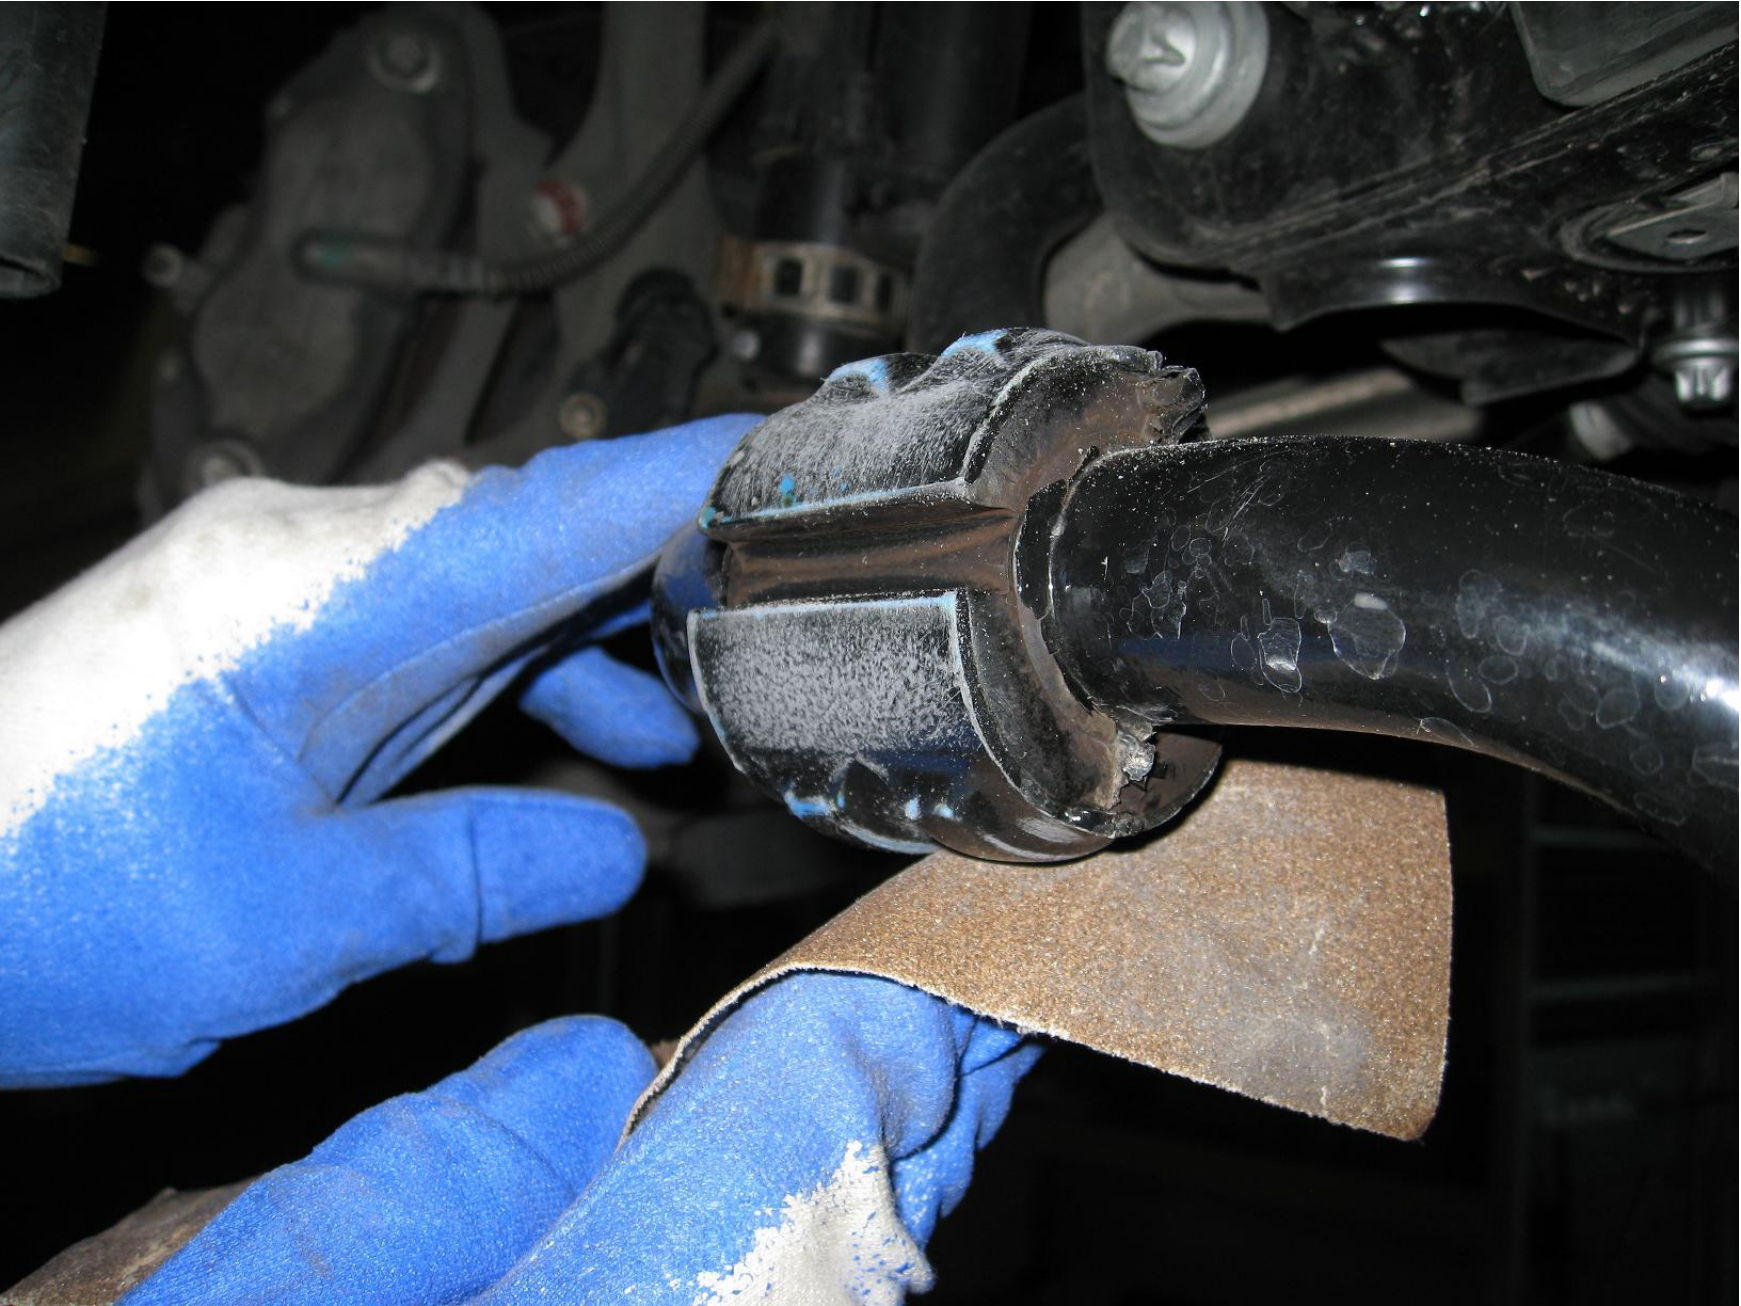
Note: Only use adhesive A005 989 0971 (Figure 1)

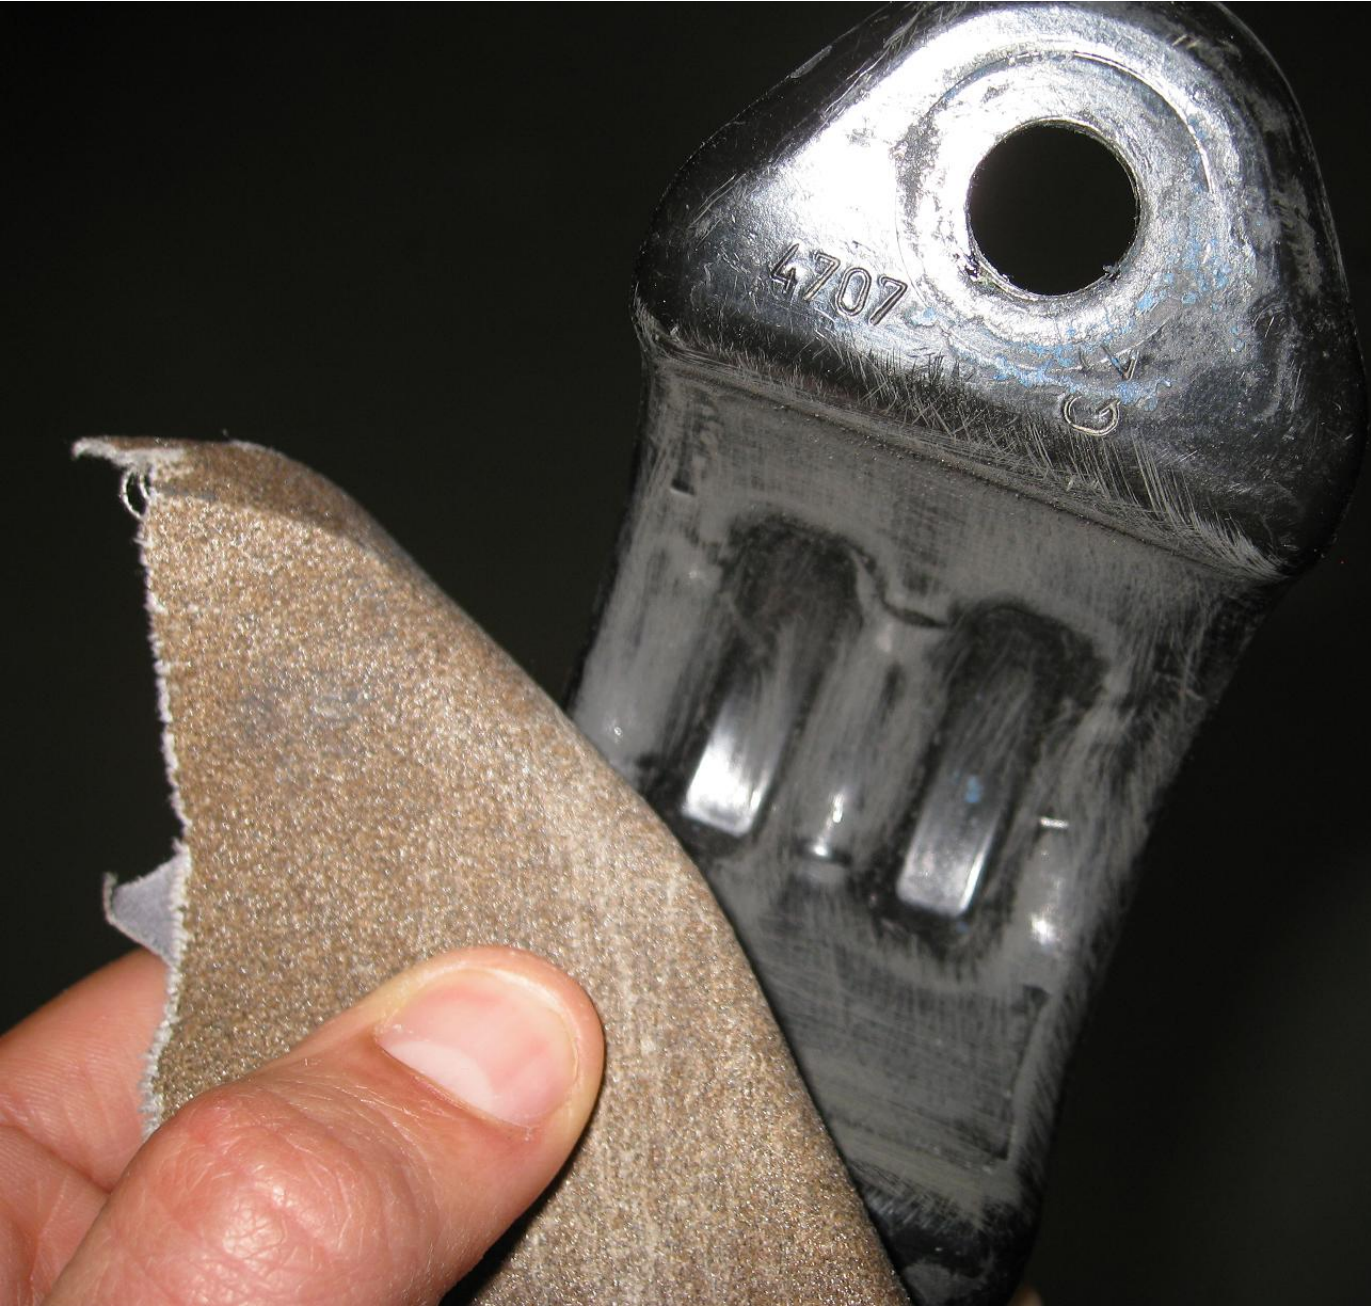
1. Detach torsion bar from torsion bar linkage and remove torsion bar mounting clamps.
2. Roughen up torsion bar mount using emery paper (Figure 2)
3. Roughen up torsion bar mount shell using emery paper (Figure 3)

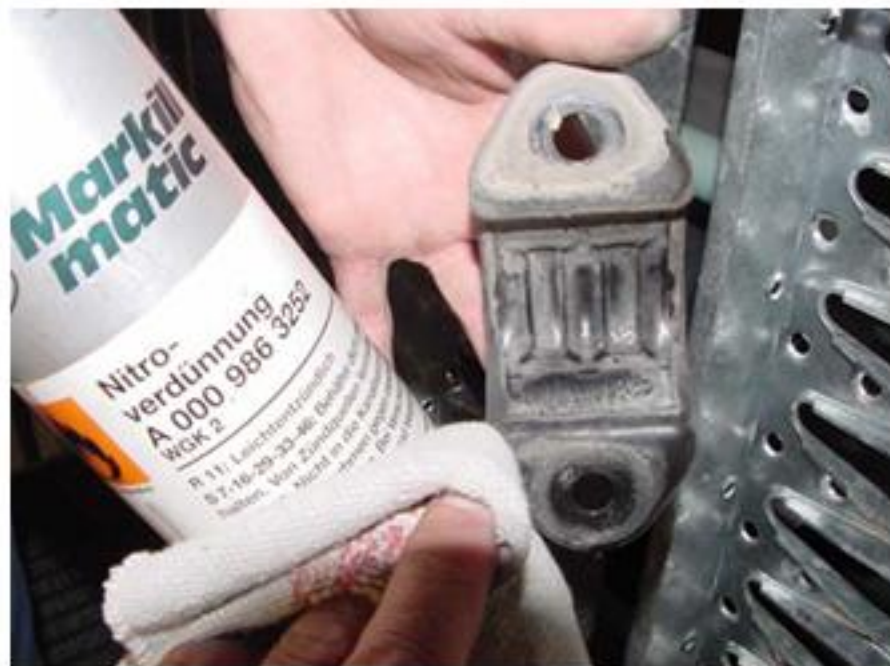
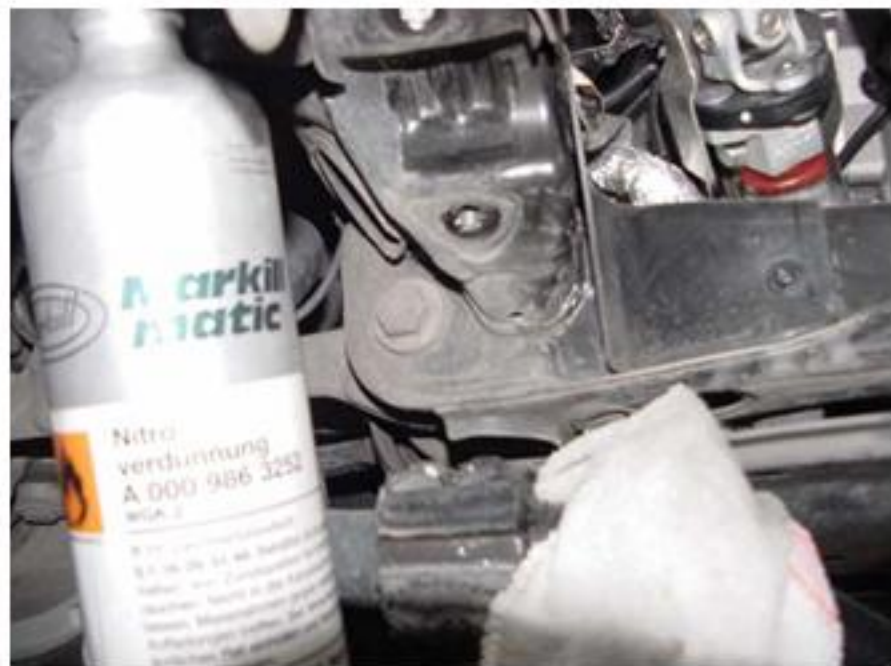
4. Roughen up counterpart of torsion bar mount in frame-type integral support using emery paper (Figure 4)
5. Clean roughened surfaces with nitro thinner, brake cleaner or similar (Figure 5)
6. Squeeze all the component adhesive out of the tubes and mix thoroughly. Use up all the adhesive (Figure 6)
7. Apply adhesive evenly to torsion bar mount, torsion bar mount shell and recesses in frame-type integral support. (Figure 7, Figure 8, Figure 9)
8. Within 5 min bolt the torsion bar onto frame-type integral support (tightening torque 70 Nm) and remove excess adhesive (Figure 10)
9. Remove vehicle from vehicle lift and allow adhesive to cure for 1h.
