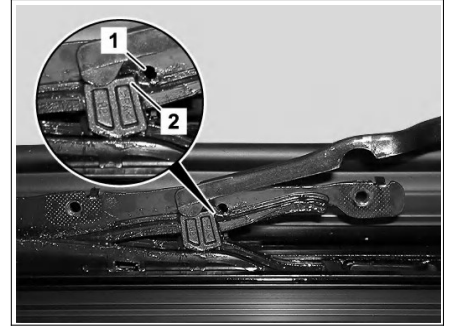
P77.20-2609-01

i Shown with tilting/sliding roof cover removed

- 1 Check position of hole (1) in upper gate, in relation to drive wedge (2) in lower gate.
i Distance of hole (1) to drive wedge (2) max. 3 mm, deviation from left to right side of vehicle, approx. 2 mm.
