Mercedes-Benz

Campaign No. 2018010009, March 2018

SUBJECT: **Models 222, 166, and 292 Model Years 2017 and 2018**
Check Left Door Locks, Replace if Necessary

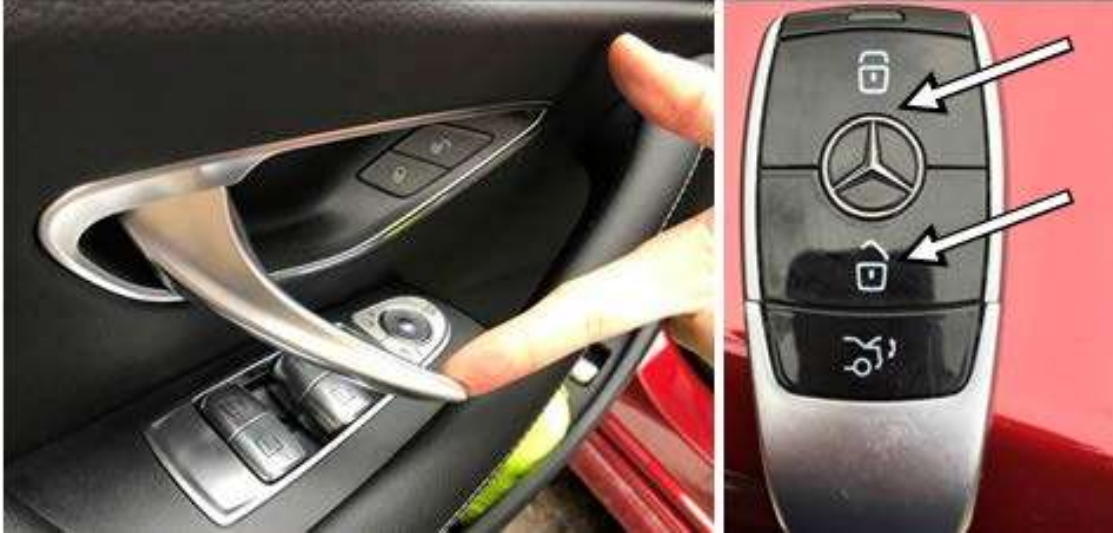
Figure 1

1. Open left rear door, pull on the inside door handle of the rear door. At the same time, lock and unlock the vehicle five times using the remote control.

2. Close the left rear door and lock the vehicle completely using the remote control.
3. On the locked vehicle, pull on the left rear door's outside door handle.
 - a. If the door on a locked vehicle can be opened: Carry out **work procedure**.
 - b. If the door on a locked vehicle **cannot** be opened: **End measure**.

1. **Replace left rear door lock.**
