Shown on right front seat

P91.60-3104-04

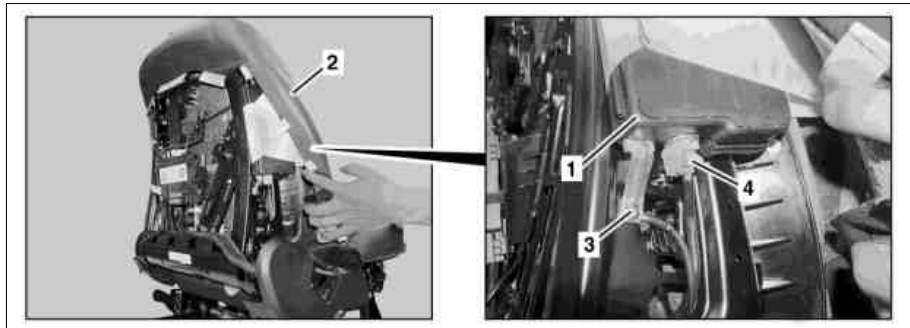
- 1 Sidebag unit
- 2 Backrest cover
- 3 Rivet
- 4 Electrical connector

Remove/install		
	Danger!	Risk of injury caused by performing testing or repair work on airbag or emergency tensioning retractor units.	Store airbag units with deployment side facing up; do not expose to temperatures greater than 100 °C. When working on these units, disconnect the power supply.
		Notes on performing repair, body work and welding on vehicles with airbags and ETR units	AH91.00-P-0002-01M
		Assessment of airbag and belt tensioner units in accident vehicles	AH91.00-P-0006-01B
		Legal regulations on handling and storing airbags and emergency tensioning retractors	AH91.00-P-0004-01A
1		Move left or right front seat forwards	
2		Detach ground line to starter battery and on-board electrical system battery	AR54.10-P-0003SX
3		Remove seat-back lining on front seat backrest	
4		Release backrest cover (2) in area of sidebag unit (1)	
5		Drill out rivet (3).	Hand riveter Drill (electric/pneumatic) *WH58.30-Z-1003-29A *WE58.40-Z-1001-03A

Detach electrical connector (4) and remove sidebag unit (1)	If sidebag unit (1) is replaced, the defective sidebag unit (1) must be properly disposed of. Refer to: ↓ Notes on disposing of airbag and emergency tensioning retractor units OS91.00-P-0001-01A
7		Install in the reverse order

8.1		Check supplemental restraint system (SRS) using STAR DIAGNOSIS Connect STAR DIAGNOSIS and read out fault memory	After replacing sidebag unit (1). STAR DIAGNOSIS diagnosis system AD00.00-P-2000-04A *WH58.30-Z-1048-13A
