Model 217, 222.0/1/9
up to model year 2018

Shown on model 222 except for code 582 (rear air conditioning)

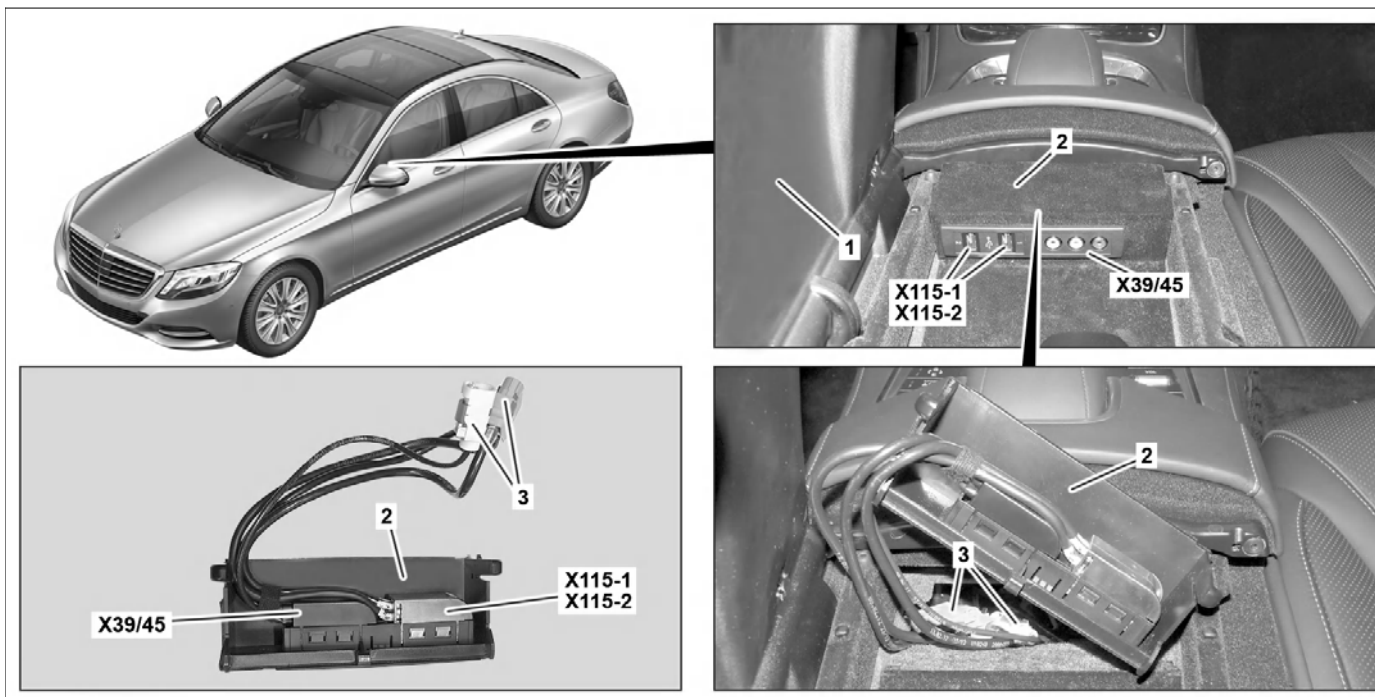
P82.60-9266-09

- 1 Armrest cover
- 2 Cover
- 3 Electrical connectors

- X39/45 AUX jack electrical connector
- X115-1 USB 1 electrical connector
- X115-2 USB electrical connector 2

Notes on avoiding damage to optical fibers during repair work		AH82.60-P-0001-05AK
	Information on preventing damage to electronic components due to electrostatic discharge		AH54.00-P-0001-01A
	Remove/install		
1	Open armrest cover (1)		
2	Unclip cover (2) upward	Removal assembly	*000589886300
3	Release and disconnect electrical connectors (3)		
4	Release and disconnect electrical connector 1 USB (X115-1), electrical connector 2 USB (X115-2) and electrical connector AUX connection(X39/45)		
5	Remove cover (2)		
6	Install in the reverse order
