Model 222

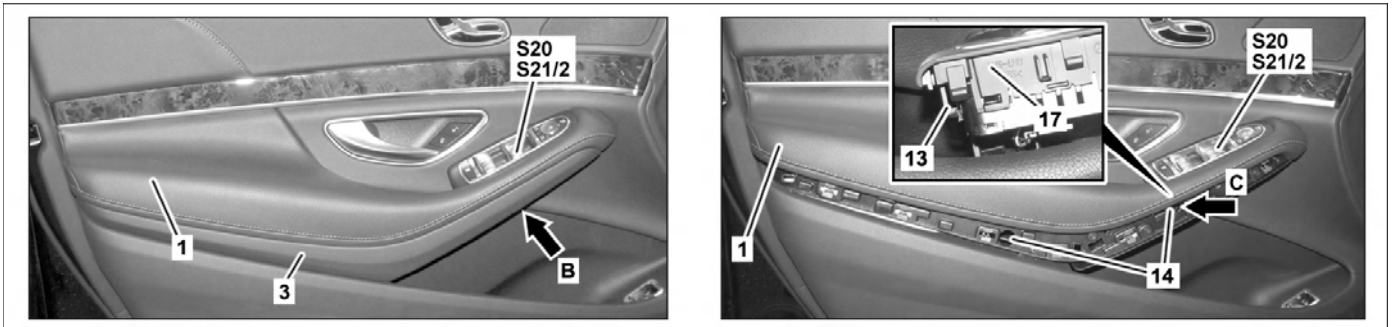
P72.10-4057-07

| 1 | Door lining | 14 | Bolts | S21/2 | Power window switch, front passenger side |
| 3 | Trim piece | 17 | Frame | | |
| 13 | Catch hook | S20 | Power window and outside mirror adjustment switch group, driver side | | |

Clip remover	*452589016300
3	Unlock catch hook (13) through opening (arrow C) in door lining (1) and remove frame (17) with driver side power window and outside mirror adjustment switch group (S20) or passenger side power window switch group (S21/2) upward out of door lining (1)	<b>i</b> Do not disconnect electrical connector.	
4	Remove screws/bolts (14)		
5	Unclip cover (12) and unscrew bolt below	Model 222 with code Z07 (Top protection)	
6	Unclip left front door exit and warning lamp (E17/3) or right front door exit and warning lamp (E17/4) from door lining (1)	<b>i</b> Do not disconnect electrical connector.

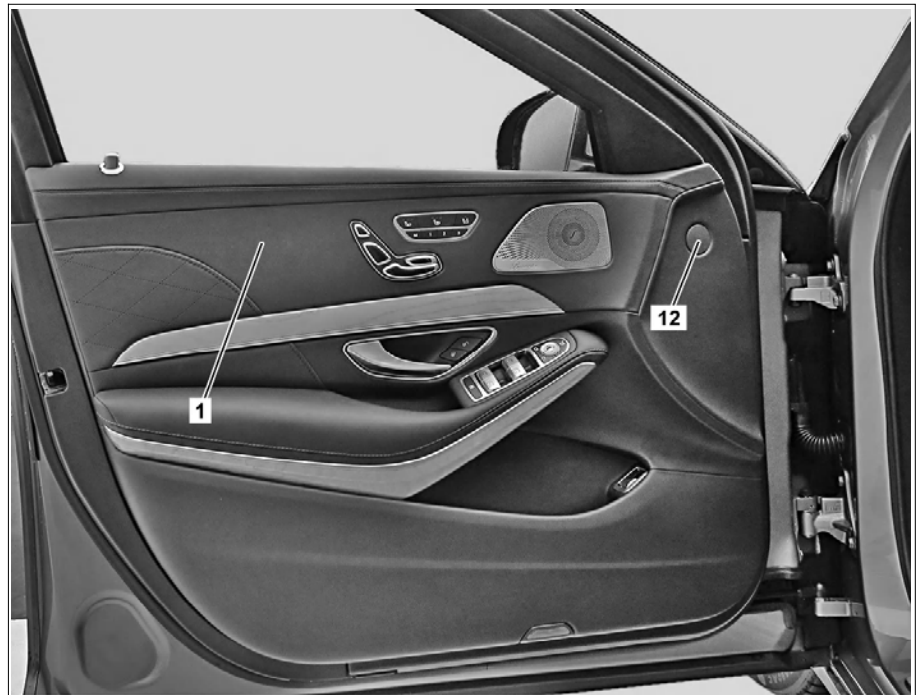
P72.10-4334-06

Shown on MODEL 222 with CODE Z07 (Top protection)

| 1 | Door lining |
| 12 | Cover |

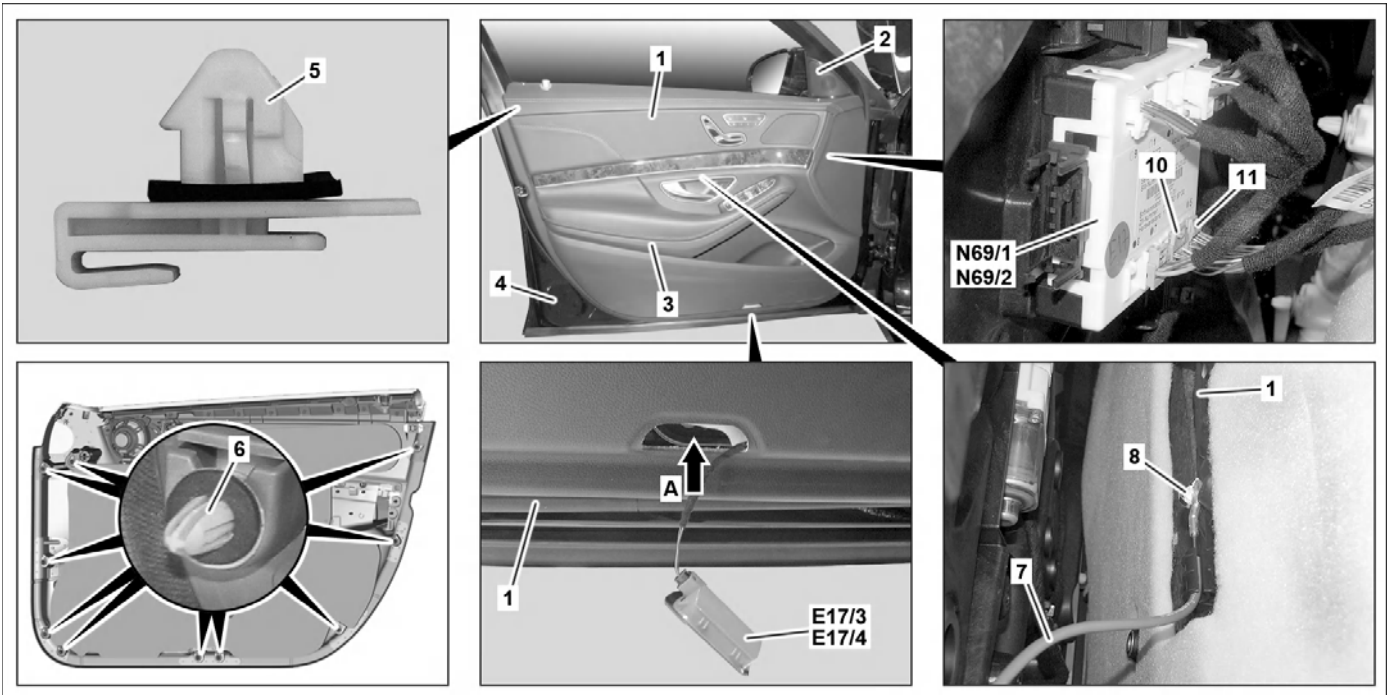
P72.10-4056-09

| 1 | Door lining | 6 | Mounting clip | E17/3 | Left front door exit and warning lamp |
| 2 | Mirror triangle paneling | 7 | Inside door opener cable | E17/4 | Right front door exit and warning lamp |
| 3 | Trim piece | 8 | Inner door handle | N69/1 | Left front door control unit |
| 4 | Front door | 10 | Electrical connector | N69/2 | Right front door control unit |
| 5 | Mounting clip | 11 | Electrical connector | | |

Clip remover	*452589016300
7	Reach into opening (arrow A) and carefully unclip retaining clip (6) on door lining (1) by pulling carefully to inner sealing rail

8	Slightly pivot door lining (1) toward inside of vehicle, then remove horizontally starting at front from inner sealing rail and push toward rear until door lining (1) moves out of retaining clip (5) and retaining clip (5) releases from front door inner panel (4)		
9	Remove door lining (1) from front door (4) until electrical connectors (10, 11) on left front door control unit (N69/1) or right front door control unit (N69/2) and inside door opener wire (7) are accessible		
10	Disconnect electrical connectors (10, 11) from left front door control unit (N691) or right front door control unit (N692)		
11	Unhook inside door opener cable (7) on inside door handle (8)		
12	Disconnect electrical connector (15) from left front door midrange speaker (H4/72) or right front door midrange speaker (H4/73)		
13	Remove door lining (1)	<b>i</b> Guide left front door warning/exit lamp (E17/3) or right front door warning/exit lamp (E17/4) through door lining (1) with electrical lines connected and allow to hang down. <b>i</b> <b>Installation:</b> The new door lining (1) is delivered together with the speaker grille. If it is different than the previously installed speaker grille, transfer or replace.

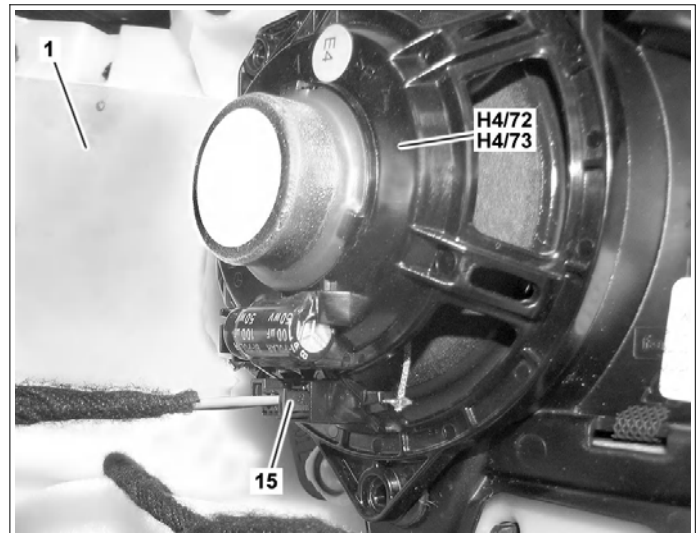
P72.10-4058-11

| 1 | Door lining |
| 15 | Electrical connector |
| H4/72 | Left front door midrange speaker |
| H4/73 | Right front door midrange speaker |
