Model series 222, noises when sitting down, driver seat backrest with rubberized hair mat, without SA code 432

Topic number	LI91.10-P-060008
Version	1
Design group	91.10 Front seats
Date	10-15-2014
Validity	Vehicles not OK as of 01.02.2014 without SA code 432
Reason for change	Remedy expanded
Reason for block

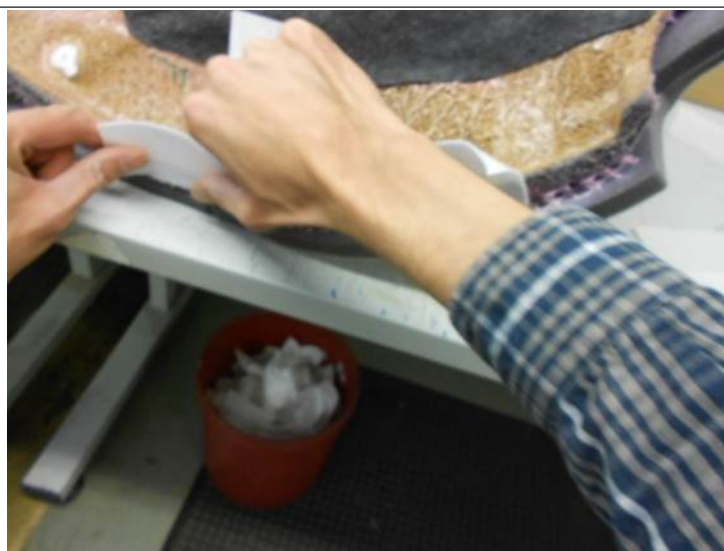
Pic 1.jpg:

Attachments	
File	Description
Pic 1.jpg	Stick on felt strip
Pic 2.jpg	Fold felt strip inwards
Pic 3.jpg	Press felt strip into contour
Pic 4.jpg	The finished backrest padding

1. The felt strip is stuck flush along the side flank following the contour. (pic1)
2. Carefully fold the felt strip inwards. Make sure that the felt strip does not wrinkle. (pic 2)
3. The felt strip must be pressed firmly into the contour. (pic 3)
