Mercedes-Benz

Campaign No. 2019040025, April 2019

SUBJECT: **Model S-Class and S-Class Coupe vehicles (222 and 217 platforms)  
Model Years 2018-2019  
Check and Rework Steering Boot**

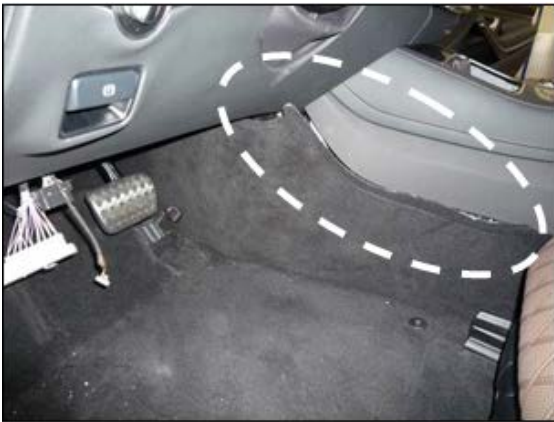
**Figure 1**

1. Remove cover under instrument panel at left.  
 For basic data, see **AR68.10-P-1500LF**.
2. Remove accelerator pedal.  
 For basic data, see **AR30.12-P-1321LF**.
3. Guide left front floor covering out of center console (**figure 1**).
4. Guide left front floor covering under brake pedal (**figure 2**).

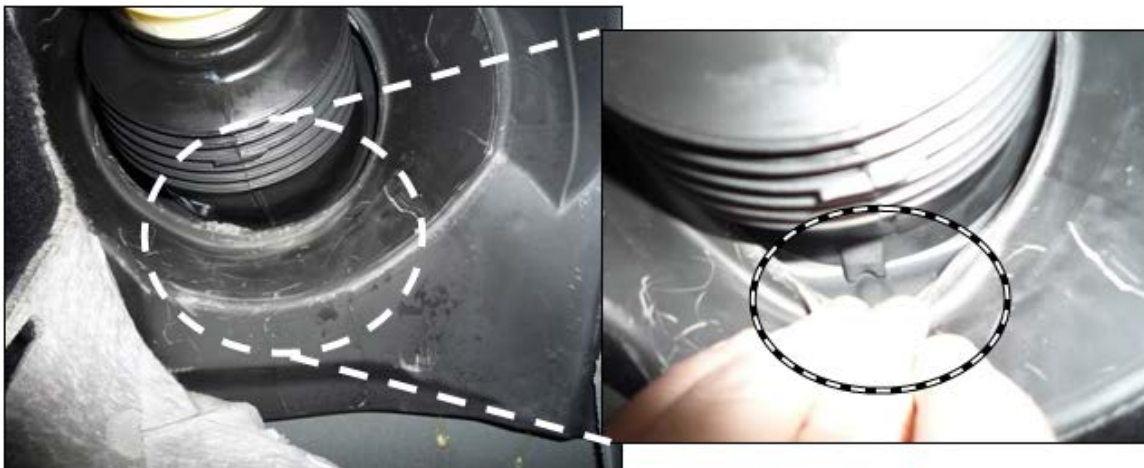
**Figure 3**

5. Press damping in lower area of steering boot downward until the mark is visible (**figure 3**).

6. Check installation position of steering boot.  
 Check position of markings on steering boot and firewall (**figure 3**)

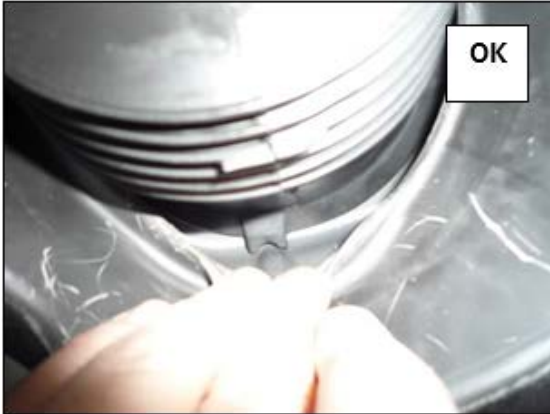
Figure 4

- a. **Installation position** of steering boot **NOT OK**: Carry out **Work Procedure 1**.
- b. **Installation position** of steering boot **OK**: **Work Procedure complete.**

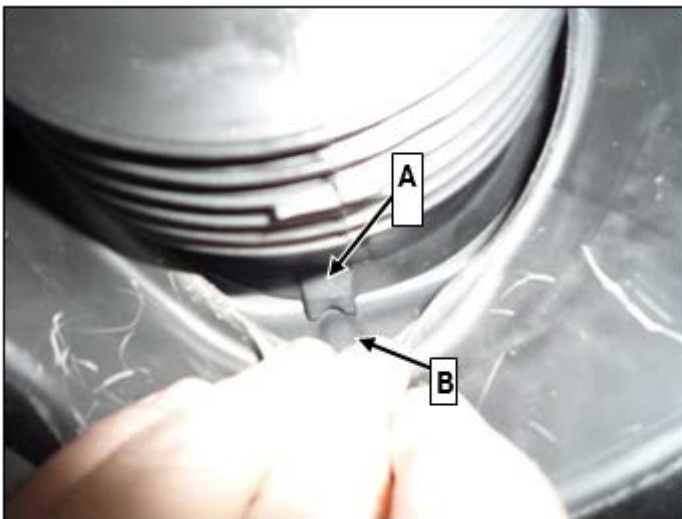
Figure 6

**i** Turn steering boot far enough until the marking on the steering boot **(A)** matches the marking on the firewall **(B)** (**figure 6**).

**i** The folds of the boot must not be deformed.

1. Correct installation position of steering boot.
