Roadster soft top open or hardtop removed Front seat cushion removed (91-055)

Removal, installation

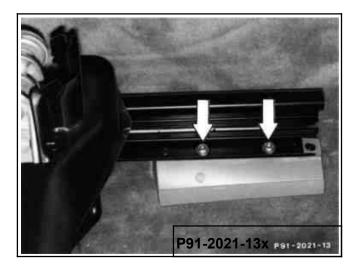
3 Unscrew screws (2 each) at rear on right seat rail.

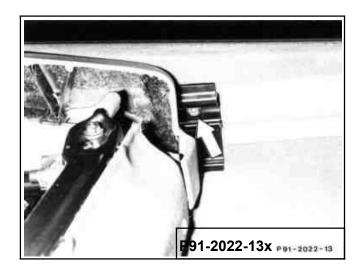
- 7 Unscrew screw (1 each) at front on left seat rail.
- 8 Turn ignition key to 0 position.
- 9 Disconnect negative pole on battery and cover.
- 10 Disconnect red 10-pin connector in footwell.
