AP46.40-P-4650-01BA	Check tie rod and center link for play

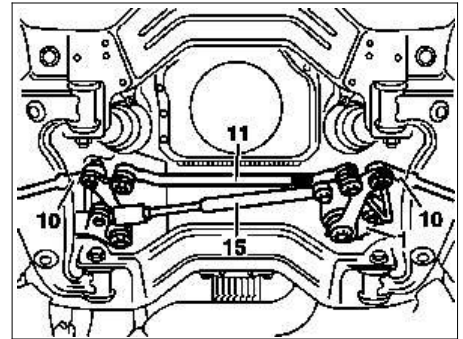
P46.40-0211-01

- Check track rod and drag link joints by pulling back and forth with force or
- move steering wheel from left to right and vice versa approx. 100 mm while having a second mechanic feel the track rod and drag link joints.

Vehicle must be standing on wheels.

If play is present, replace track rod ball joints or drag link	
---------------------	--	--	--

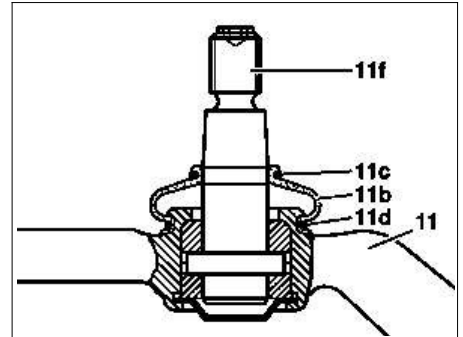
P46.00-0223-01

On model 140 the left drag link joint and on model 202, 208, 170 the right drag link joint is a pin type joint.

This prevents the drag link from tipping.
