AR68.30-P-8150R	Remove/install trunk lid paneling	20.12.05
-----------------	-----------------------------------	----------

MODEL 230.4

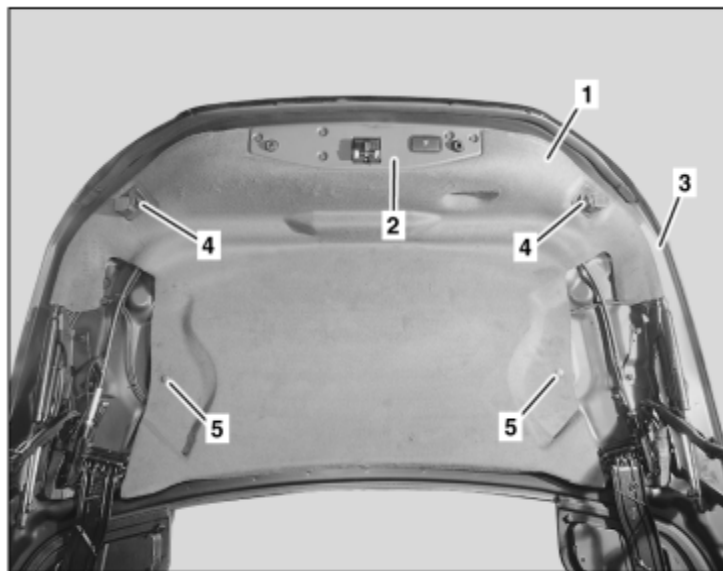
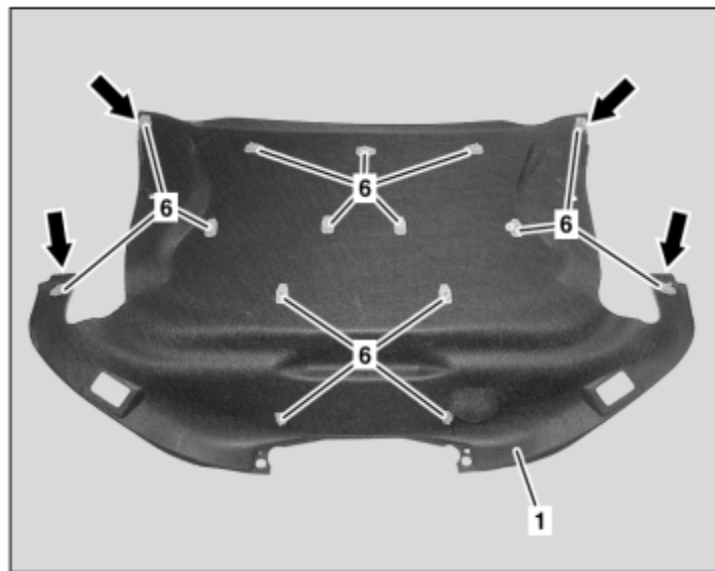
P68.30-3262-08

- 1 Paneling
- 2 Cover
- 3 Trunk lid

- 4 Closing wedge
- 5 Expansion clip
- 6 Clip

1	Completely open Vario roof		
2	Remove cover (2) from trunk lid (3)	i Installation: Replace damaged expansion clips.	
3	Remove closing wedges (4) from trunk lid (3)	Nm	BA88.50-P-1015-01A
4	Remove expansion clips (5)	i Installation: Replace damaged expansion clips (5).	
5	Unclip paneling (1) from trunk lid (3) starting at outer clips (6) (arrows) and remove.	! Position mounting wedge directly to corresponding clip (6) to unclip, to prevent damaging paneling (1).	
		i Installation: Replace damaged clips (6).	
		!	110 589 03 59 00
6	Install in the reverse order		
7	Check trunk lid adjustment (3), correct if necessary	Vehicles up to vehicle ident. end no. 063909	AR88.50-P-5200R
		Vehicles as of vehicle ident. end no. 063910	AR88.50-P-5200RA
