Dismantle constant velocity joint

Check constant velocity joint

Assembling CV joint

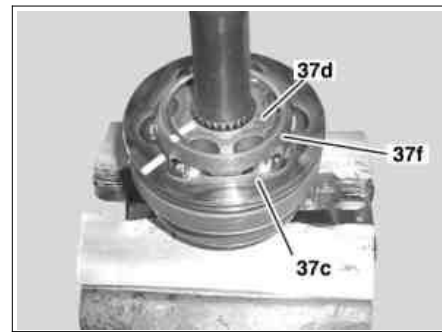
P35.30-2050-01

1 Mark the position of the joint ring (37c), joint hub (37d) and ball retainer (37f) in relation to one another.

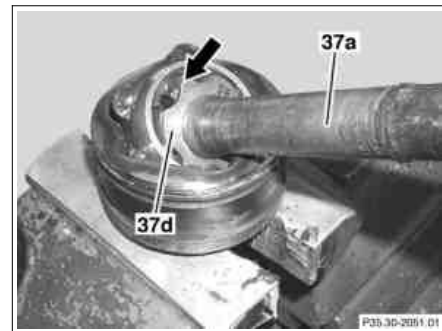
P35.30-2051-01

2 Align rear axle shaft (37a) so that narrow step (arrow) of joint hub (37d) points upward.

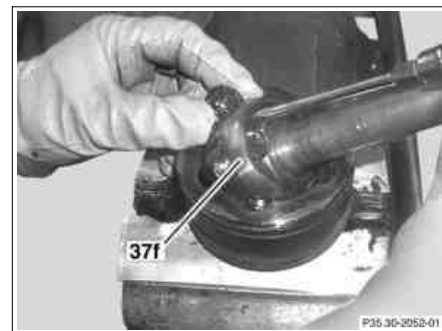
P35.30-2052-01

3 Use a suitable tool to press the two top balls out of their race.

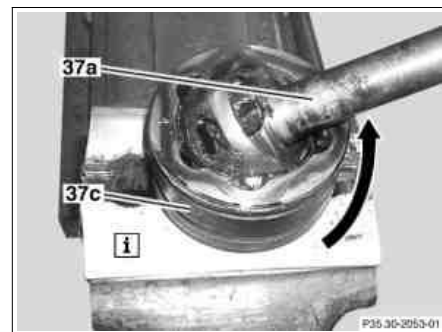
P35.30-2053-01

4 Tilt rear axle shaft (37a) and turn slightly to remove from the joint ring (37c).

i Hold the remaining balls in place when removing.

5 Remove remaining balls from joint ring (37c).

6 Remove ball cage from joint hub.

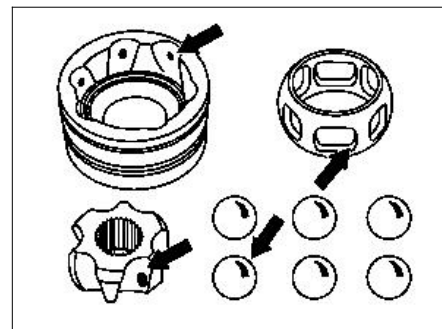
P35.30-2054-01

8 Check joint ring, joint hub, ball retainer ball raceways and ball bearings for depressions (pitting) and traces of wear (arrows).

i If these components display major wear then the entire rear axle shaft should be replaced. Smooth areas and running marks caused by the balls do not indicate any need to replace the rear axle shaft.

i If the outer constant velocity joint is defective, then the rear axle shaft must be replaced.

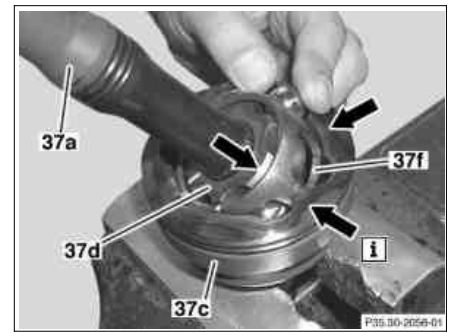
P35.30-2056-01

- 9 Insert rear axle shaft (37a) with joint hub (37d) and ball retainer (37f) into joint ring (37c) and align so that balls can be inserted.

i Before inserting the joint hub (37d), pack half the grease provided in the repair kit into the joint ring (37c).

- 10 Position ball retainer (37f) onto joint hub (37d).

i Watch the alignment marks made earlier. If a marking was not made the ball retainer (37f) has to be positioned on the joint hub (37d) such that a wide bar of the joint hub (37d) is always opposite a narrow bar of the joint ring (37c).

- 11 Insert balls one after the other.
