MODEL 230.4 except CODE (P99) "AMG Black Series" special model

**Trunk lid**

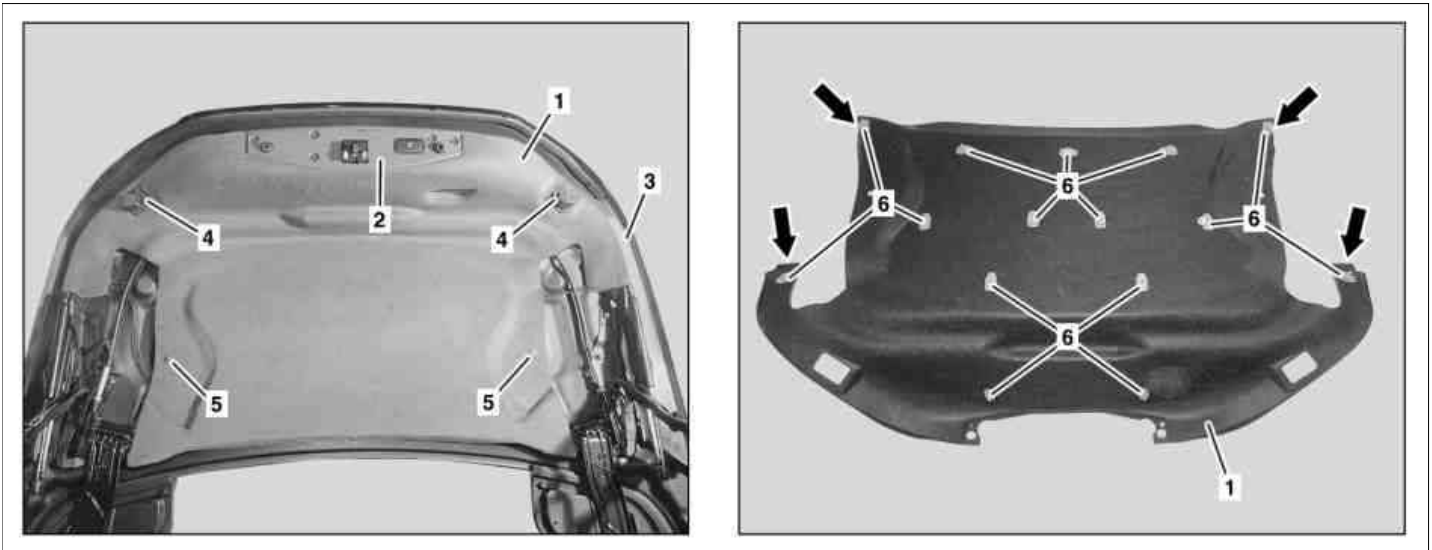
P68.30-3262-08

- 1 Trim
- 2 Cover
- 3 Trunk lid

- 4 Locking wedge
- 5 Expansion clip
- 6 Clip

<b>Remove/install</b>		
<b>Danger!</b>	<b>Risk of injury</b> caused by moving parts that can <b>pinch, crush</b> or, in extreme cases, even <b>sever</b> extremities	No parts of the body or limbs should be within the operating range of the mechanism when moving components.	AS00.00-Z-0009-01A
1	Completely open Vario roof		
2	Remove cover (2) from trunk lid (3)	<b>Installation:</b> Replace damaged expansion clips.	
3	Remove closing wedges (4) from trunk lid (3)		*BA88.50-P-1015-01A
4	Remove expansion clips (5)	<b>Installation:</b> Replace damaged expansion clips (5).	
5	Unclip paneling (1) from trunk lid (3) starting at outer clips (6) (arrows) and remove.	Position mounting wedge directly to corresponding clip (6) to unclip, to prevent damaging paneling (1). <b>Installation:</b> Replace damaged clips (6). 	*110589035900
6	Install in the reverse order		
7	Check trunk lid adjustment (3), correct if necessary	Vehicles up to end no.. 063909 Vehicles as of end no. 063910	AR88.50-P-5200R AR88.50-P-5200RA

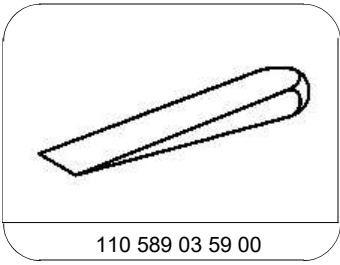
110 589 03 59 00

Mounting wedge
