FILE: SERVICE: GROUP 00 OF SERVICE INFORMATION BINDER
PARTS: GROUP I OF INFORMATION – PARTS & ACCESSORIES BINDER

Campaign No. 2005070007, May 2006

SUBJECT: **MODELS 211, 230**
MODEL YEAR 2004
INSPECT SBC HYDRAULIC UNIT, REPLACE AS DIRECTED

This Recall Campaign has been initiated because DCAG has determined that on the affected vehicles (see VIN range below) the SBC brake system may shift to the hydraulic back up mode due to the loosening of the ground wire harness connection over time, or due to premature failure of the hydraulic pump. On Model 211, dealers will install a bracket and replace the ground wire, and if required, replace the hydraulic pump and suction hose. On Model 230, dealers will install a bracket and replace the ground wire, replace the suction hose, and if required replace the hydraulic pump.

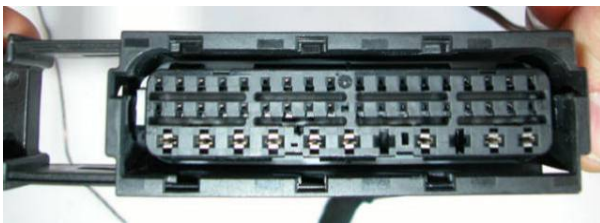
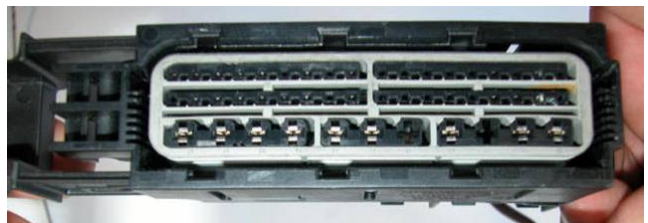
There are two different versions of the SBC wiring harness connector (Figure 8a, b) installed in vehicles involved with this campaign.

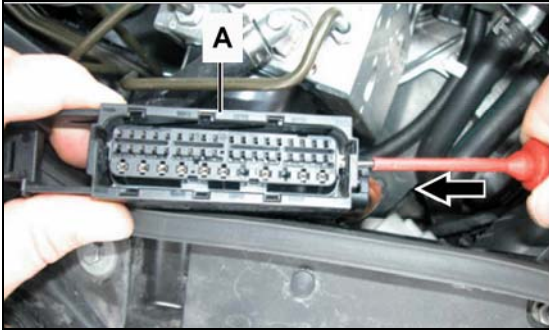
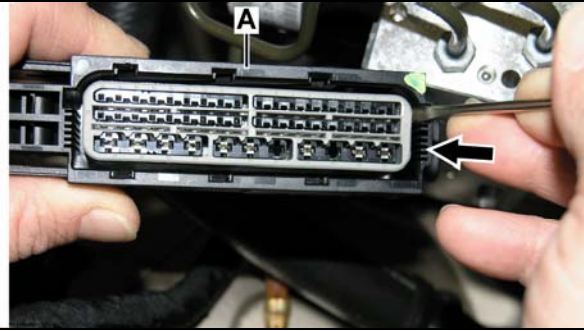
14. Open the (gray) secondary lock in the SBC connector housing (A, Figure 9) by sliding the lock in the direction indicated by the arrows (Figure 9) using a small screwdriver.

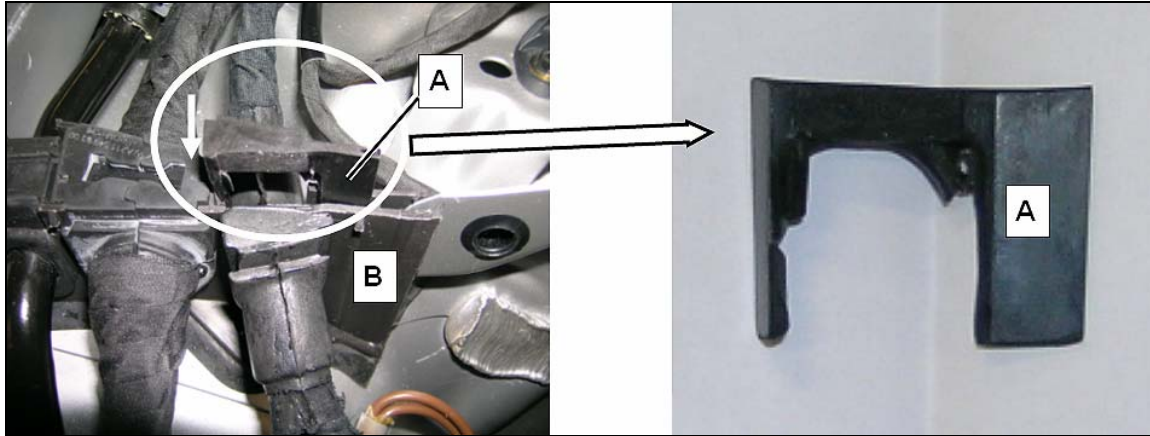
Figure 18

- Insert new routing clip (A, Figure 18) into wire harness guide (B) until top of clip (A) is flush with top of wire harness guide (B).
- Reinstall top of wire harness guide (C, Figure 16).

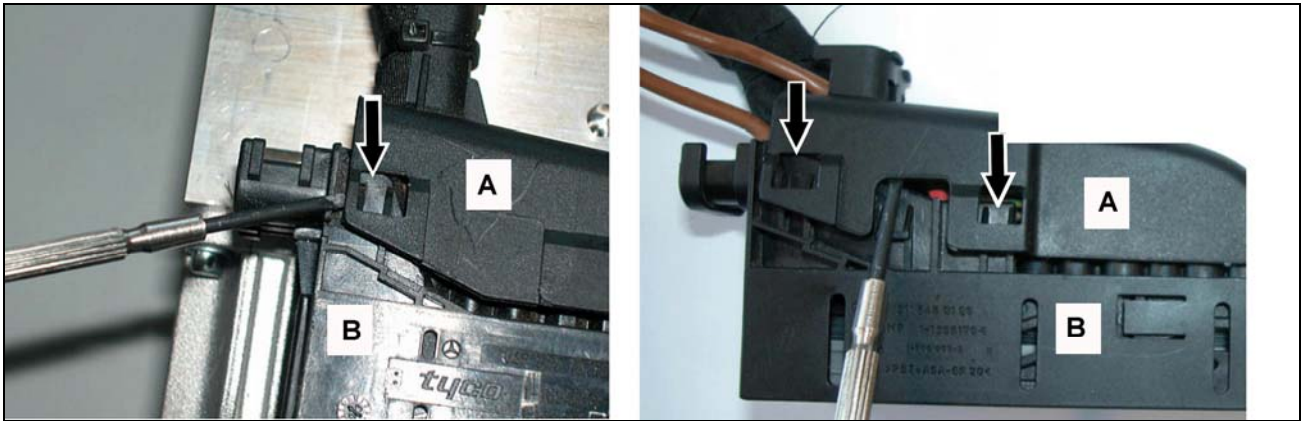
Figure 13

12. Remove SBC connector housing cover (A, Figure 13):

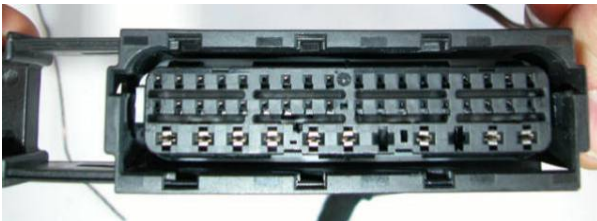
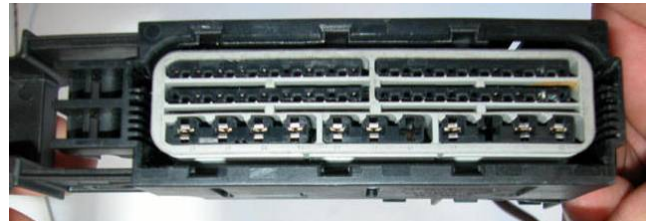
There are two different versions of the SBC wiring harness connector (Figures 14a, b) installed in vehicles involved with this campaign.

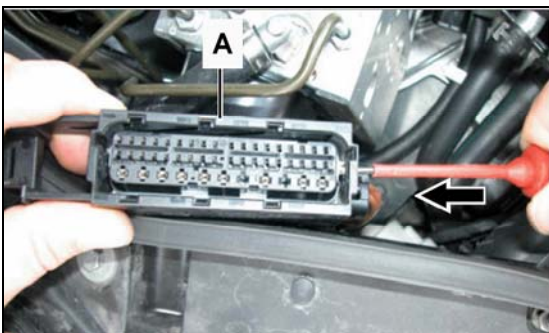
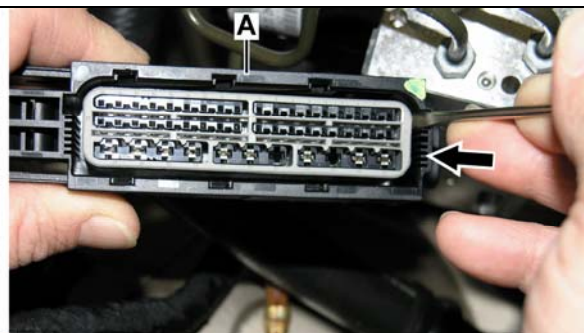
13. Open the (gray) secondary lock in the SBC connector housing (A, Figure 15) by sliding the lock in the direction indicated by the arrows (Figure 15) using a small screwdriver.

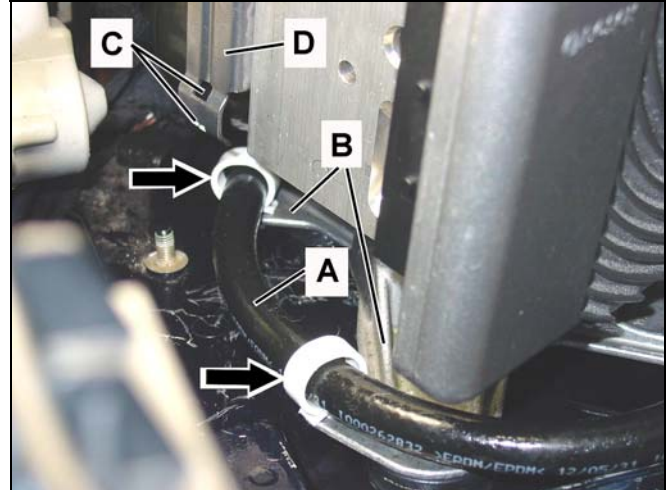
Figure 25

25. Secure new SBC suction hose (A, Figure 25) to SBC hydraulic unit mounting bracket (B) using **new** (“omega” type) mounting clips (arrows).
