Campaign No. 2005110001, June 2006

SUBJECT: **MODEL 211, MODEL YEAR 2003-2006**
MODEL 219, MODEL YEAR 2006
MODEL 230, MODEL YEAR 2003-2005
INSTALLATION OF GROUND WIRES AND BRACKET TO SBC WIRING HARNESS

This Recall Campaign has been initiated because DCAG has determined that on the affected vehicles (see VIN range on the following page) the SBC brake system may shift to the hydraulic back up mode due to the loosening of the ground wire harness connection over time. Dealers will install a bracket and replace the ground wire.

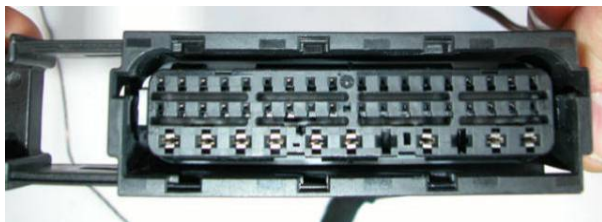
There are two different versions of the SBC wiring harness connector (Figure 7a, b) installed in vehicles involved with this campaign.

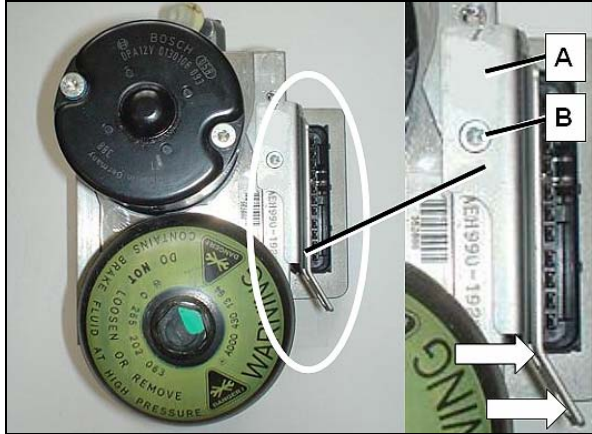
Figure 17

19. Insert a cable tie through slots (arrows, Figure 17) in bracket, **do not** close cable tie.

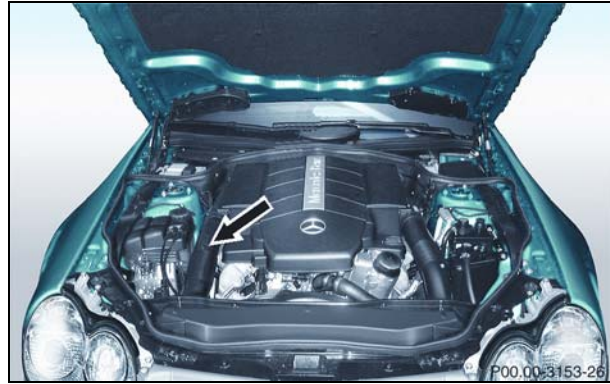
Figure 3

1. Lock the vehicle globally and then wait for 30 seconds for the SBC control module to power-down.
2. Remove right intake air duct (arrow, Figure 3).

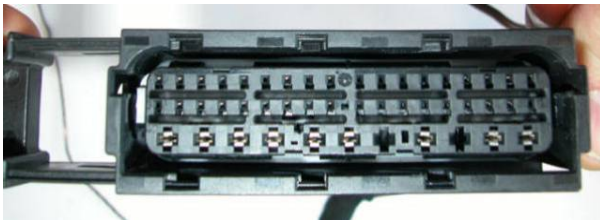
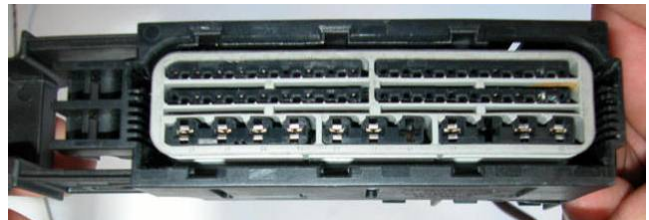
There are two different versions of the SBC wiring harness connector (Figure 8a, b) installed in vehicles involved with this campaign.

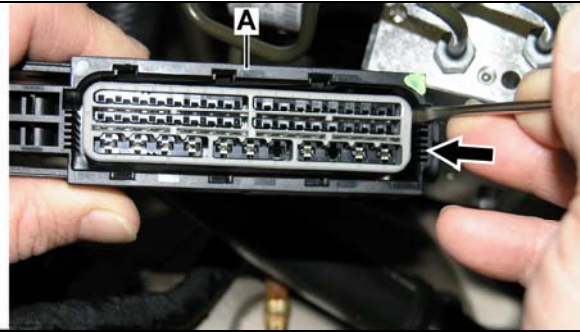
7. Open the (gray) secondary lock in the SBC connector housing (A, Figure 9) by sliding the lock in the direction indicated by the arrows (Figure 9) using a small screwdriver.
8. Remove cable tie (arrow, Figure 10) securing ground wires (A) to SBC connector housing (B).

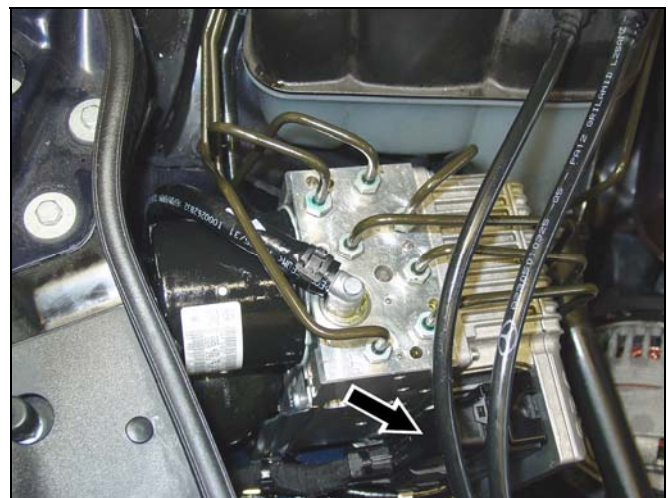
Figure 19

18. Connect the SBC wire harness connector (Arrow, Figure 19) to the SBC hydraulic unit and secure with connector locking mechanism.
