AR67.20-P-3000-06R	Checking adjustment of rear window on Vario roof, if necessary adjusting		
--------------------	--	--	--

**Nm** Rear window

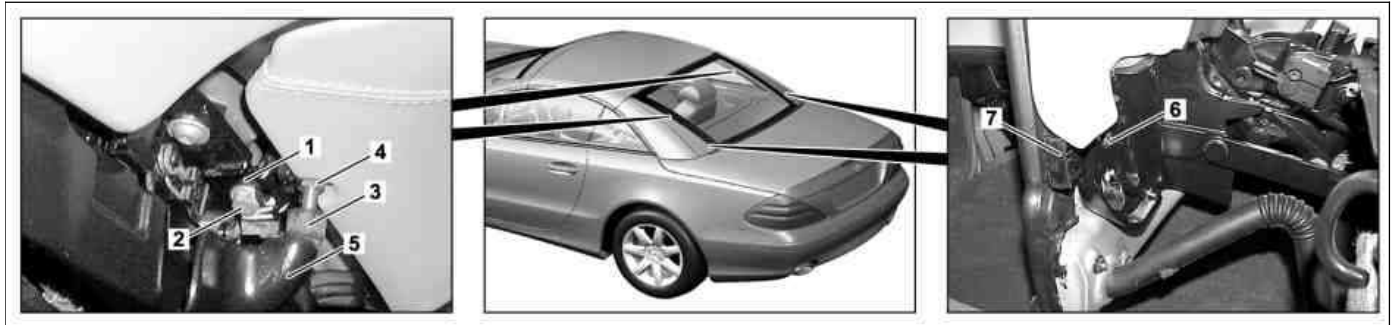
P67.20-2269-07

- 1 Visual inspection of upper Y-stops (1) and lower Y-stops (7).  
**i** If traces of wear are present on the upper Y-stops (1) and lower Y-stops (7), the contact pressure is too high and the corresponding upper Y-stops (1) and lower Y-stops (7) require adjustment.
- 2 Slightly grease upper Y-stops (1) and lower Y-stops (7).
- 3 Completely close Vario roof and open several centimeters.

- 4 Check contact surfaces on upper Y-stops (1) and lower Y-stops (7) visually.  
**i** If traces of grease are not visible on the contact surfaces, the contact pressure is too high and the corresponding upper Y-stops (1) and lower Y-stops (7) require adjustment.
- 5 Check whether Z-stops (3) are under tension on rear window mounts (5) on left and right.  
**i** If pretension is not present, adjust Z-stops (3).

- 6 Loosen bolt (2) and press upper Y-stop (1) toward inside, tighten bolt (2).

- 7 Loosen screw (6) and press lower Y-stop (7) toward outside and tighten bolt (6).

- 9 Loosen counternut (4) and screw in Z-stops (3) several turns
- 10 Completely close Vario roof with soft top switch
- 11 Remove Z-stops (3) until they make contact with rear window mounts (5)
- 12 Open Vario roof several centimeters with soft top switch  
**i** Leave ignition switched on (stop mode).
- 13 Turn Z-stops (3) back one turn and tighten jam nut (4) to specified torque.
