Spark Plug Indexing for Direct Injection Engines

QEC / ES

John Dahlquist
April 24, 2014

Mercedes-Benz

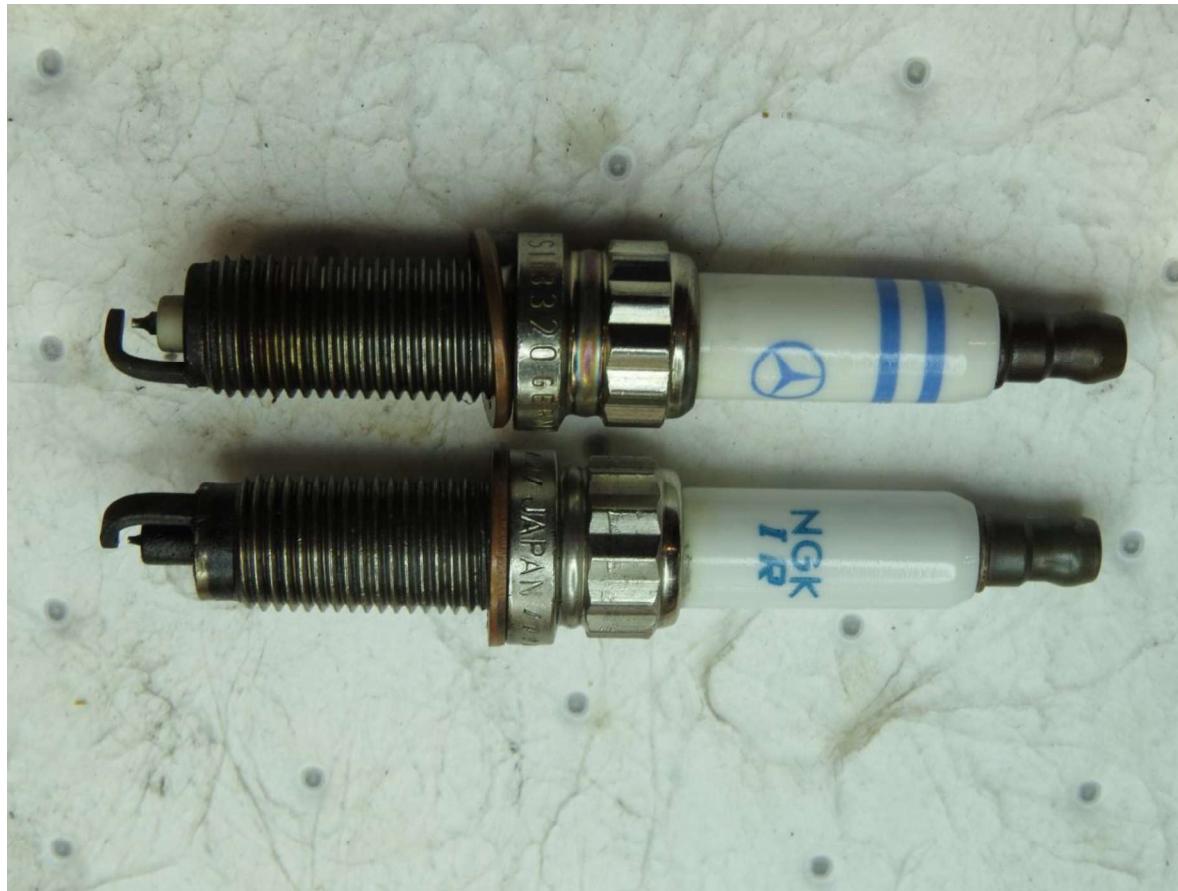
In the picture, an NGK unapproved spark plug is compared to a Mercedes approved spark plug. The NGK plug does not have the correct thread length for proper indexing and it isn't the correct heat range.

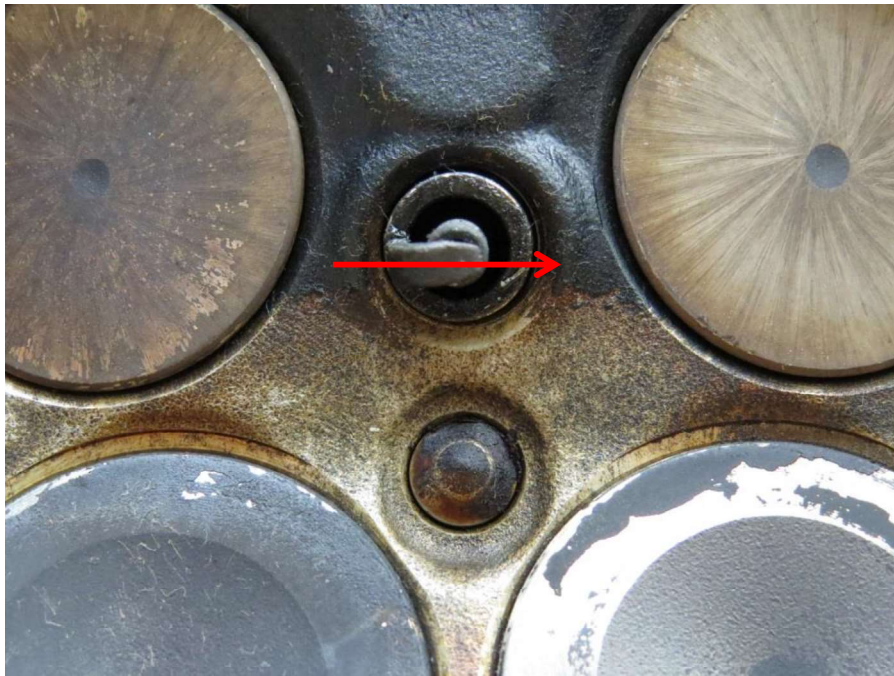
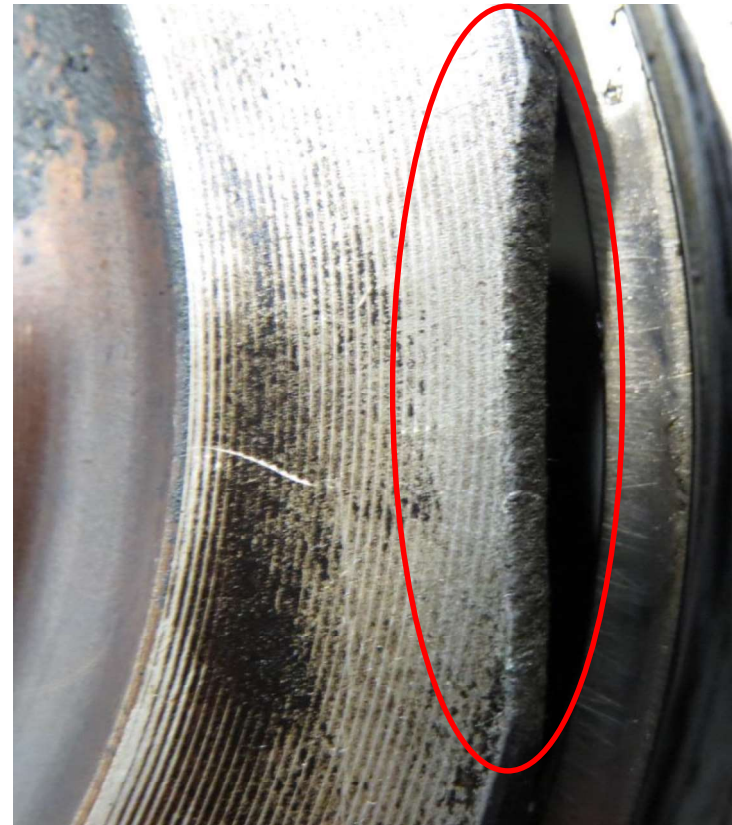
NGK Plug

In this case, the incorrect spark plug caused major engine damage (melted piston) that lead to a complete engine replacement. This is not a warrantable defect.
