WARRANTY COVERAGE EXTENSION

Date: January 9, 2015
Order No.: P-B-47.10/63
Group: 47

SUBJECT: Model 211, Model Years 2003- 2009 (AMG models not included at this time) and Model 219, Model Years 2006- 2011 (AMG models not included at this time) Fuel Odor In the Area of the Fuel Tank

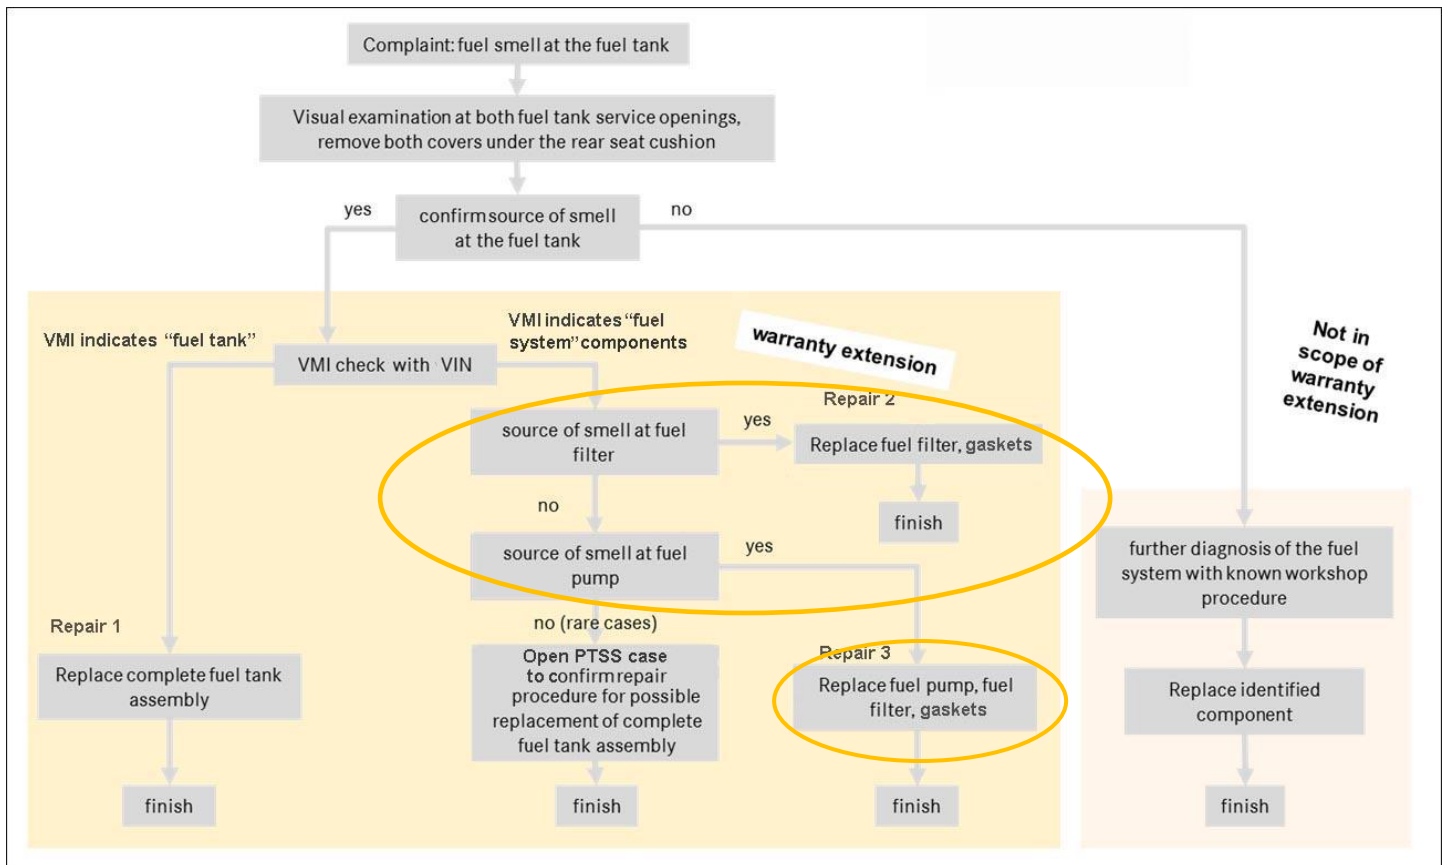
Work process flow chart

Please note, this flow chart does not include all the steps for this procedure. Please be sure to read all steps included in the Procedure starting on the following pages:

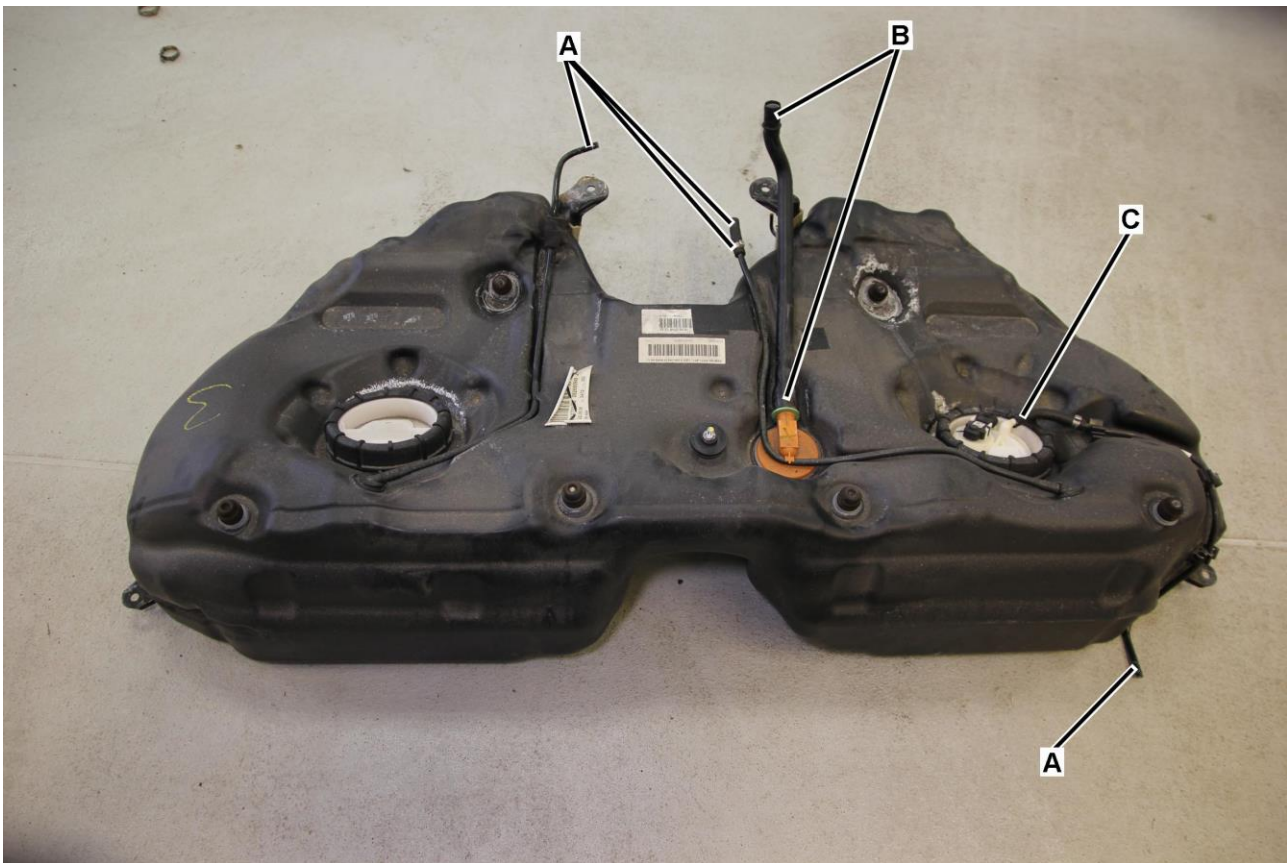
Figure 2 (shown on model 211.056 installation locations on other models may vary)

A	Hose clamp (qty. 4)	A 006 997 18 90
B	Hose clamp (qty. 2)	A 000 995 89 10
C	Hose clamp (qty. 1)	A 005 997 83 90

- It is not necessary to disconnect the emergency brake cable from the emergency brake shoes when removing fuel tank.
- Refer to Figure 2 for location of clic® clamps according to part number.
- Be careful not to break mounting studs for underbody panels when removing plastic nuts securing under body panel to vehicle. Apply rust penetrant to stud to help prevent breakage of stud.

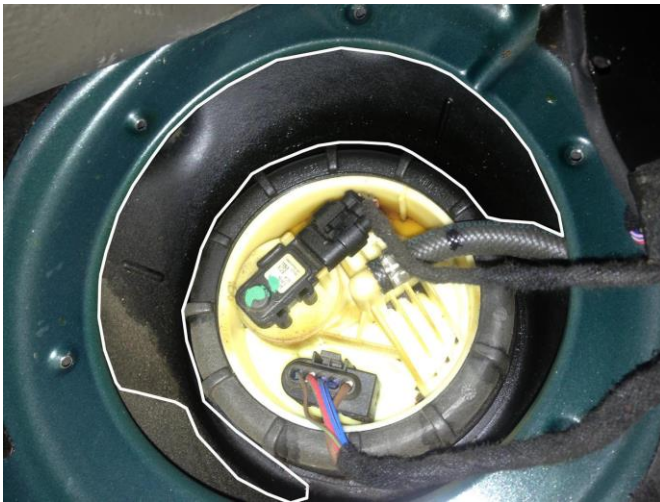
Figure 3 (Fuel residue outlined)

**Note:** Fuel residue (outlined, Figure 3) and/or liquid fuel must be visible in photo.

- Provide symptom string: Power Generation / Fuel systems / Fuel system odor / Odor
- Attach (detailed) photographs of the suspect area to the case. (see example, Figure 3).
