Date: February 3, 2015  
Order No.: P-B-47.10/63b  
Supersedes: P-B-47.10/63a, January 16, 2015  
Group: 47

**SUBJECT: Model 211, Model Years 2003- 2009 and  
Model 219, Model Years 2006- 2011  
Fuel Odor In the Area of the Fuel Tank**

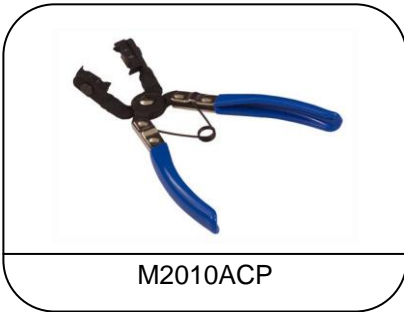
Assenmacher® Tool: Angled  
Fuel/EVAP Clamp Pliers
