Date: March 29, 2017
Order No.: P-B-47.10/63d
Supersedes: P-B-47.10/63c, June 10, 2015
Group: 47

**SUBJECT: Model 211, Model Years 2003- 2009 and
Model 219, Model Years 2006- 2011
Fuel Odor In the Area of the Fuel Tank**

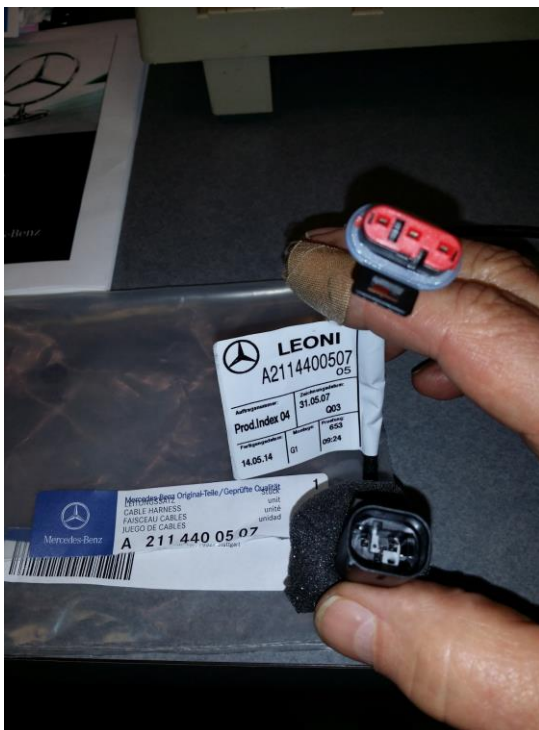
Figure 4 (Fuel tank sending unit jumper harness)

¹⁾ Older vehicles with 2 prong connectors on fuel tank sending unit (with integrated fuel filter) require jumper harness (Figure 4) to connect new sending unit to existing wiring harness.
