Instructions for replacing the Lever Position Detection Module located on the Electronic Shift Module. This is a 2005 model W211 with the sliding cover console. *Earlier hinged covers have a different removal procedure for the console!* Photos have been rearranged for clarity but you may notice oddities such as screws removed in an early photo but still installed in a later photo. This was due to additional photos taken during reassembly. When working on the module, push the release button so you can move the shift lever when working around the lever.

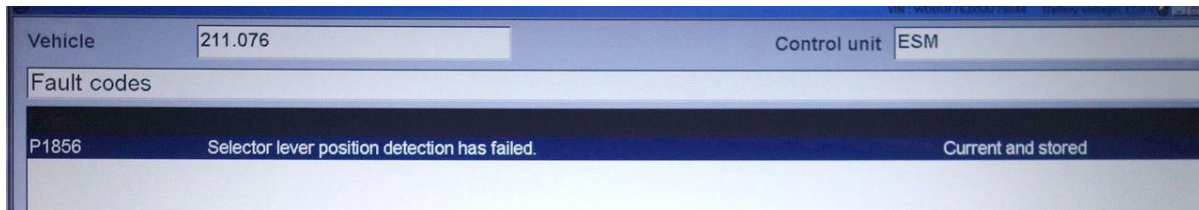
Troubleshooting: Using diagnostic system, the following code was found and would not clear:

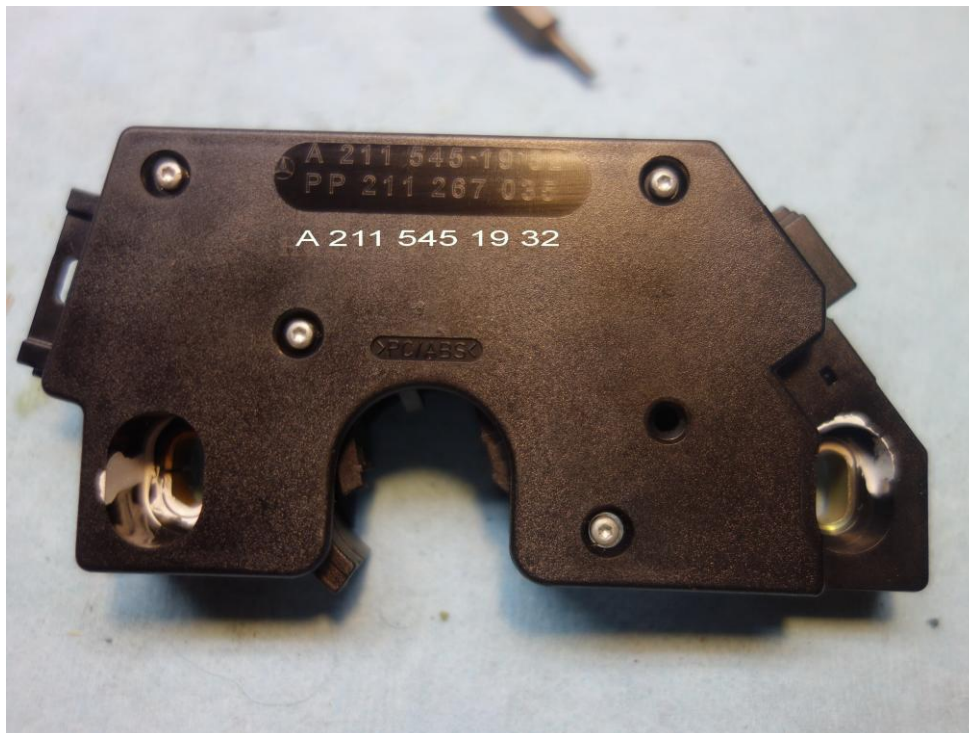
Research showed the following module was most likely at fault (often the opto-sensors):

The module can be replaced with a repaired module or your module can be sent to a repair shop with the attendant shipping delay. I purchased a repaired module off of Ebay for \$135.

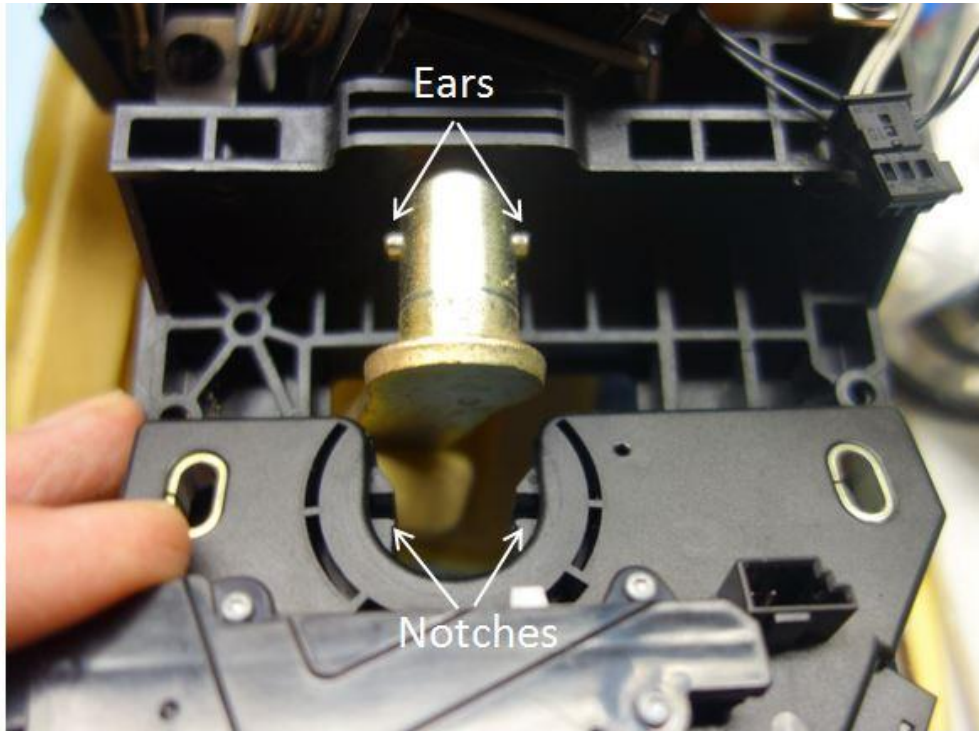
The two ears fit into the two notches to mate the shift lever axle to the shift position sensor.
