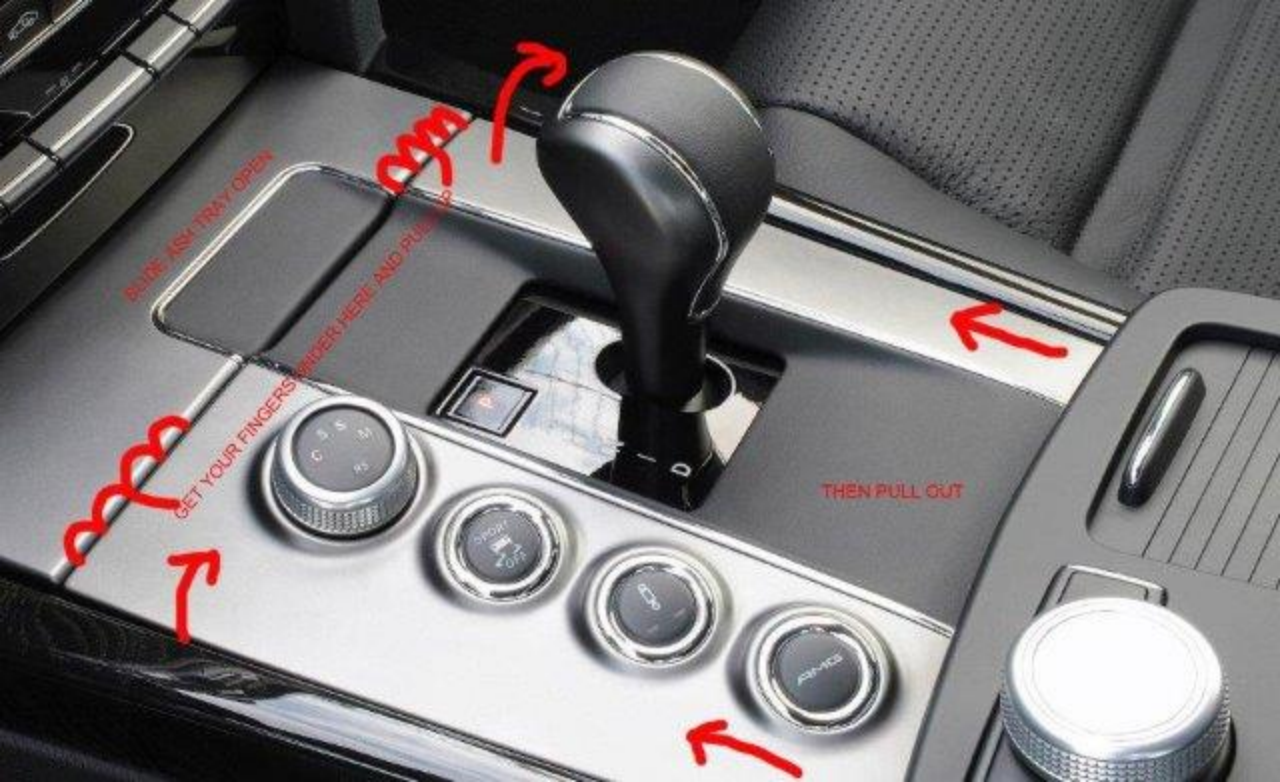
BEFORE HSB TRAY OPEN

GET YOUR FINGERS UNDER HERE AND PULL UP

THEN PULL OUT

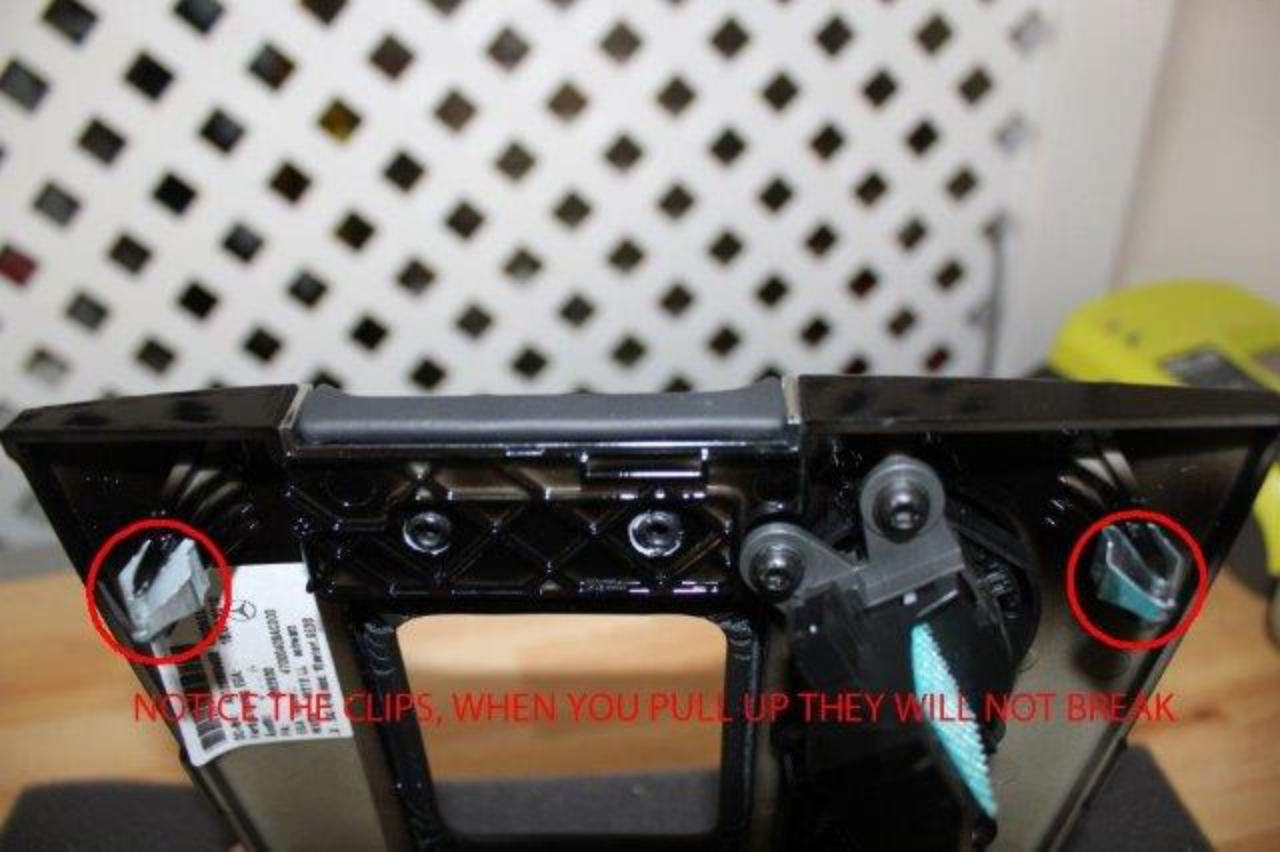
NOTICE THE CLIPS, WHEN YOU PULL UP THEY WILL NOT BREAK

AFTER PULLING UP, YOU TILT AND PULL FORWARD

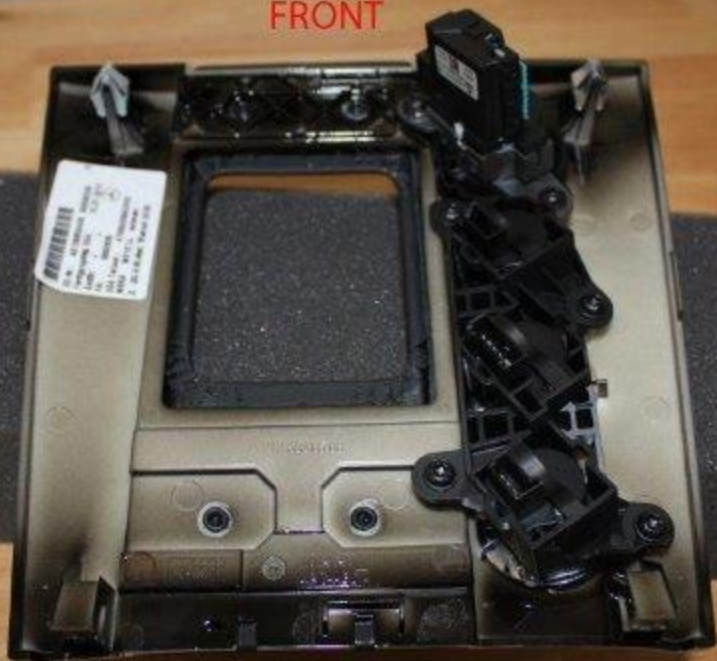
REMOVE SCREWS

SLIDE OUT FORWARD

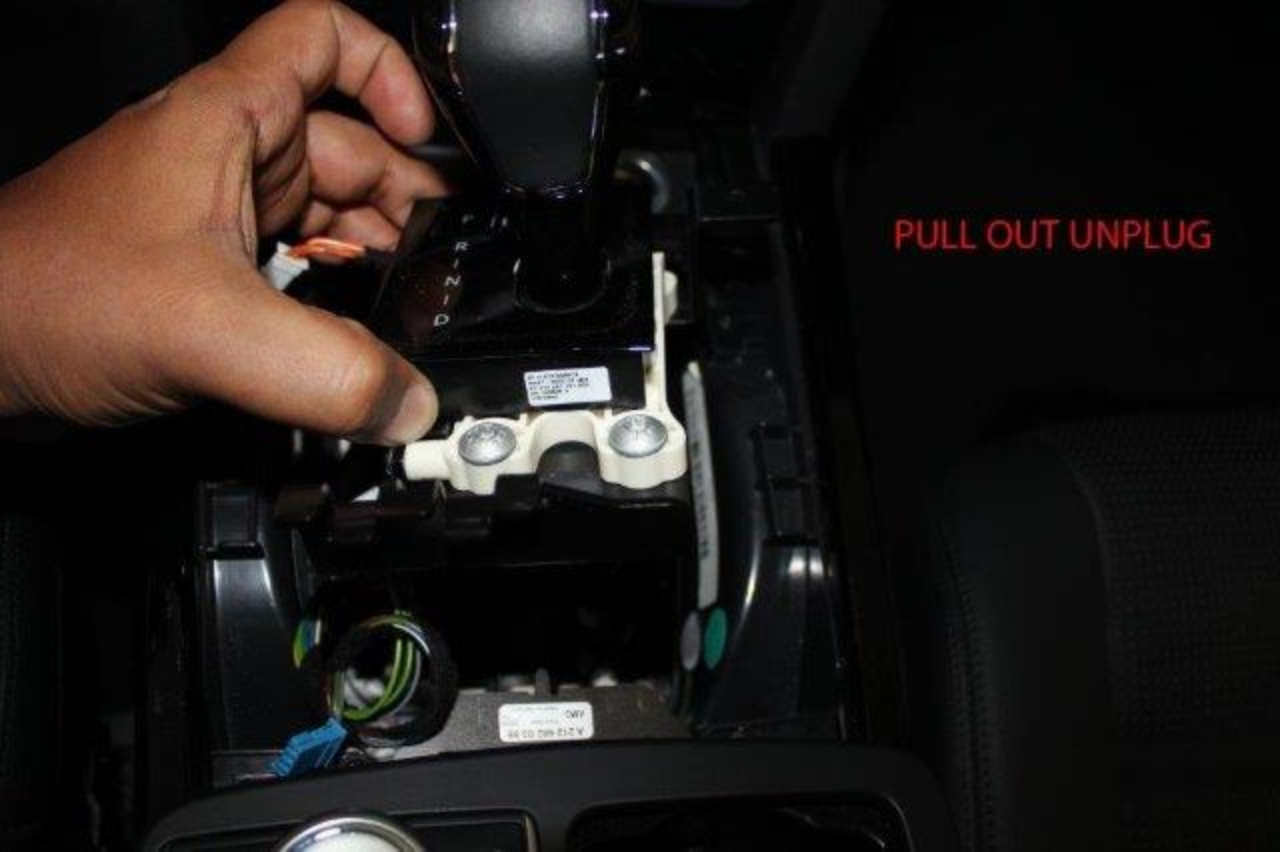
PULL OUT UNPLUG

AFTER YOU MOVE SHIFTER
YOU CAN SLIDE OUT ASH TRAY

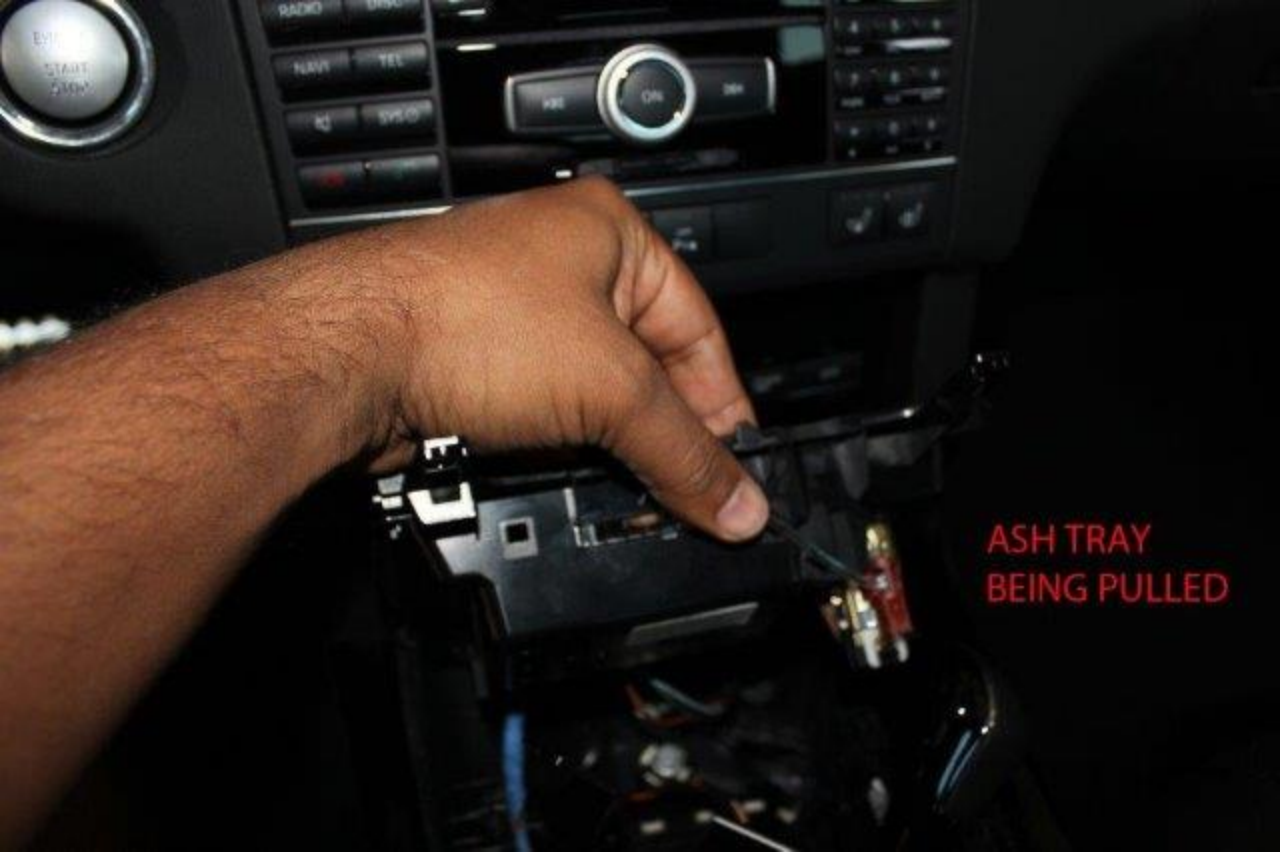
ASH TRAY
BEING PULLED

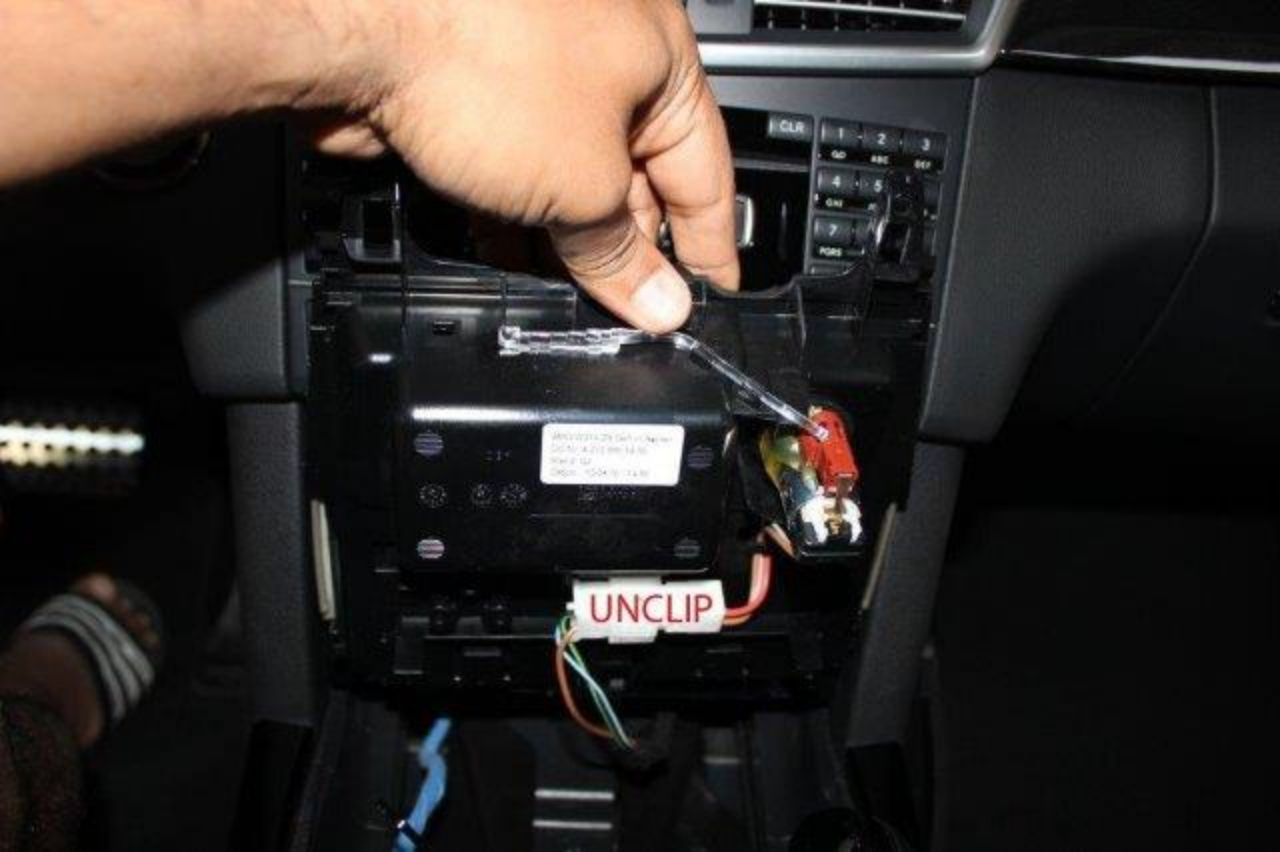
UNCLIP

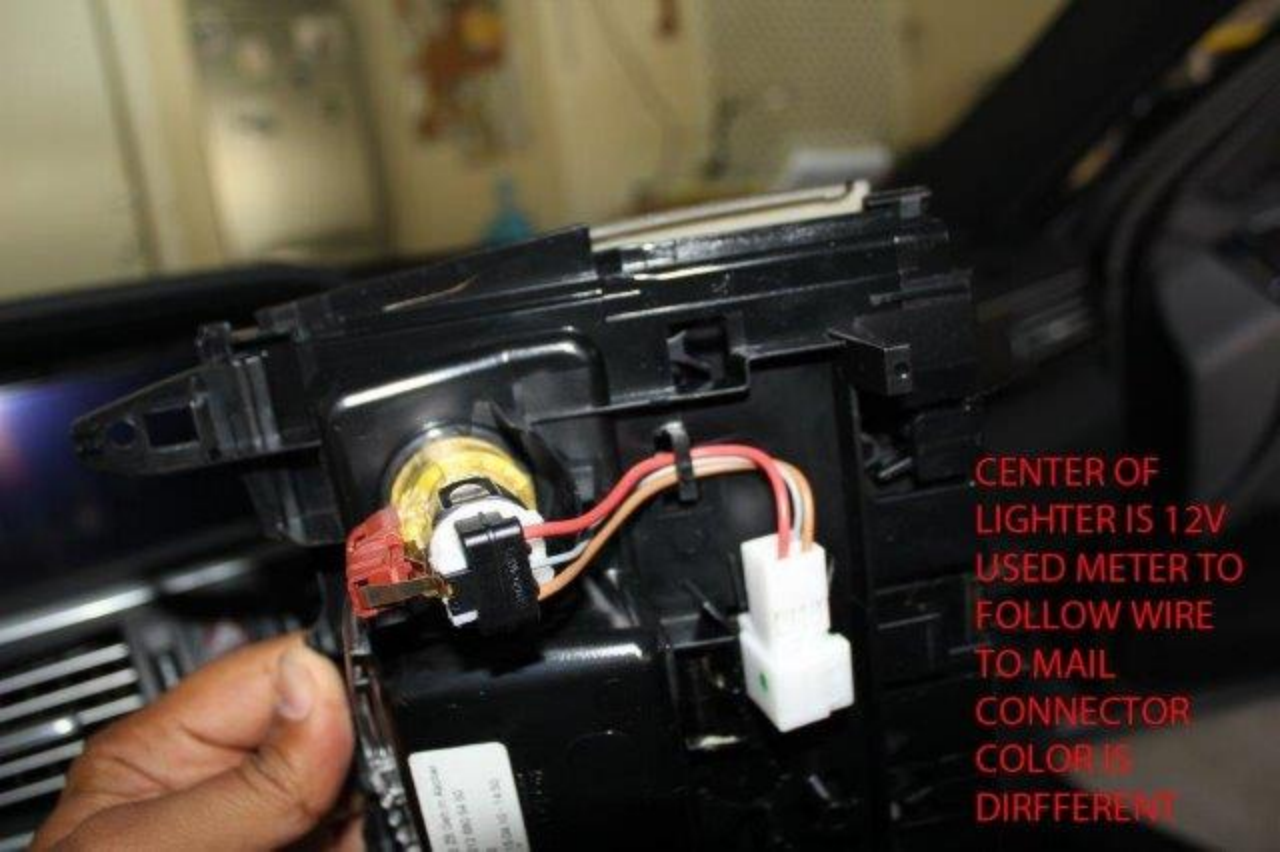
CENTER OF
LIGHTER IS 12V
USED METER TO
FOLLOW WIRE
TO MAIL
CONNECTOR
COLOR IS
DIRFFERENT

BLACK/GREEN WIRE IS 12V SWITCHED

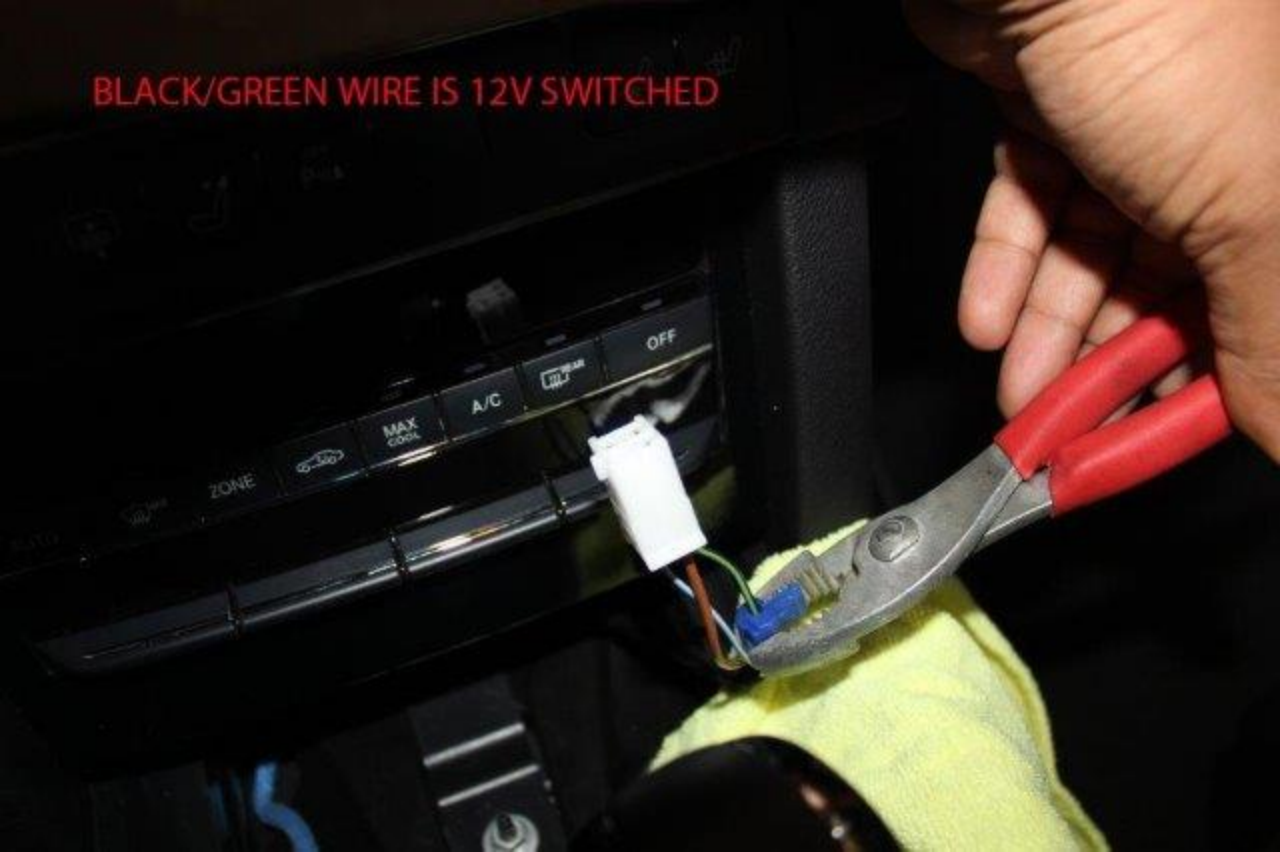
CLOSER LOOK, DONT
USE THE OTHER THE OTHER WIRES

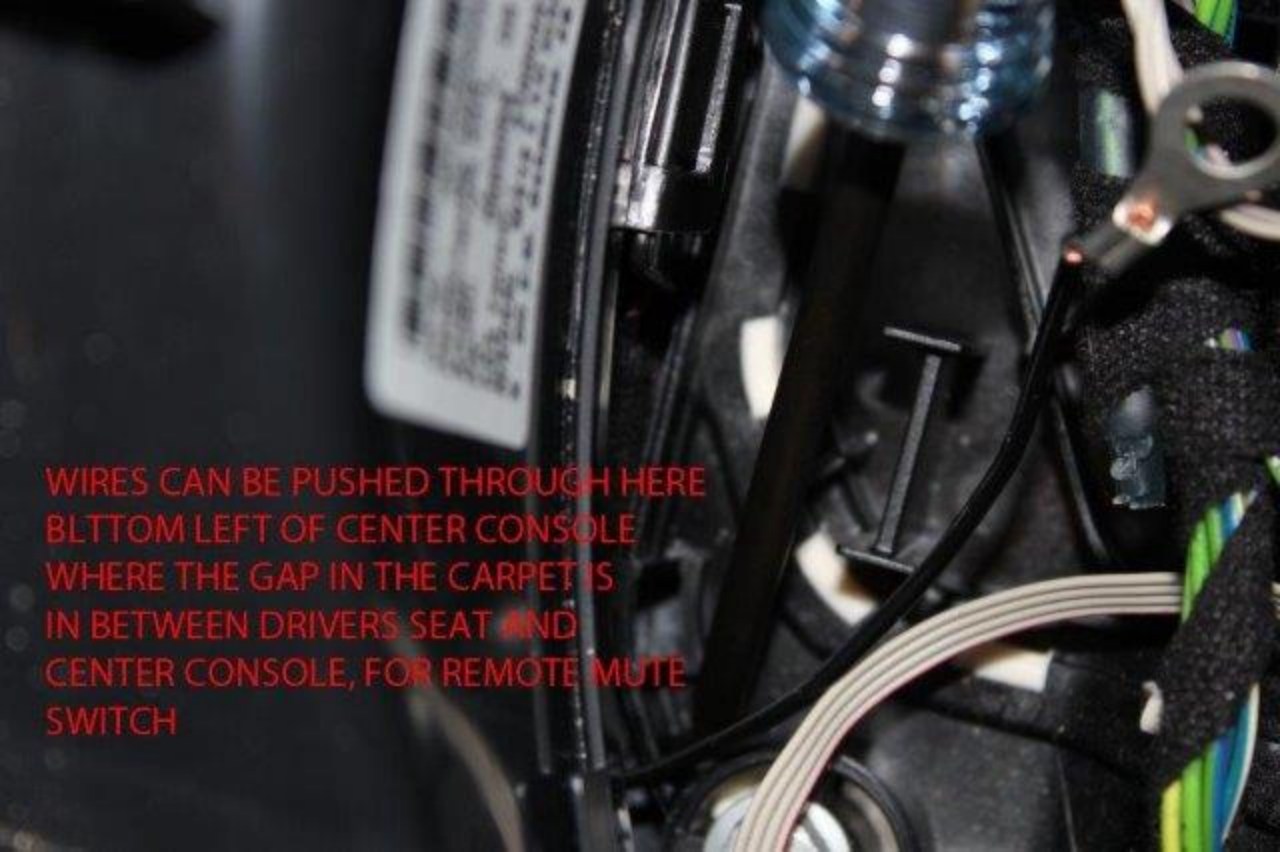
WIRES CAN BE PUSHED THROUGH HERE
BLTTOM LEFT OF CENTER CONSOLE
WHERE THE GAP IN THE CARPET IS
IN BETWEEN DRIVERS SEAT AND
CENTER CONSOLE, FOR REMOTE MUTE
SWITCH

REMOTE MUTE
SWITCH

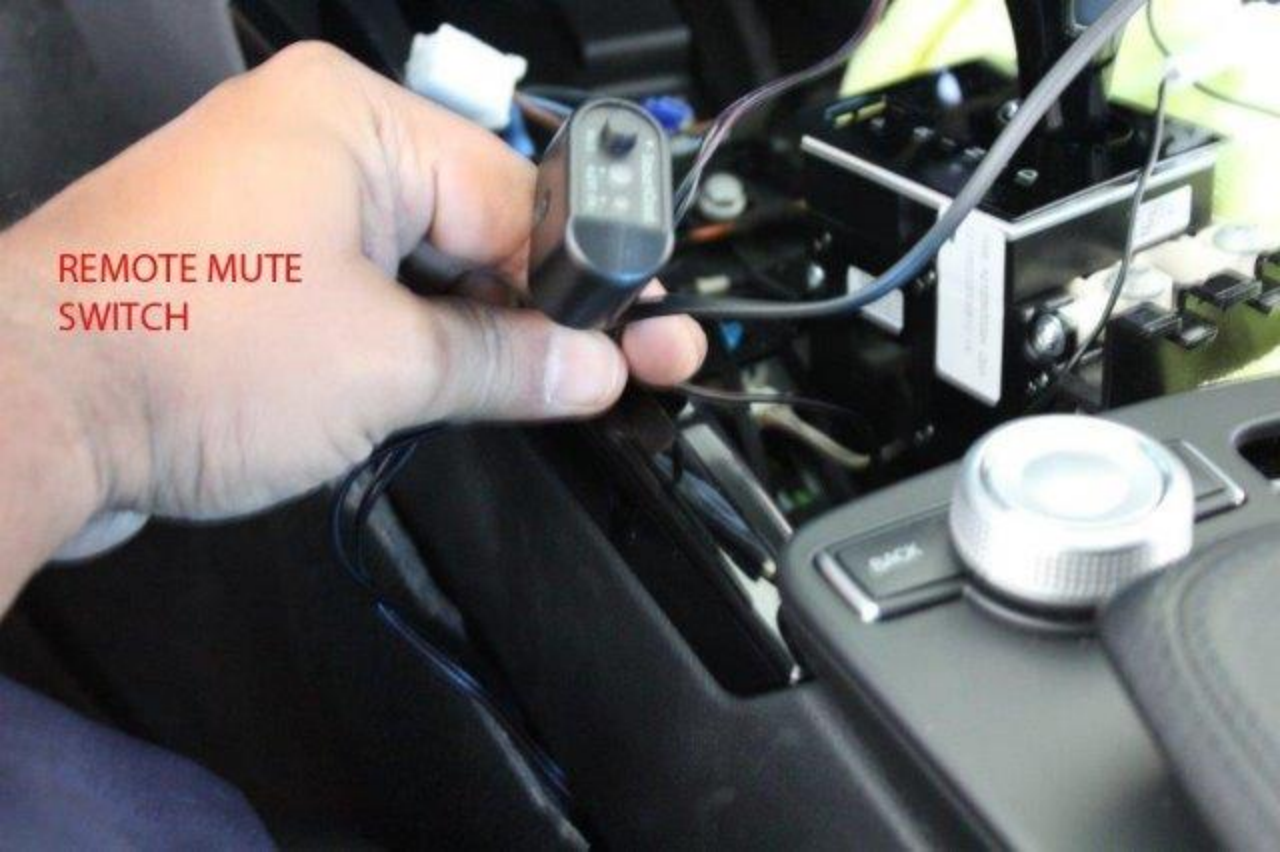
REMEMBER TO MOVE THIS FORWARD
IF THE WIFE MOVES THE SEAT UP
THE MASSAGE SEAT CONTROLS
WILL HIT AND RIPP OFF THE SWITCH
VELCRO AND ALL

VELCRO SUCKS
NEED TO MAKE
A CLIP BRACKET
VELCRO FOR NOW

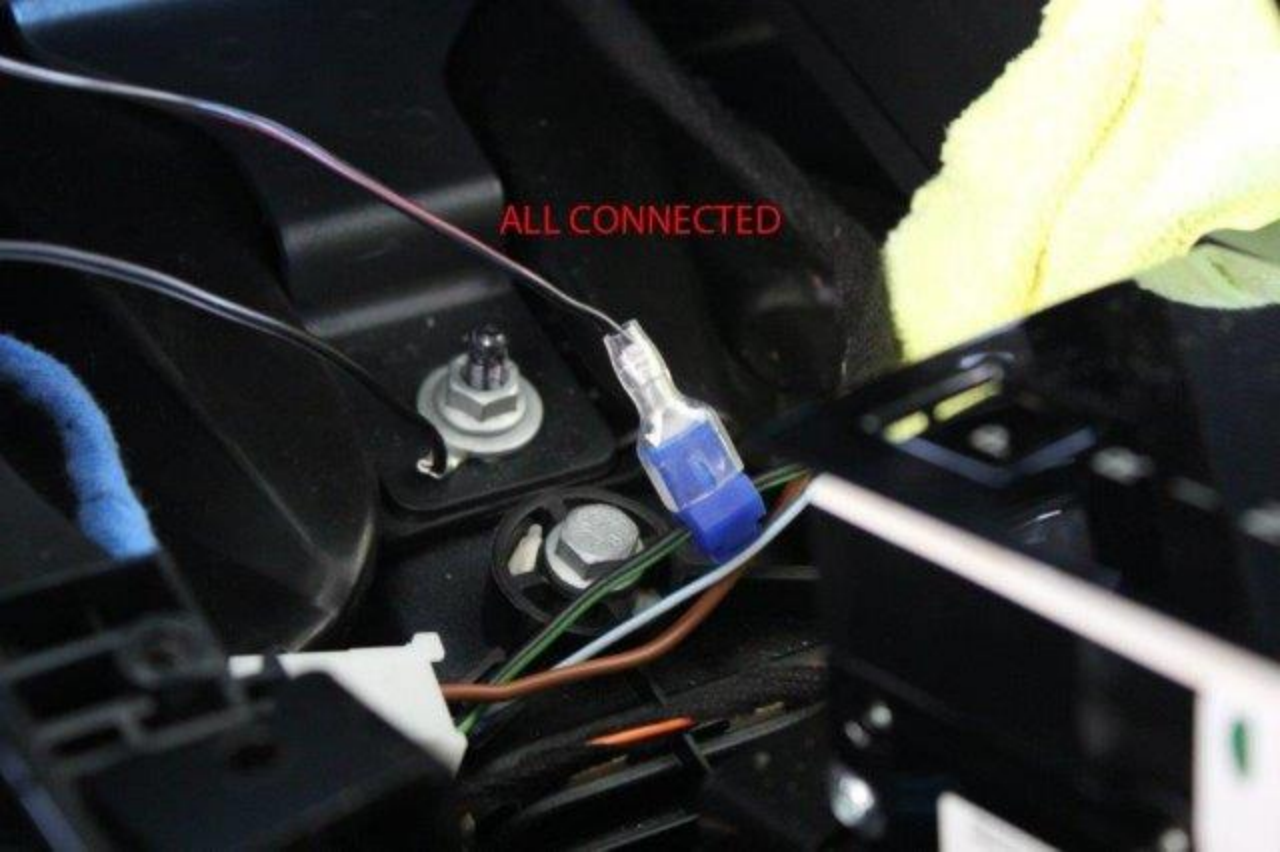
RUN WIRE UP UNDER THE
SIDE OF CENTER CONSOLE

ZIP TIE EXCESS, WILL
BE TUCKED AWAY LATER

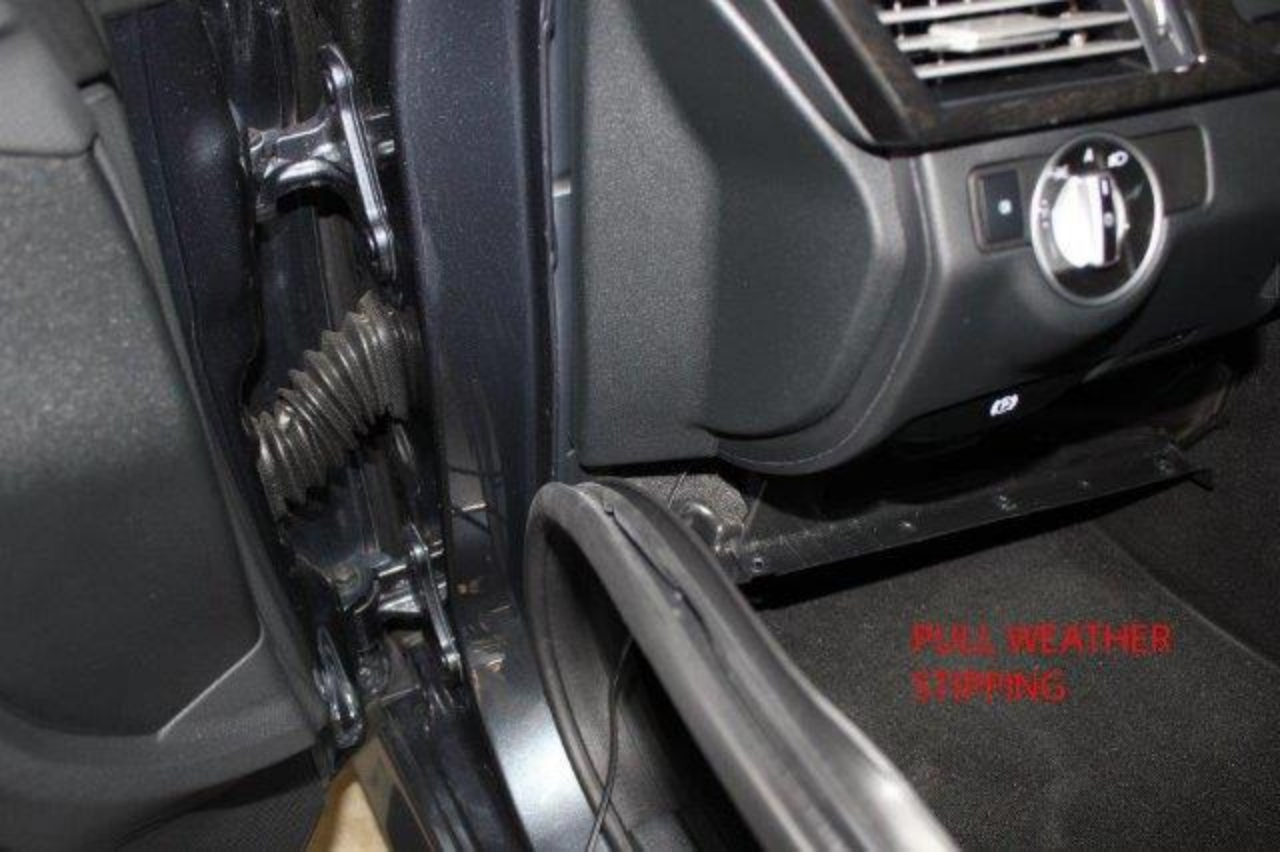
PULL WEATHER
STIPPING

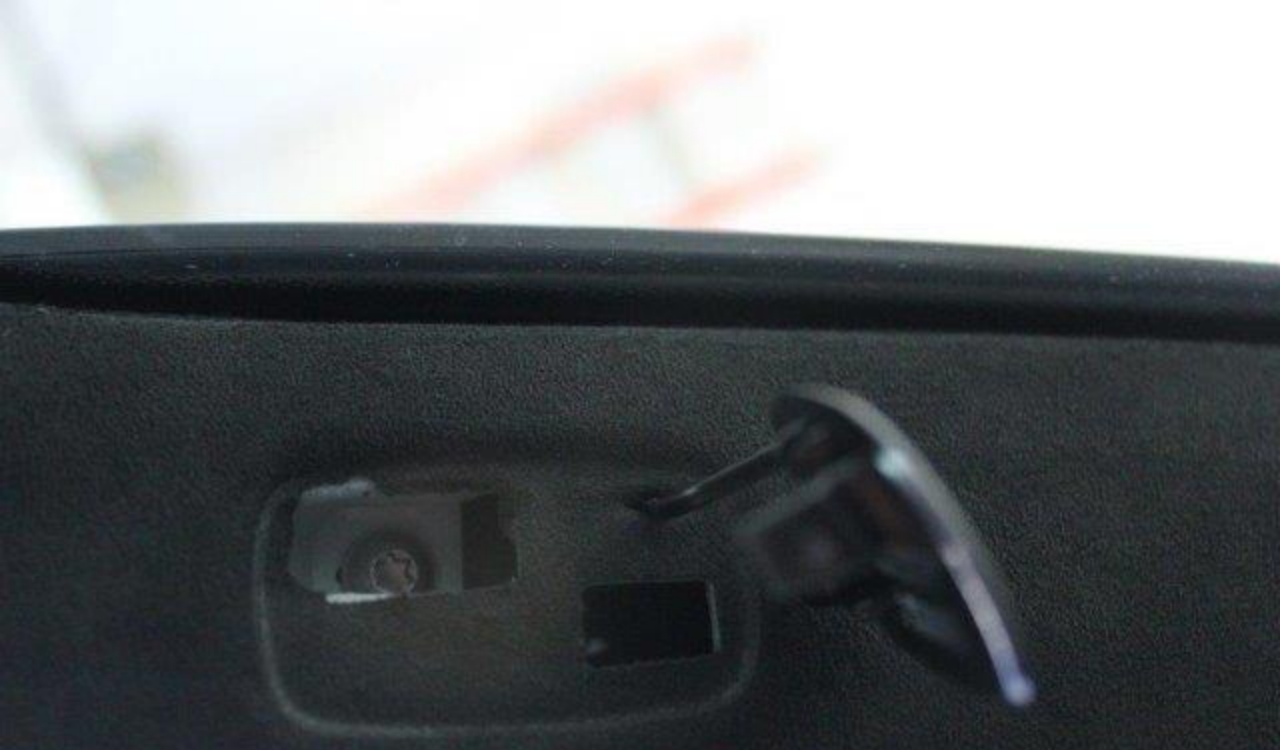
PRY OFF PLASTIC AIR BAG LABEL AND REMOVE SCREW ON PILLAR

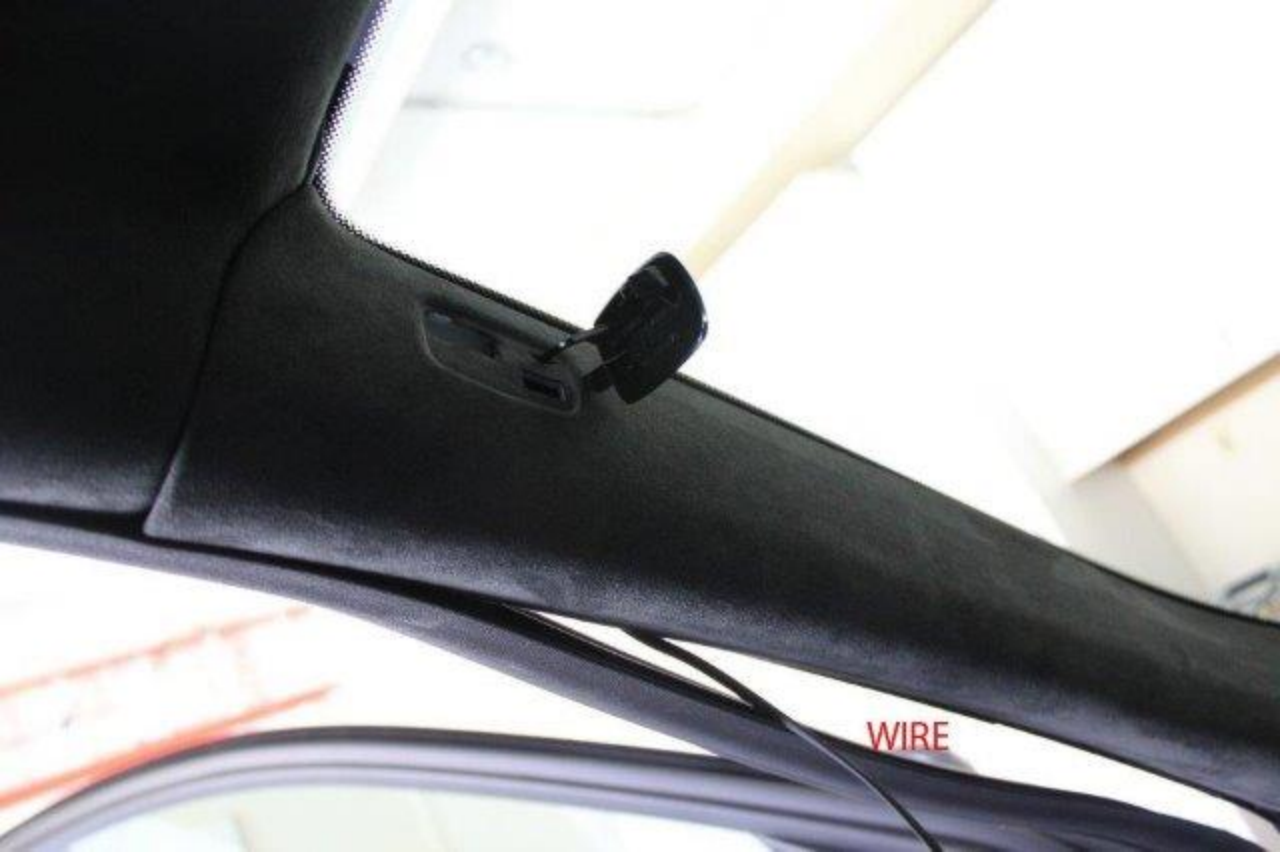
WIRE

TUCK THE WIRE HERE
