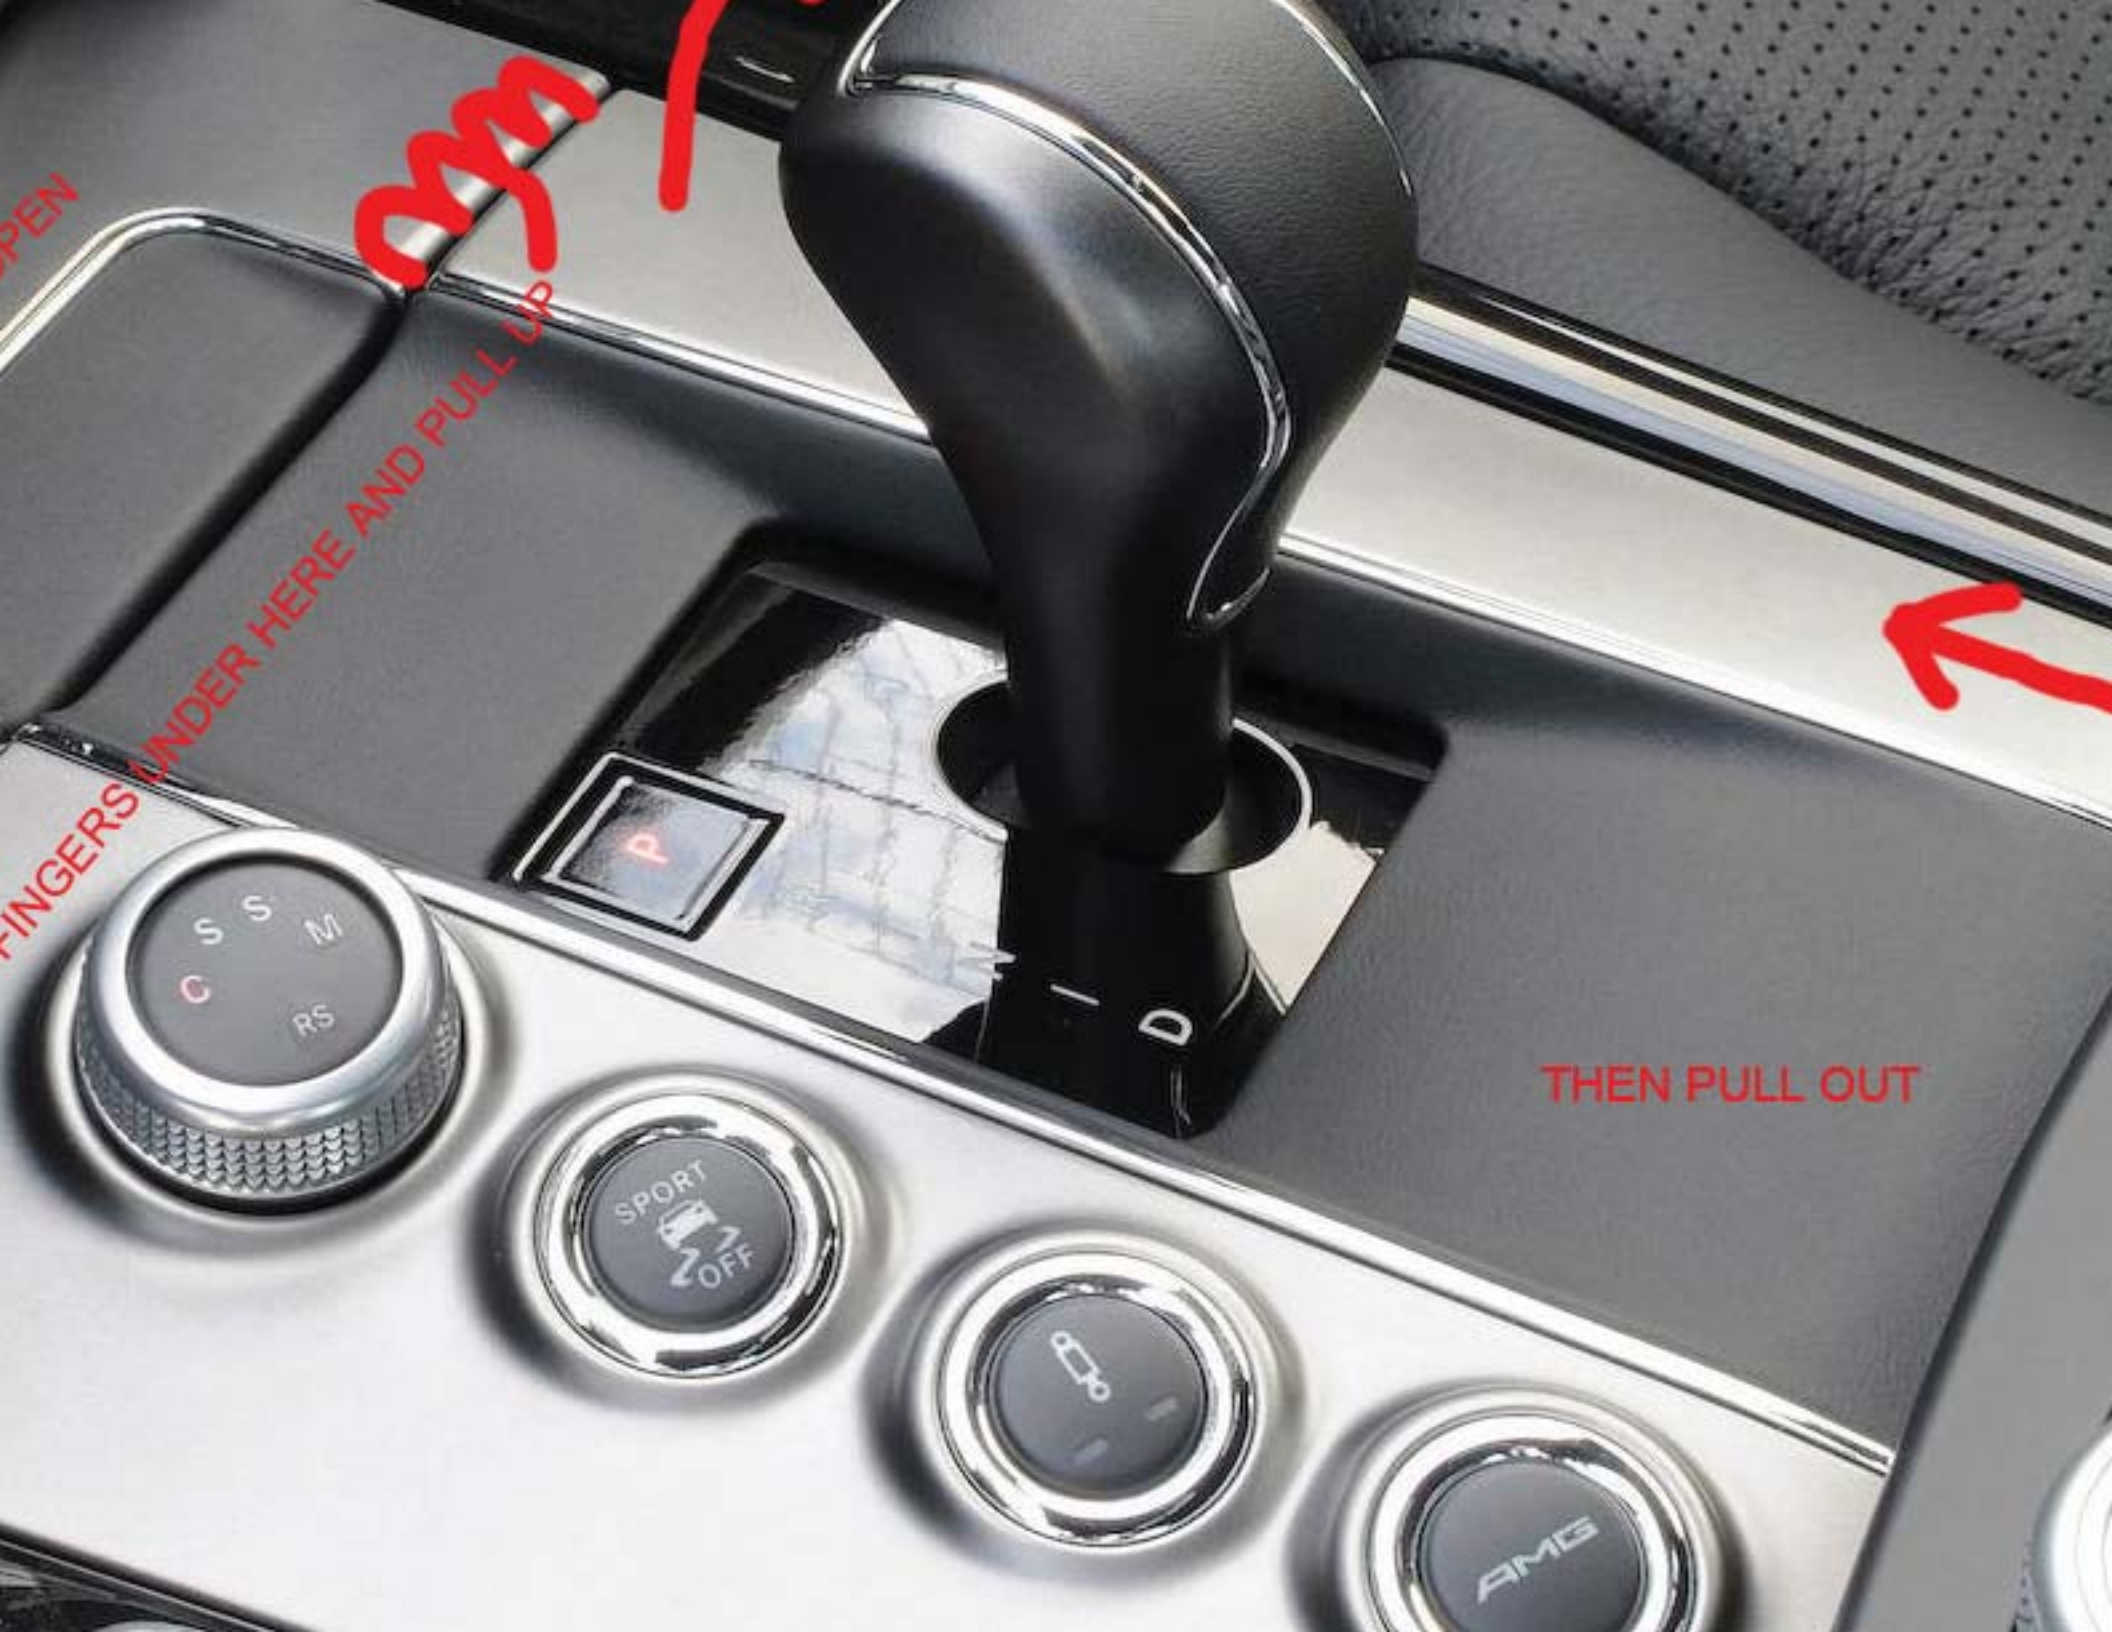
FINGERS UNDER HERE AND PULL UP

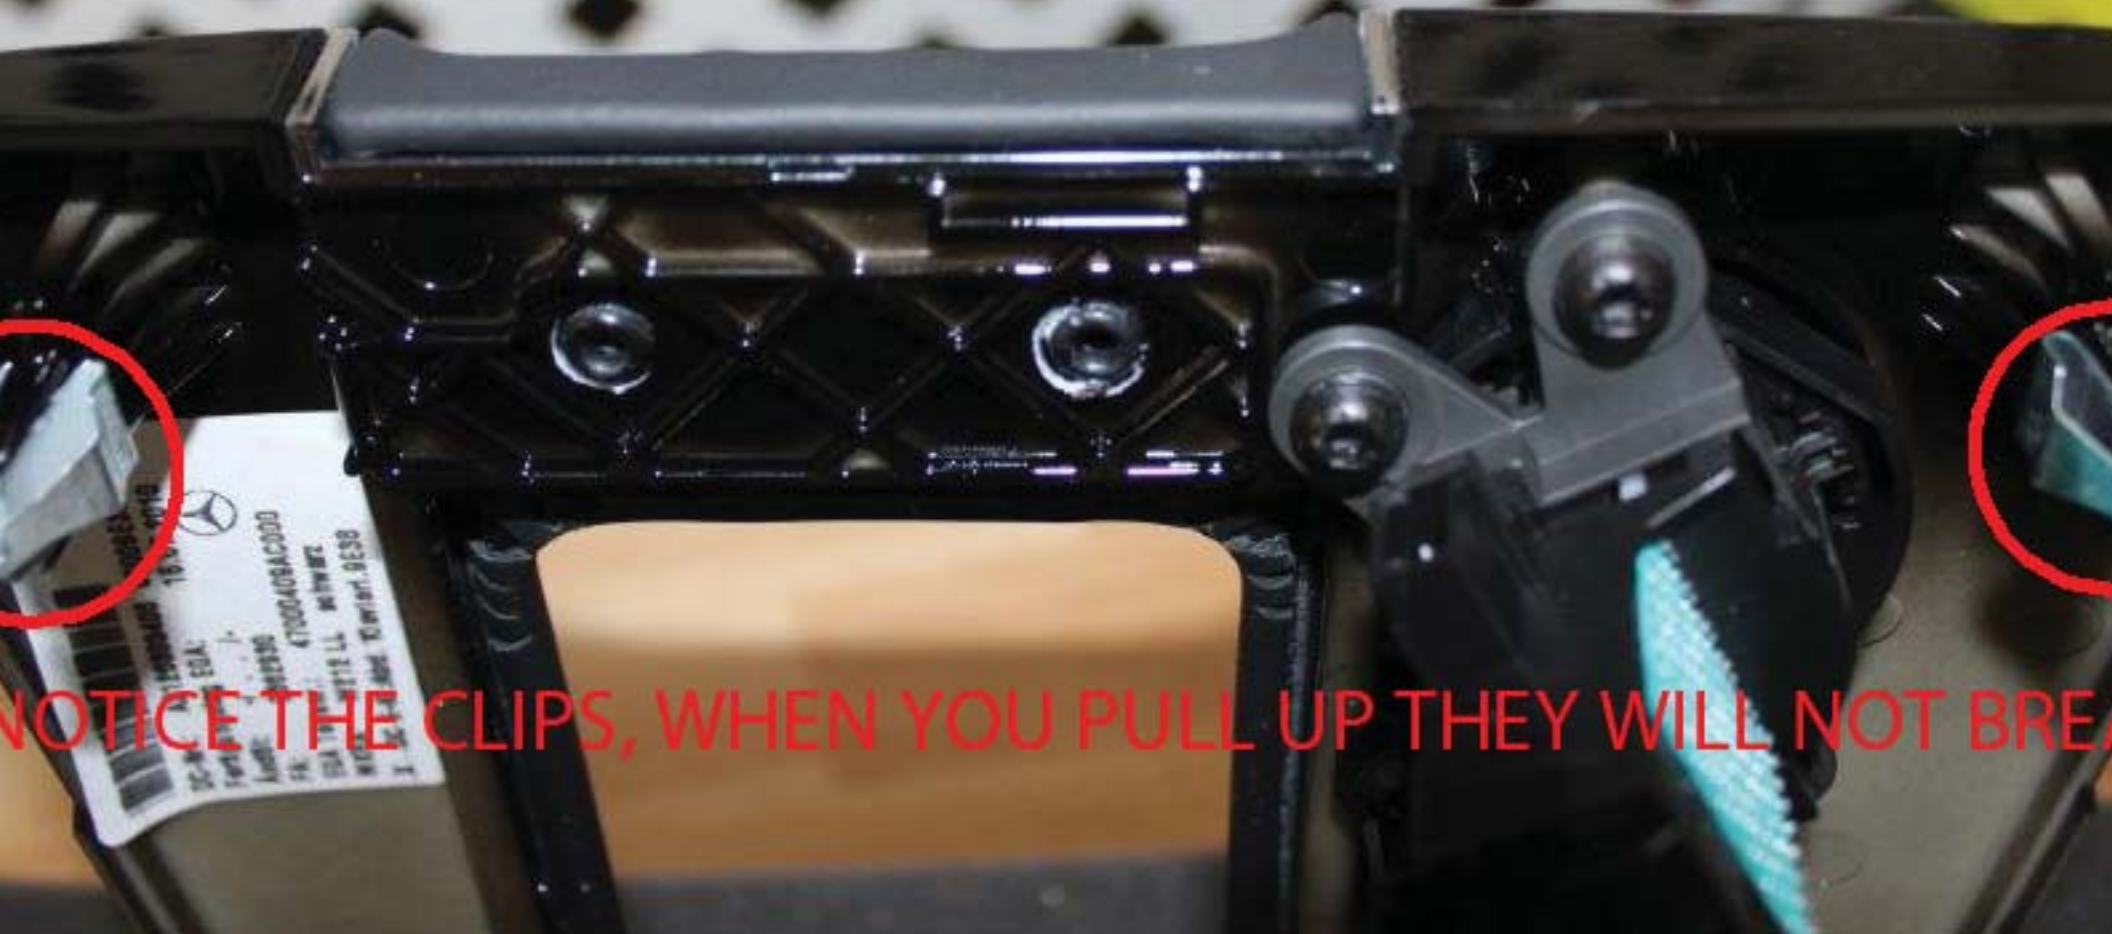
THEN PULL OUT

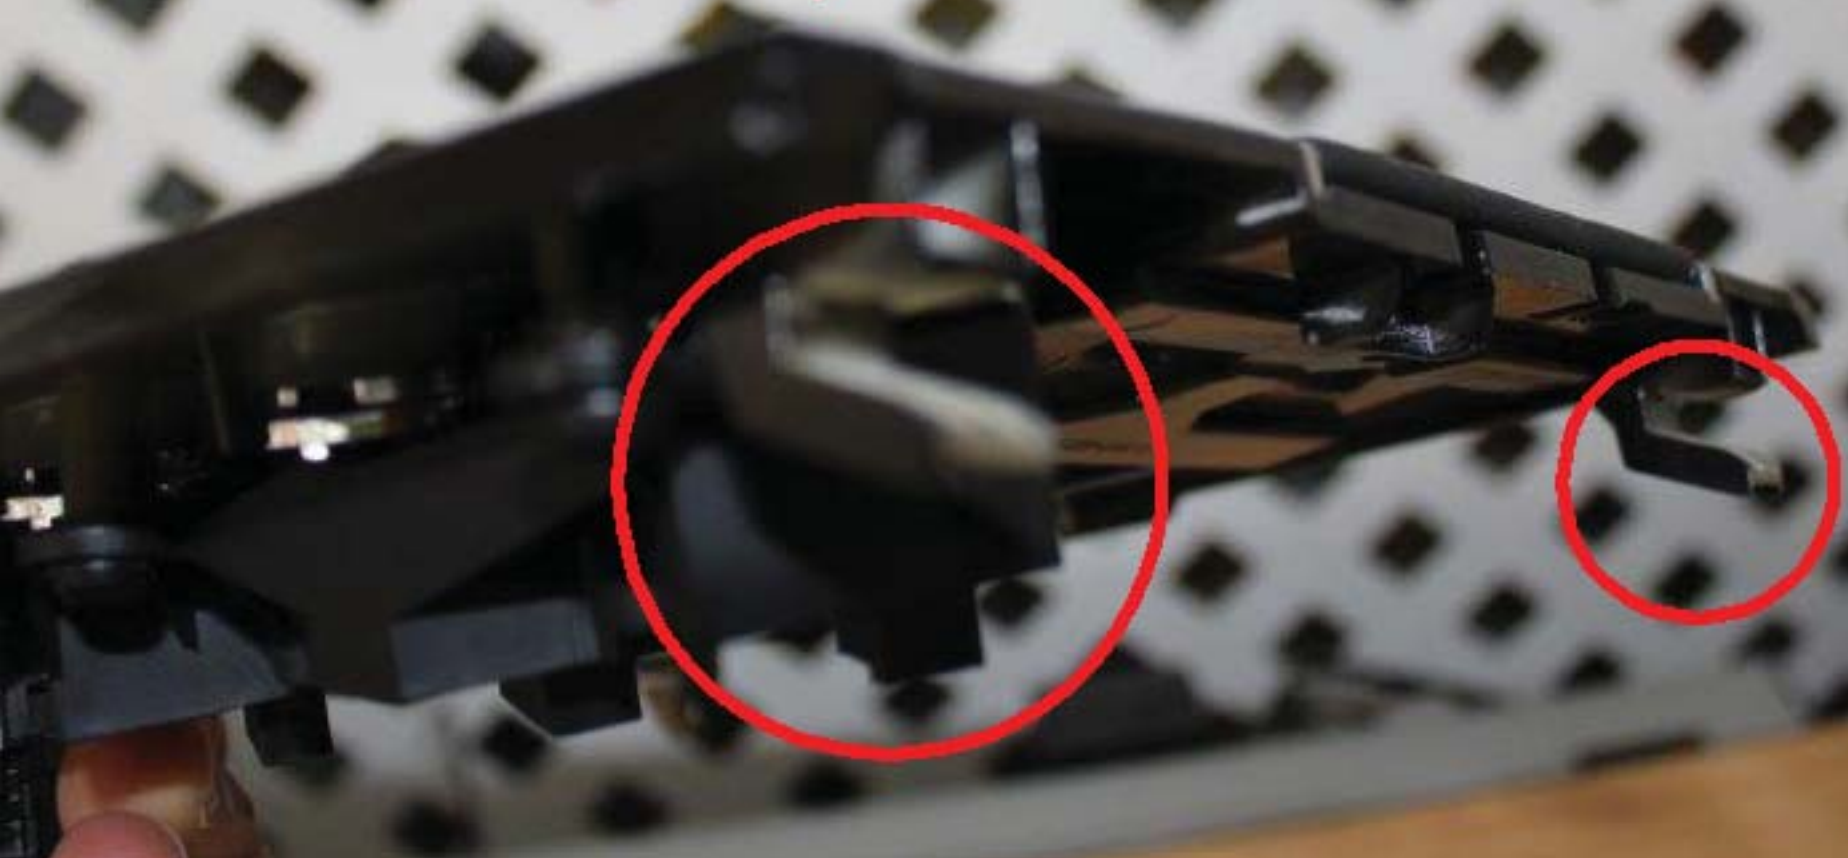
NOTICE THE CLIPS, WHEN YOU PULL UP THEY WILL NOT BREAK

AFTER PULLING UP, YOU TILT AND PULL FORWARD

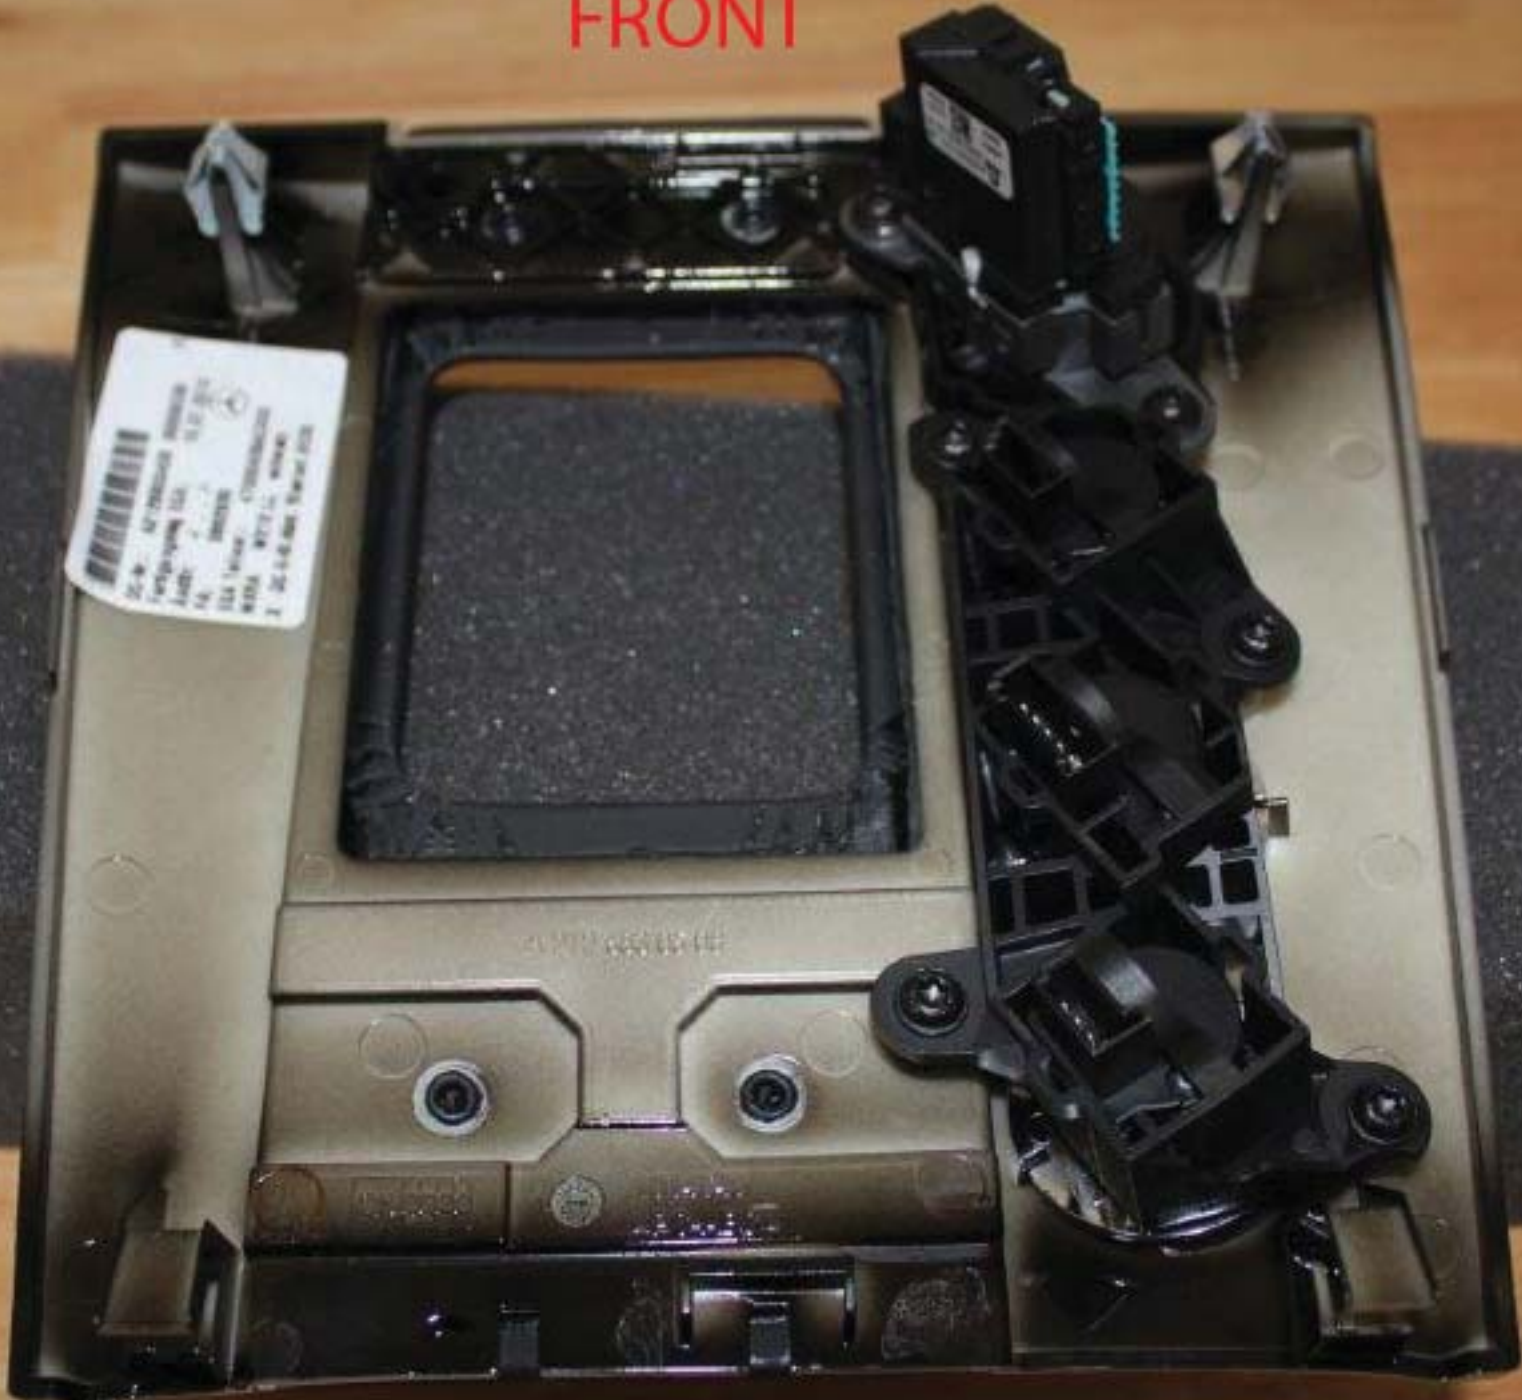
FRONT

REMOVE SCREWS

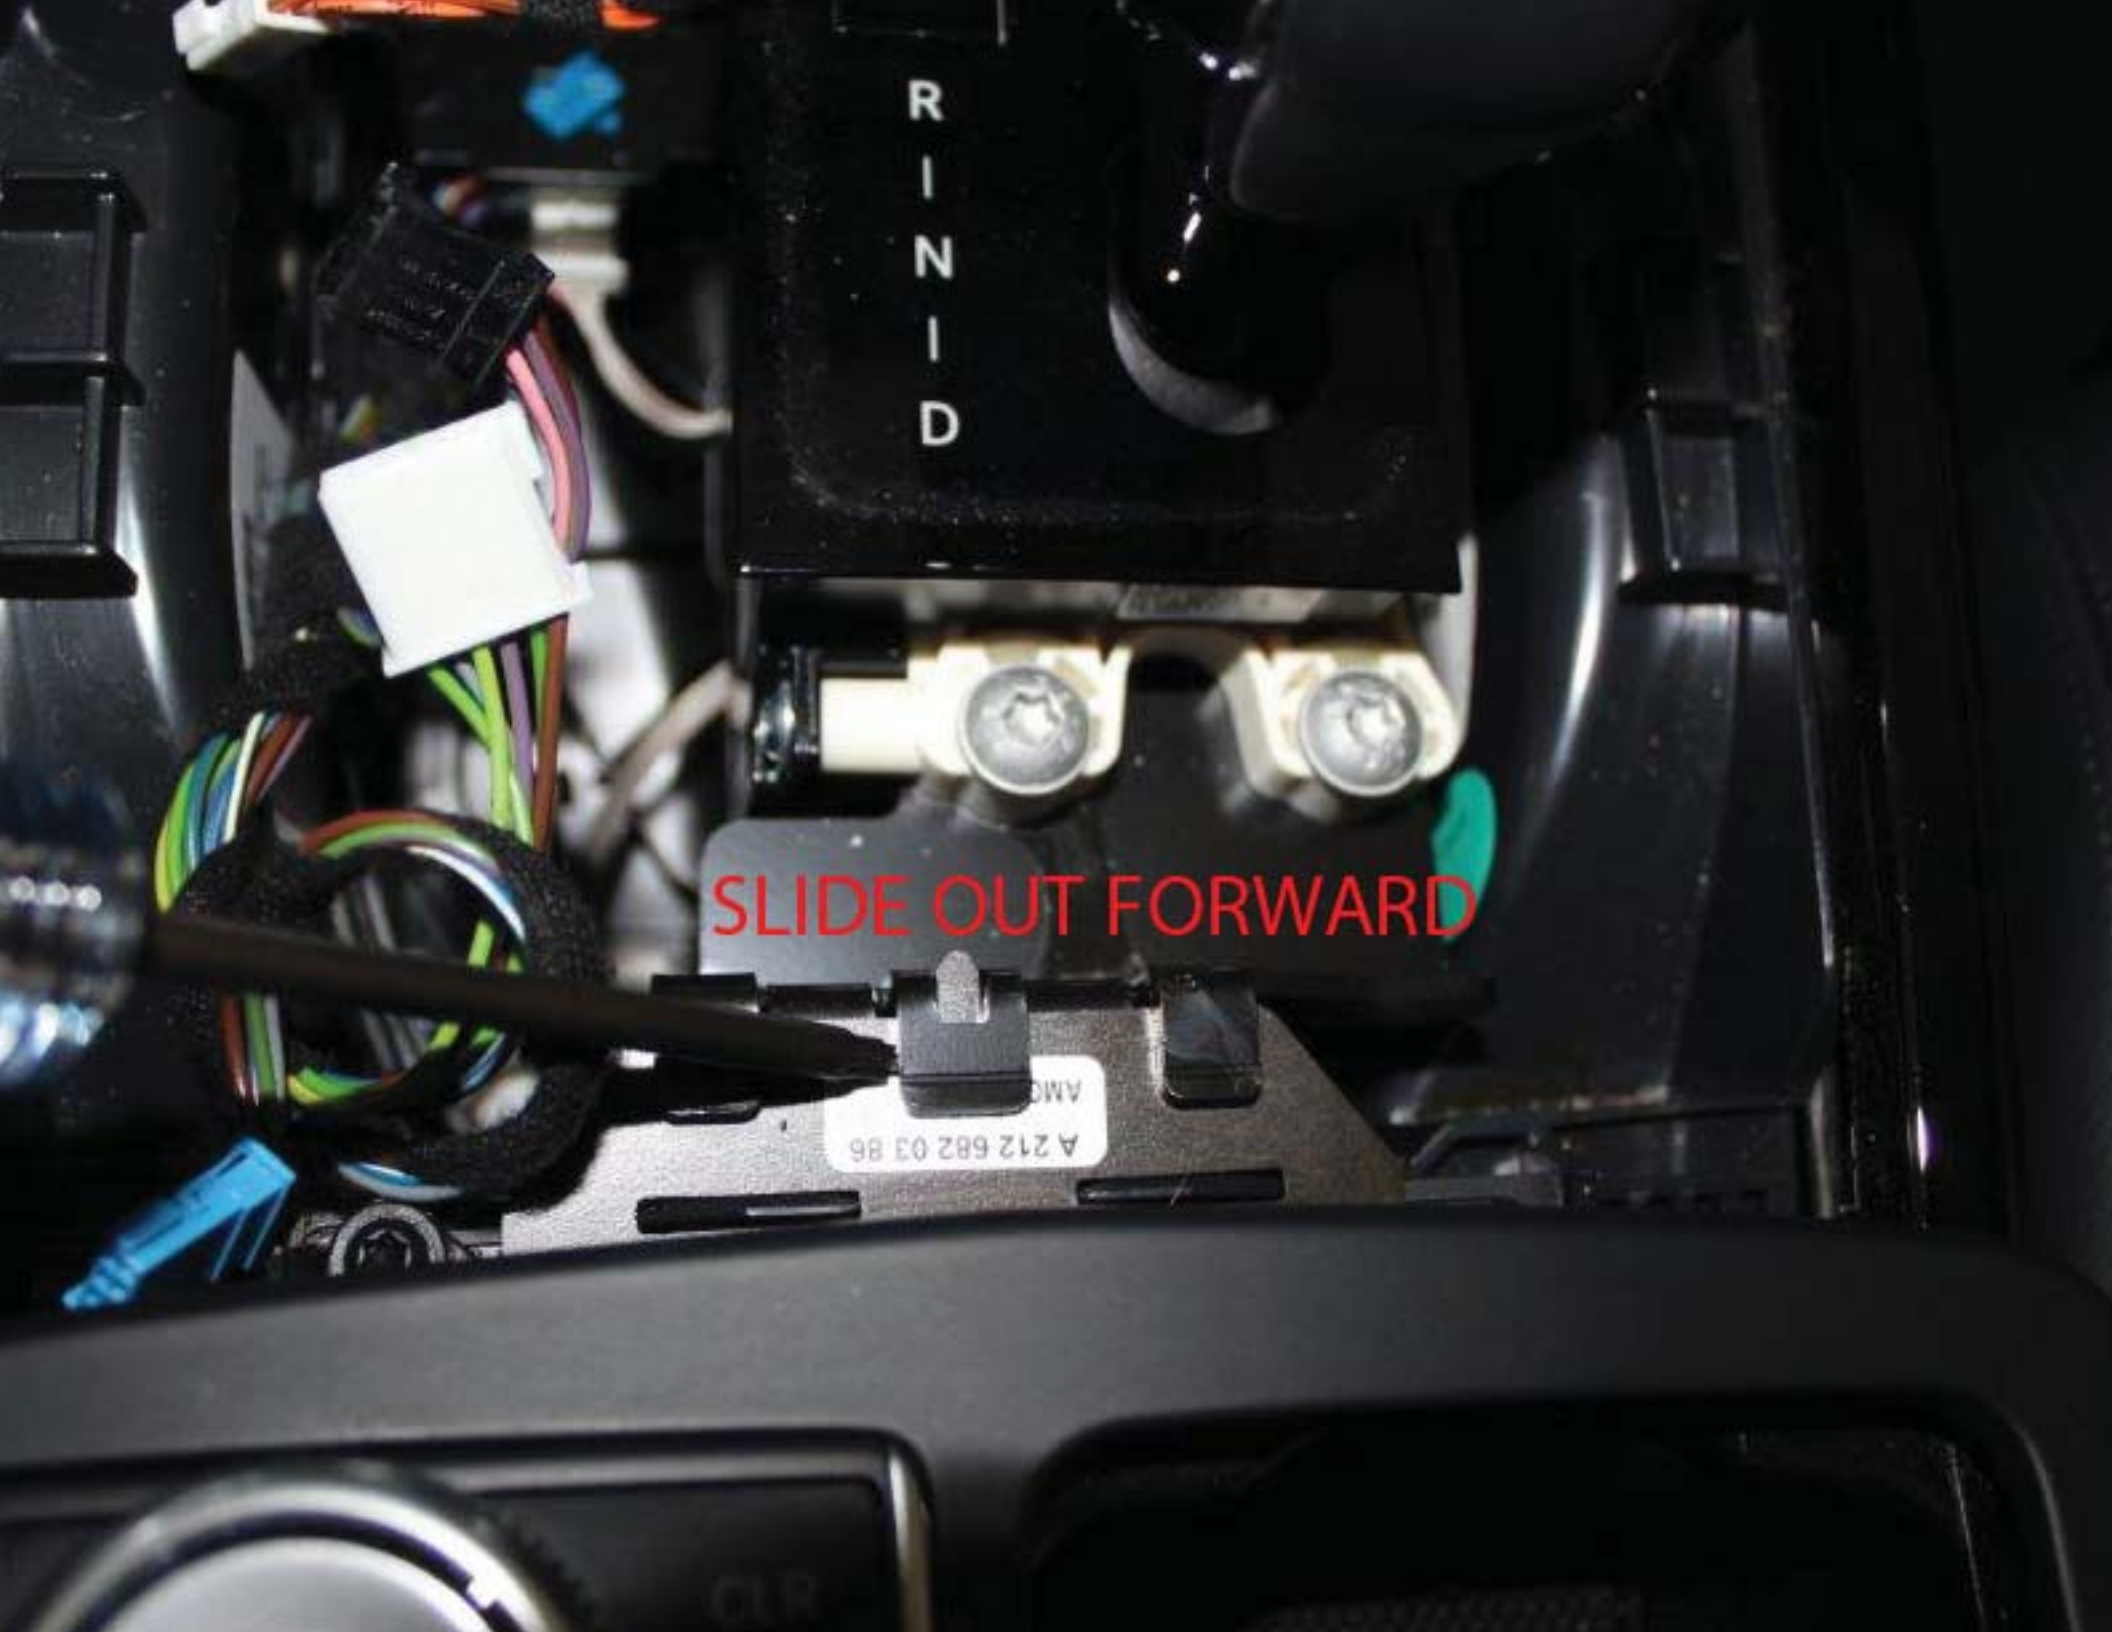
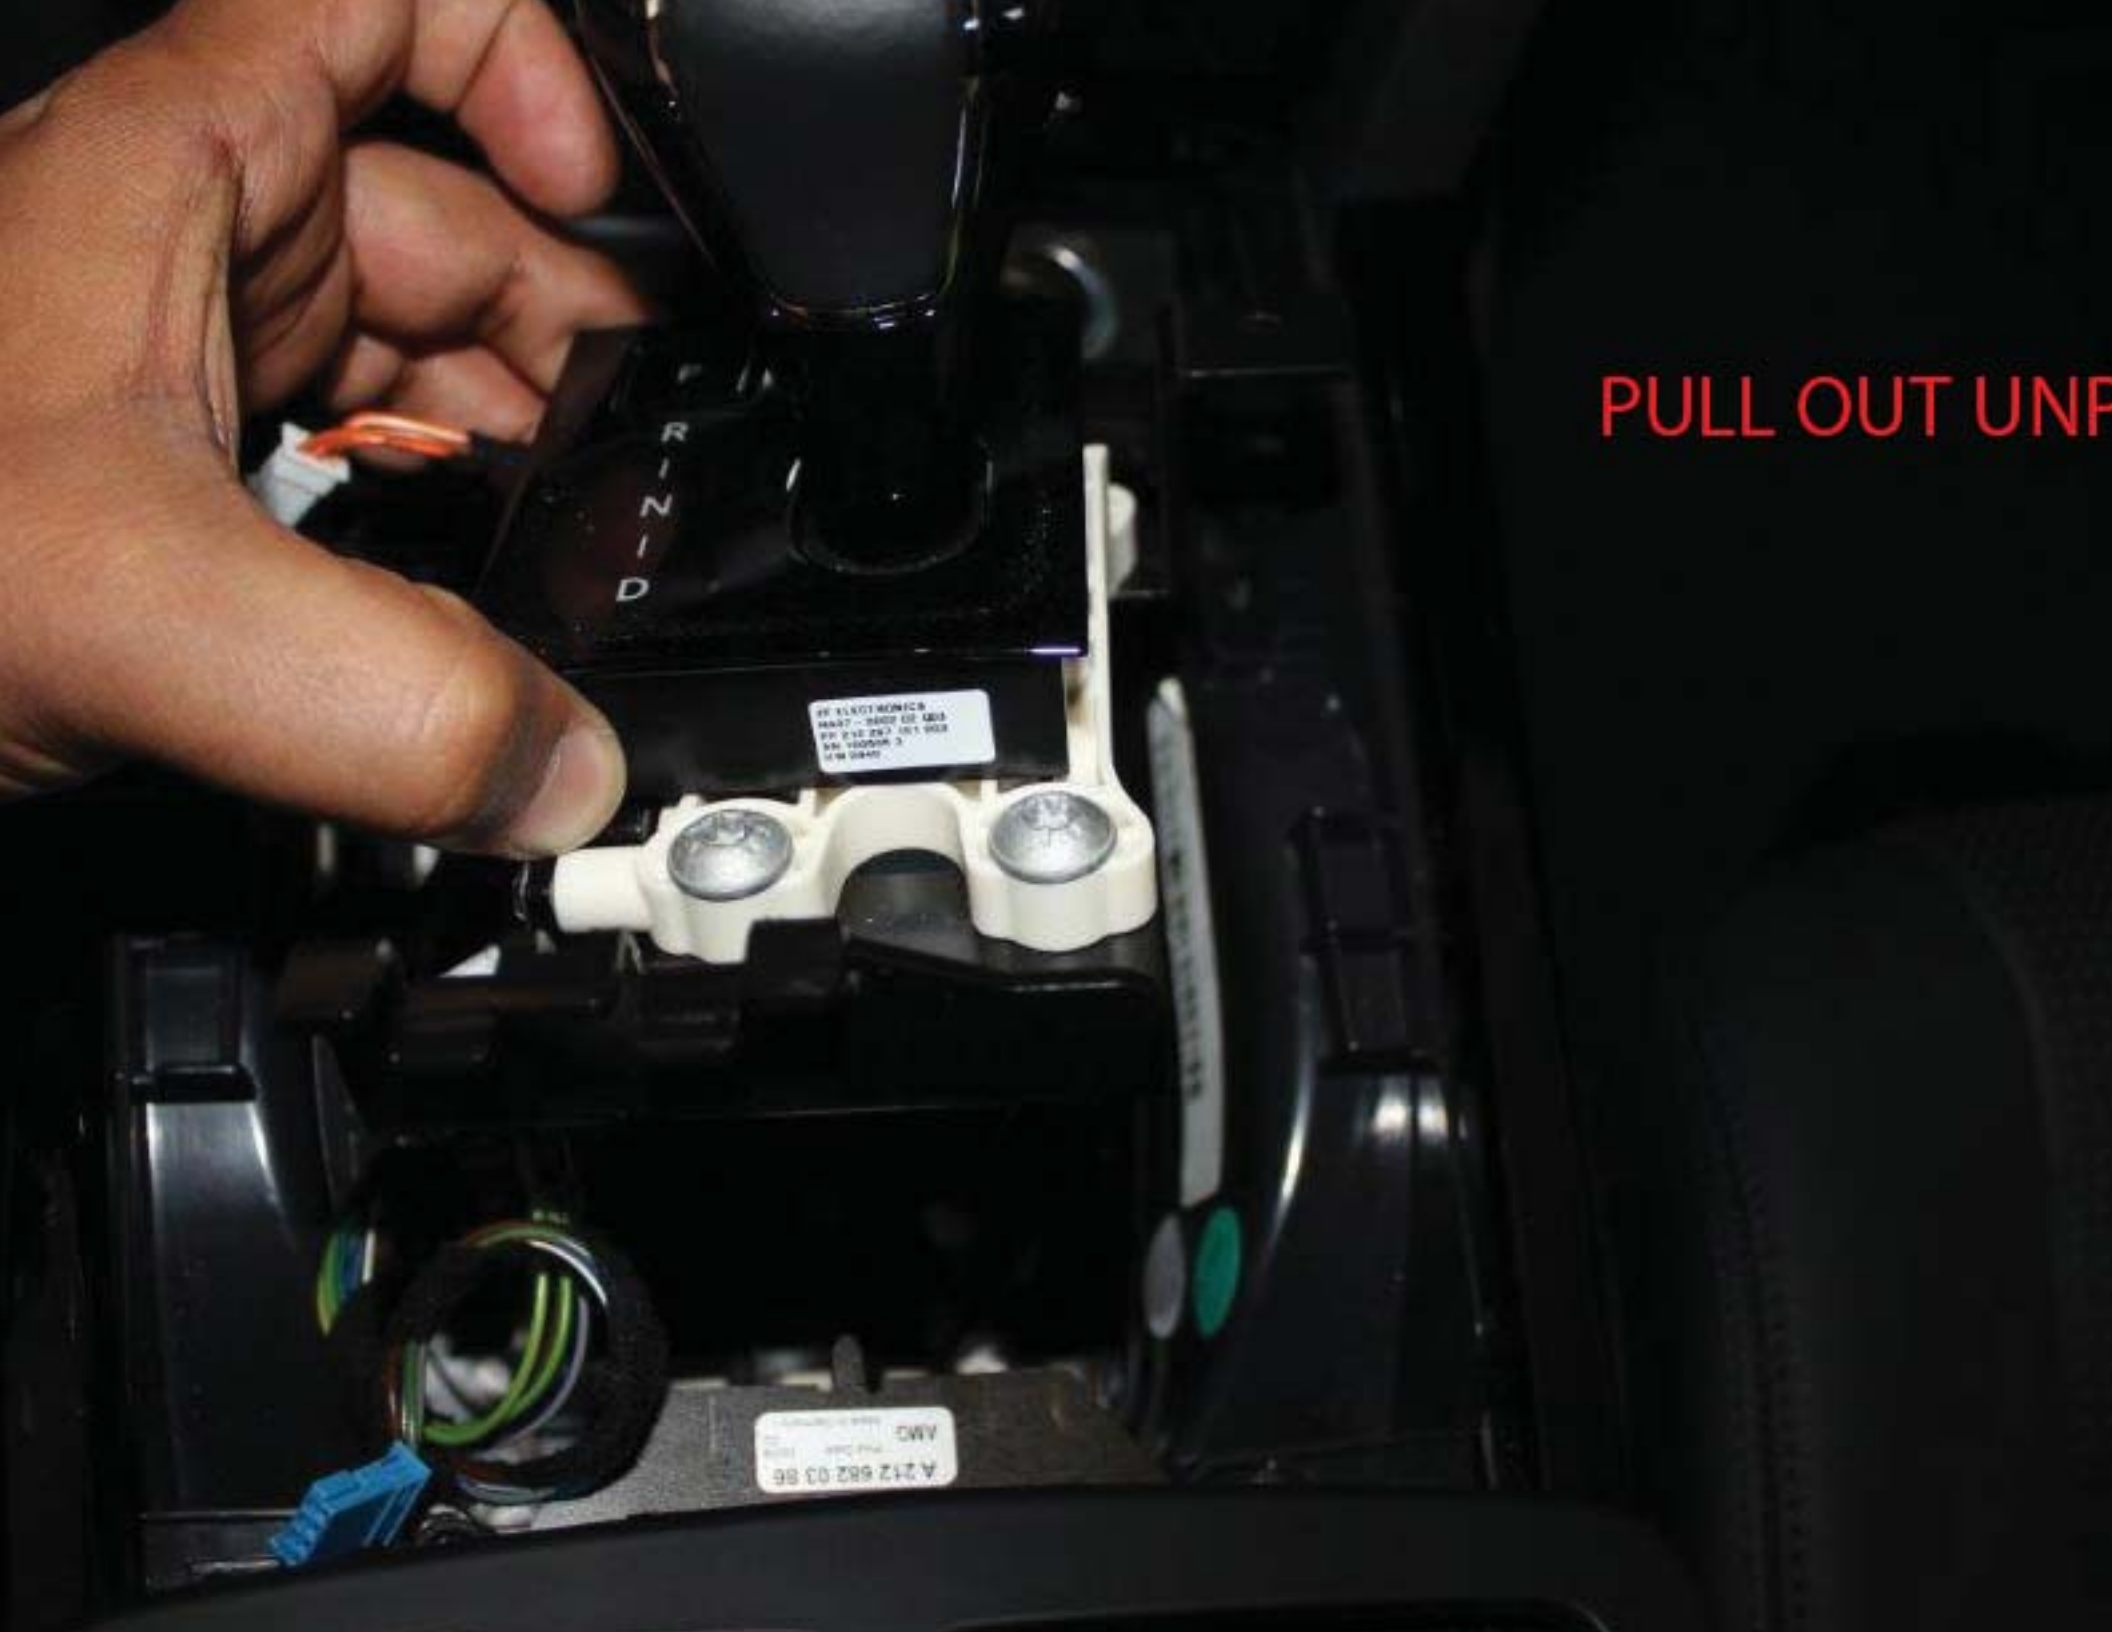
SLIDE OUT FORWARD

PULL OUT UNF

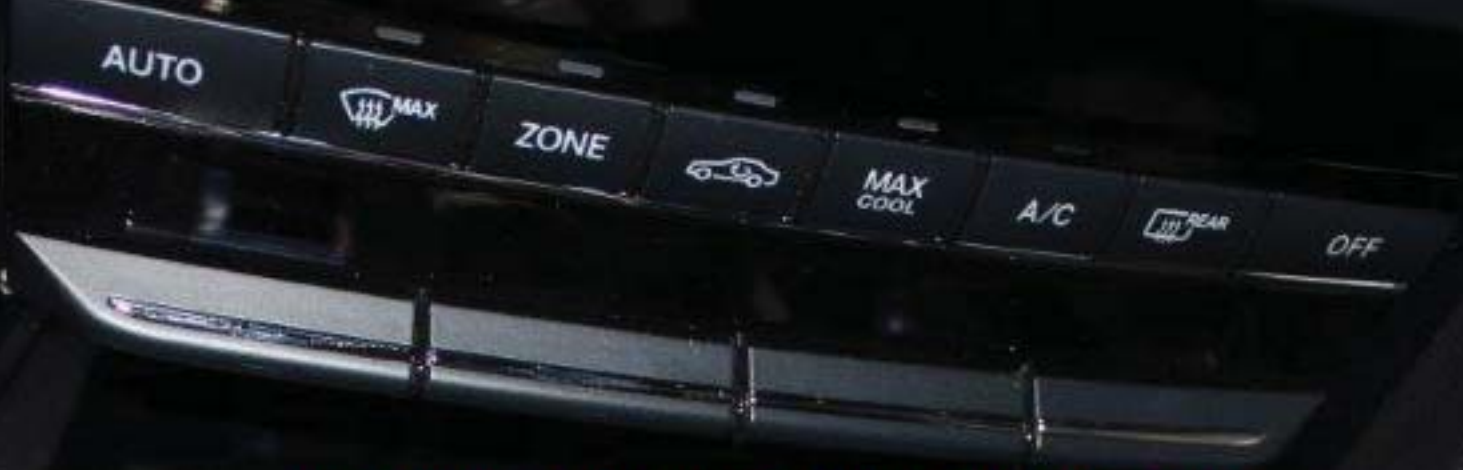
AFTER YOU MOVE SHIFTER
YOU CAN SLIDE OUT ASH TRAY

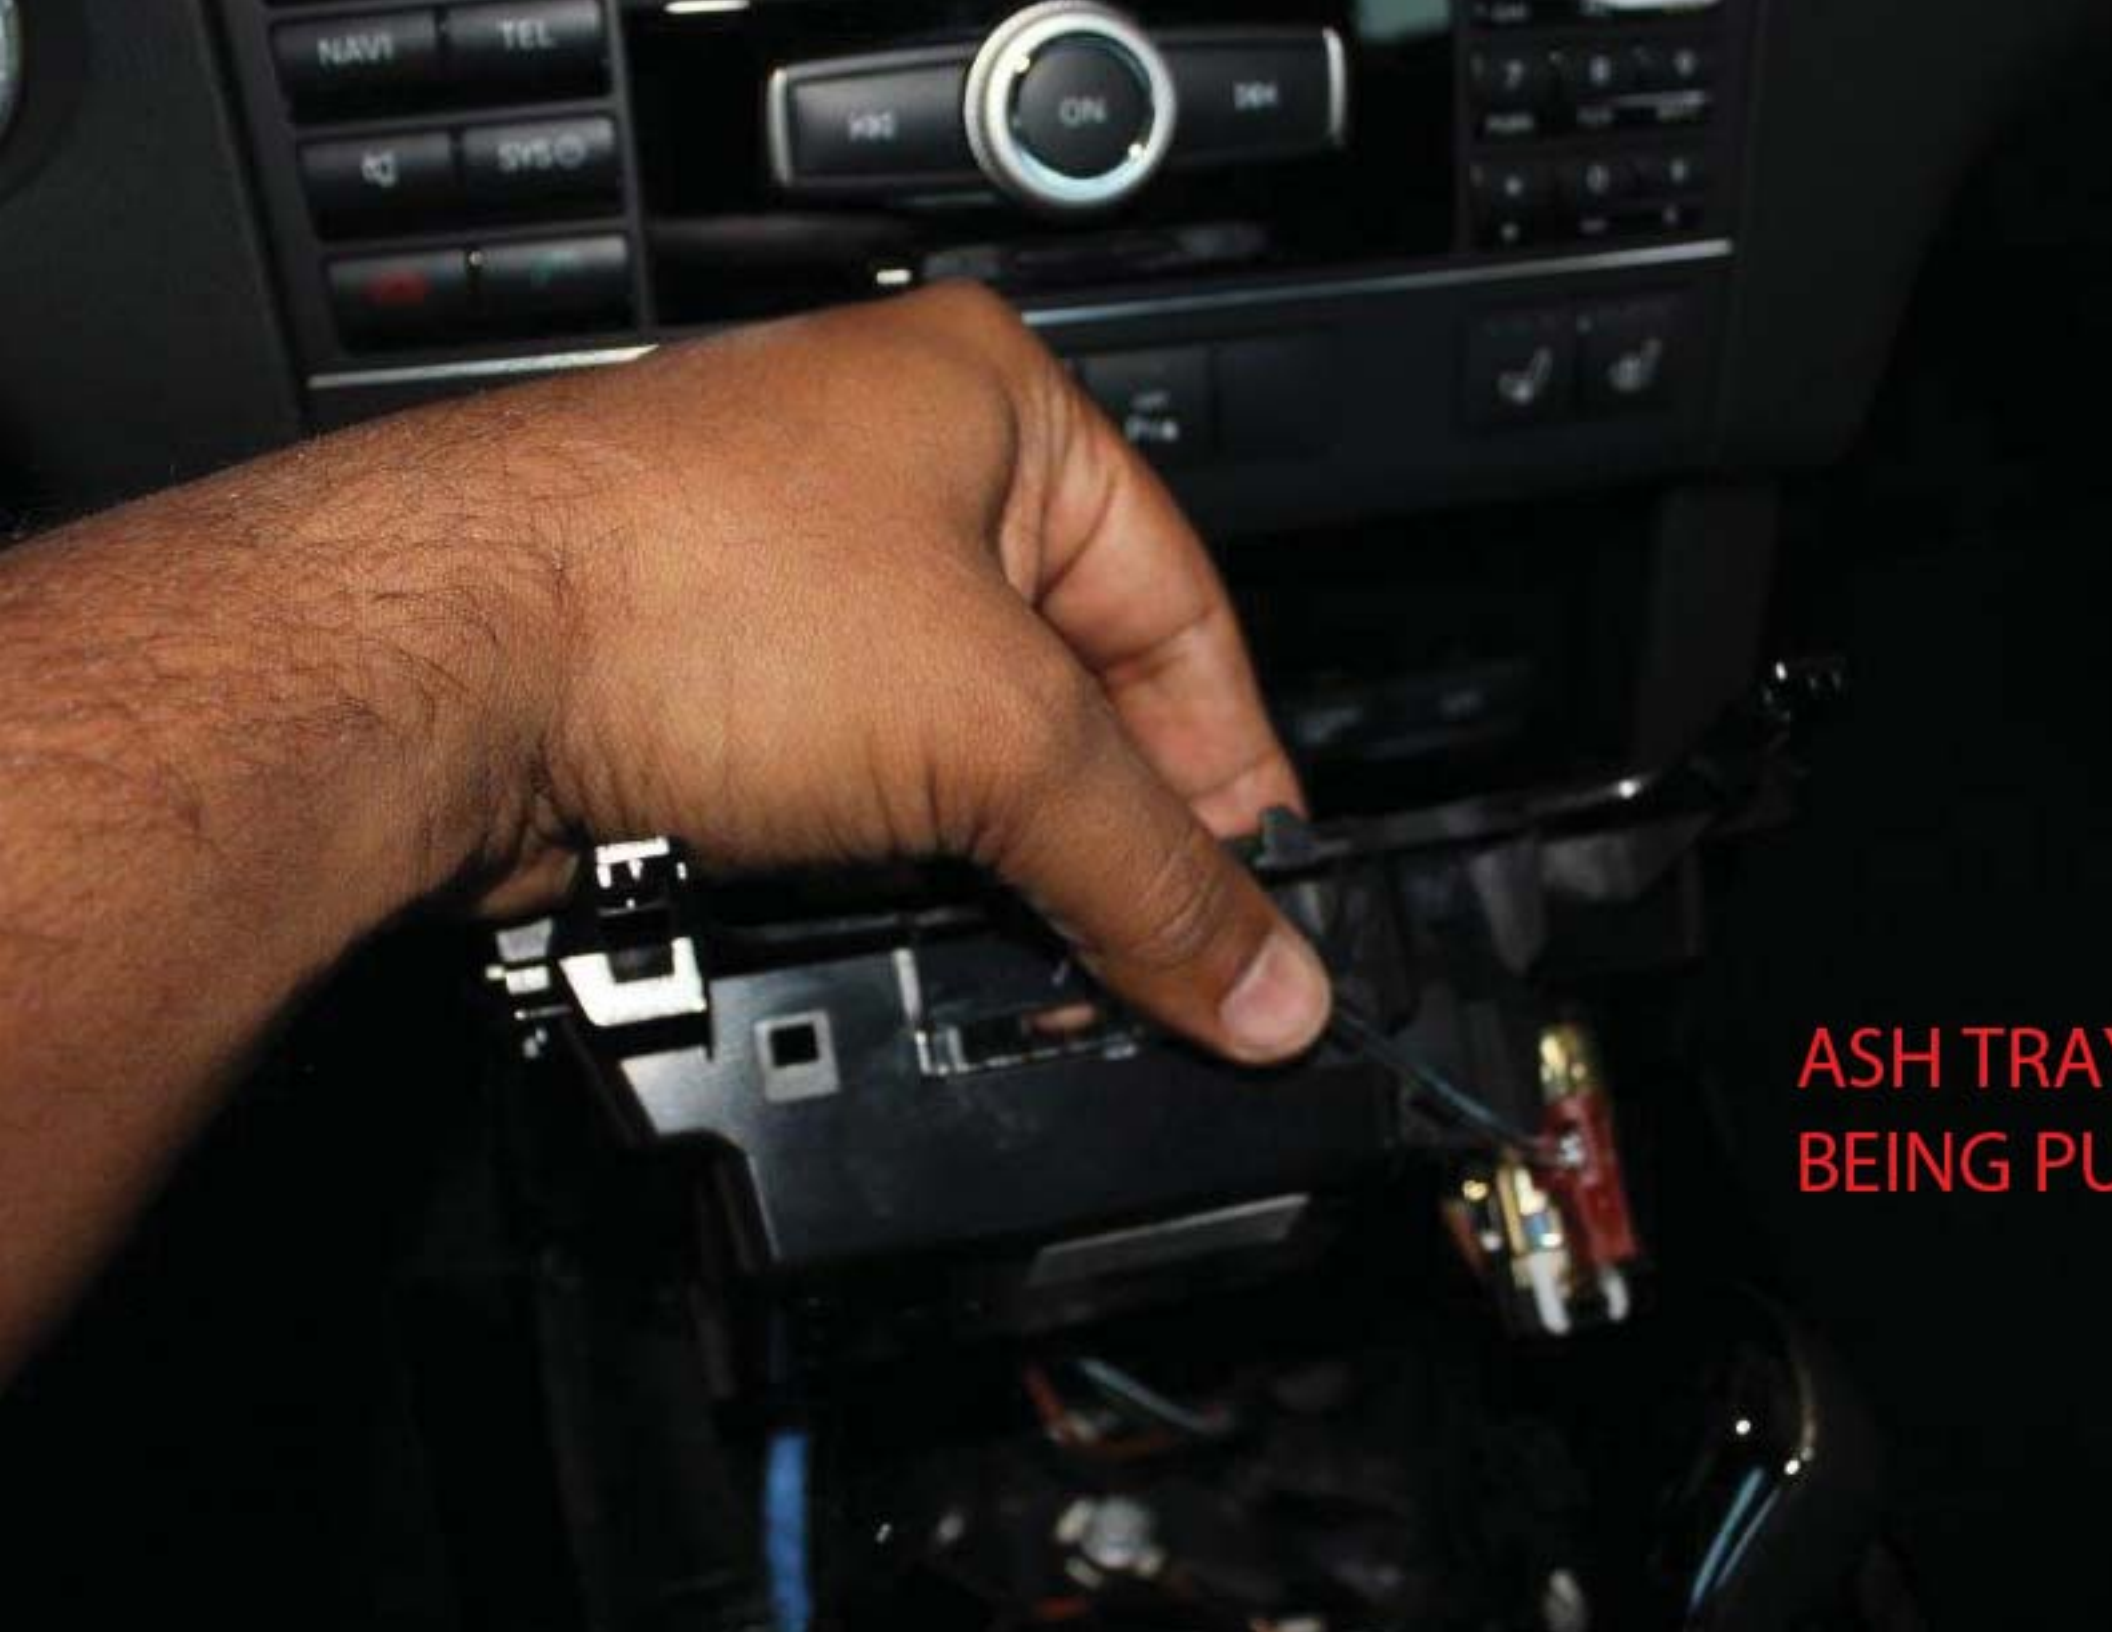
ASH TRAY
BEING PULLED
