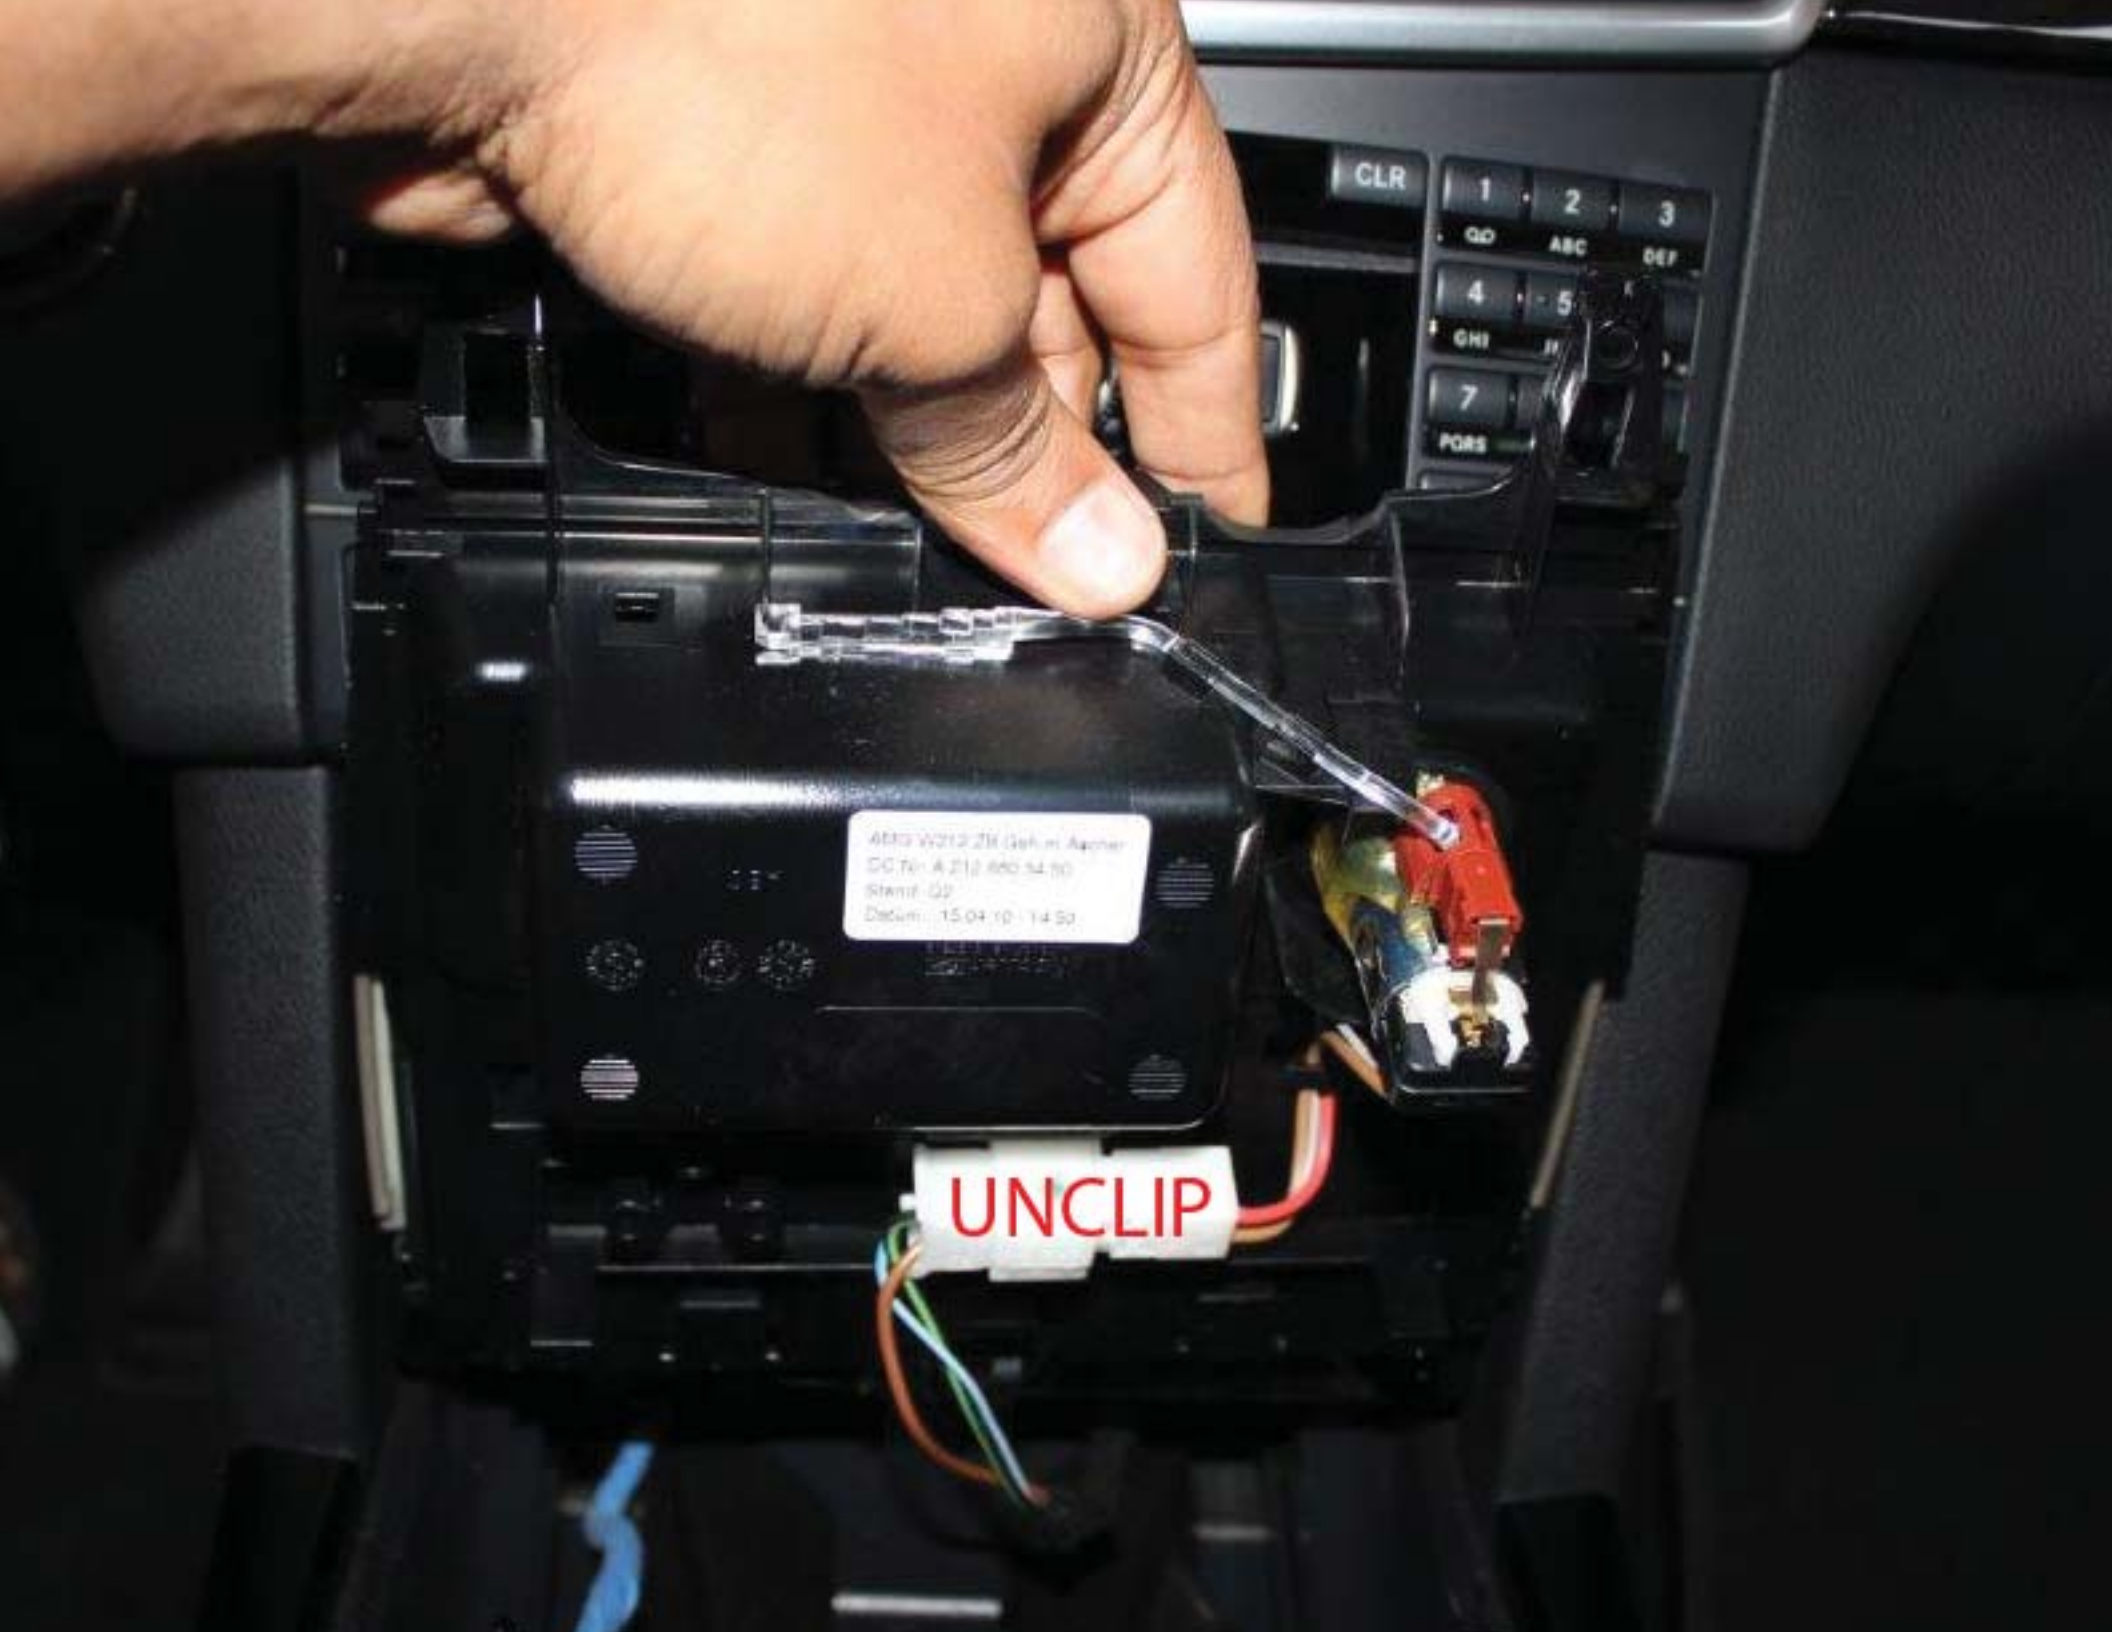
UNCLIP

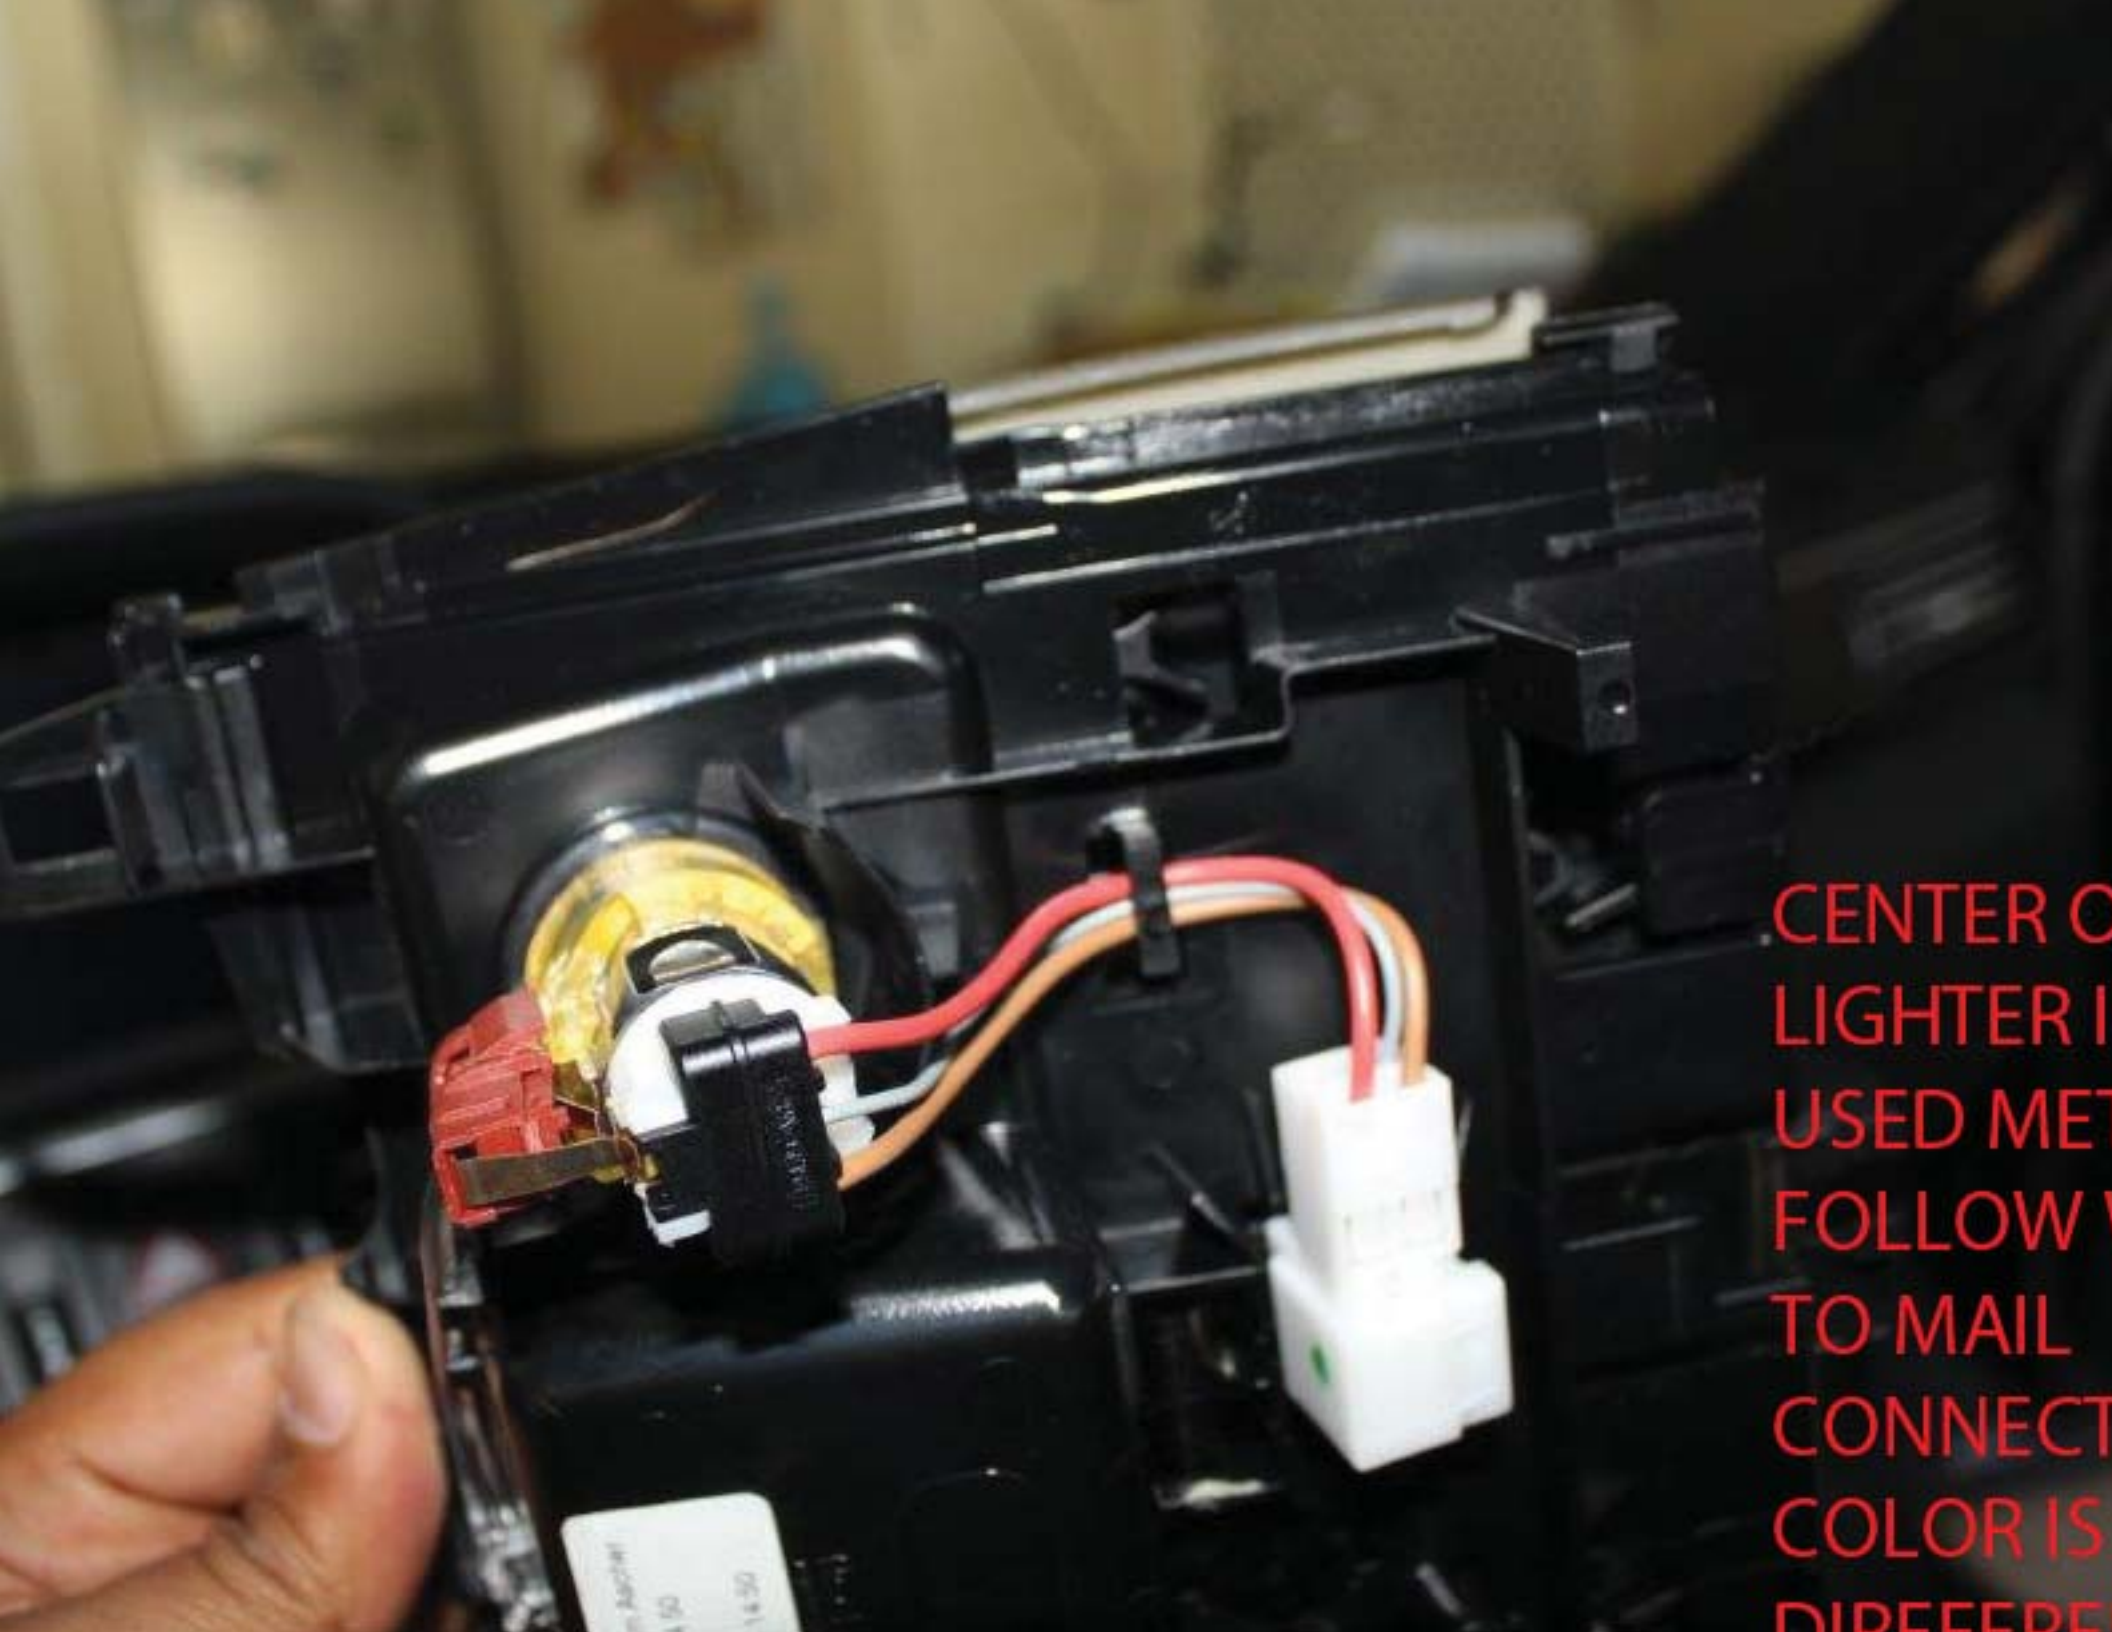
CENTER OF
LIGHTER IS
USED MET
FOLLOW V
TO MAIL
CONNECT
COLOR IS
DIFEEPE

BLACK/GREEN WIRE IS 12V SWITCHED

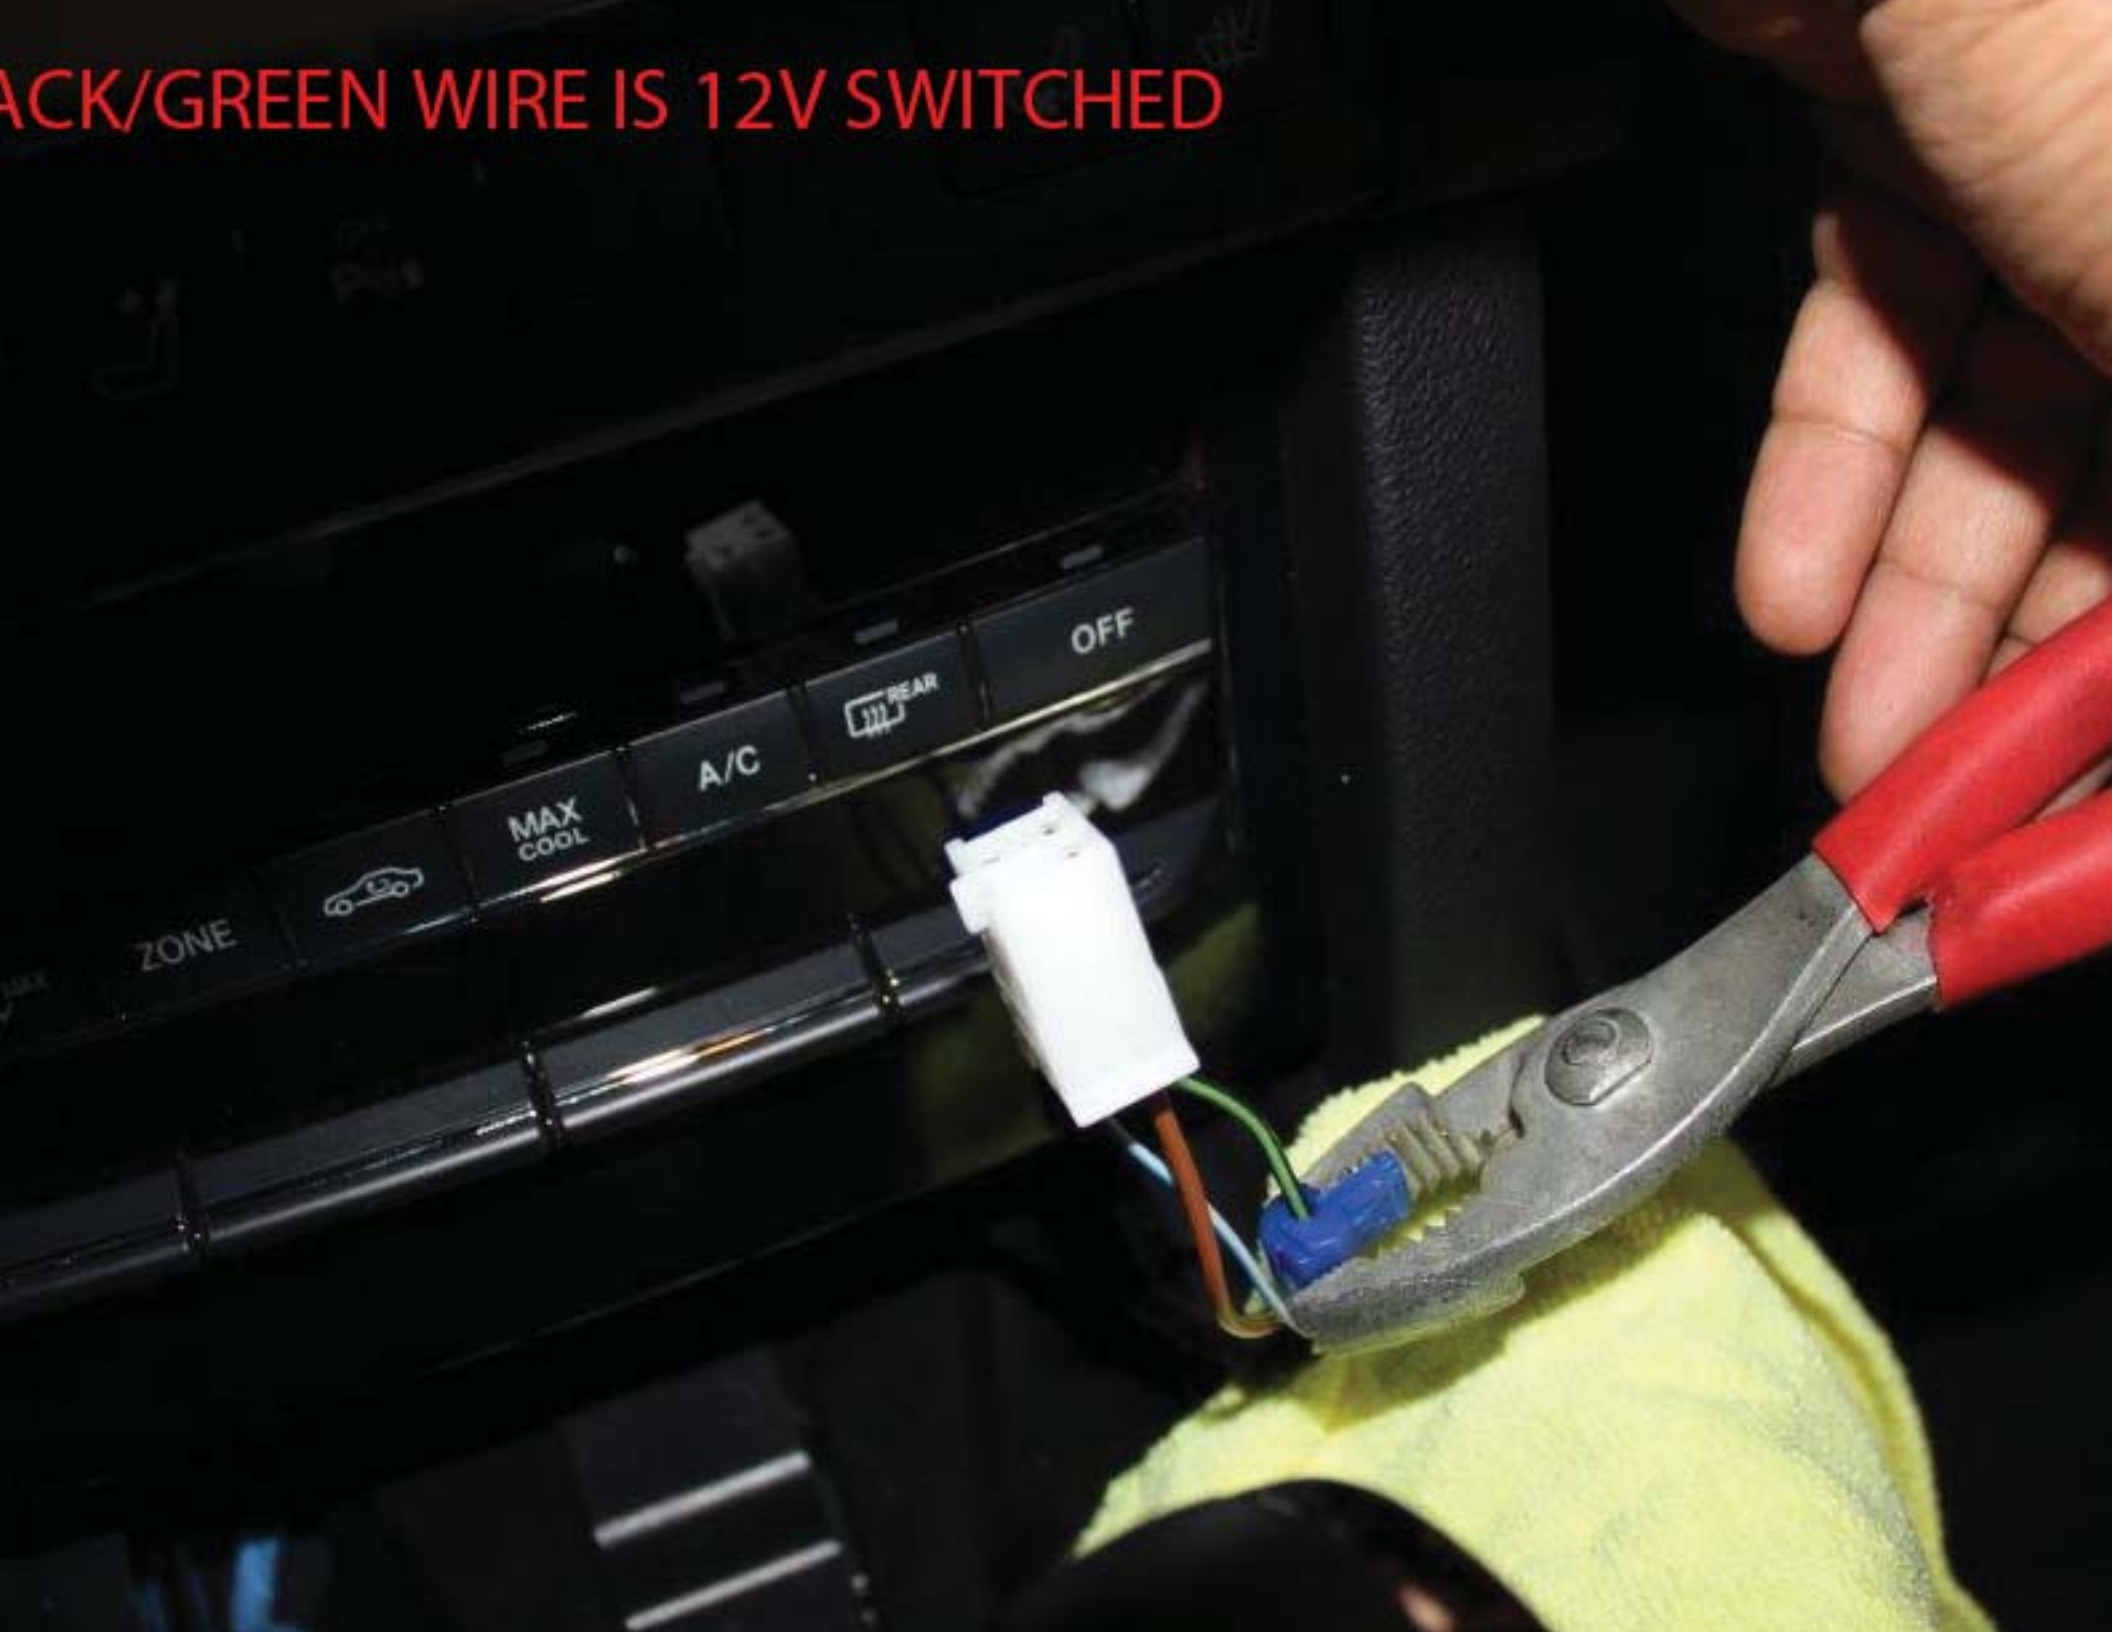
CLOSER LOOK, DONT
USE THE OTHER THE OTHER WIR

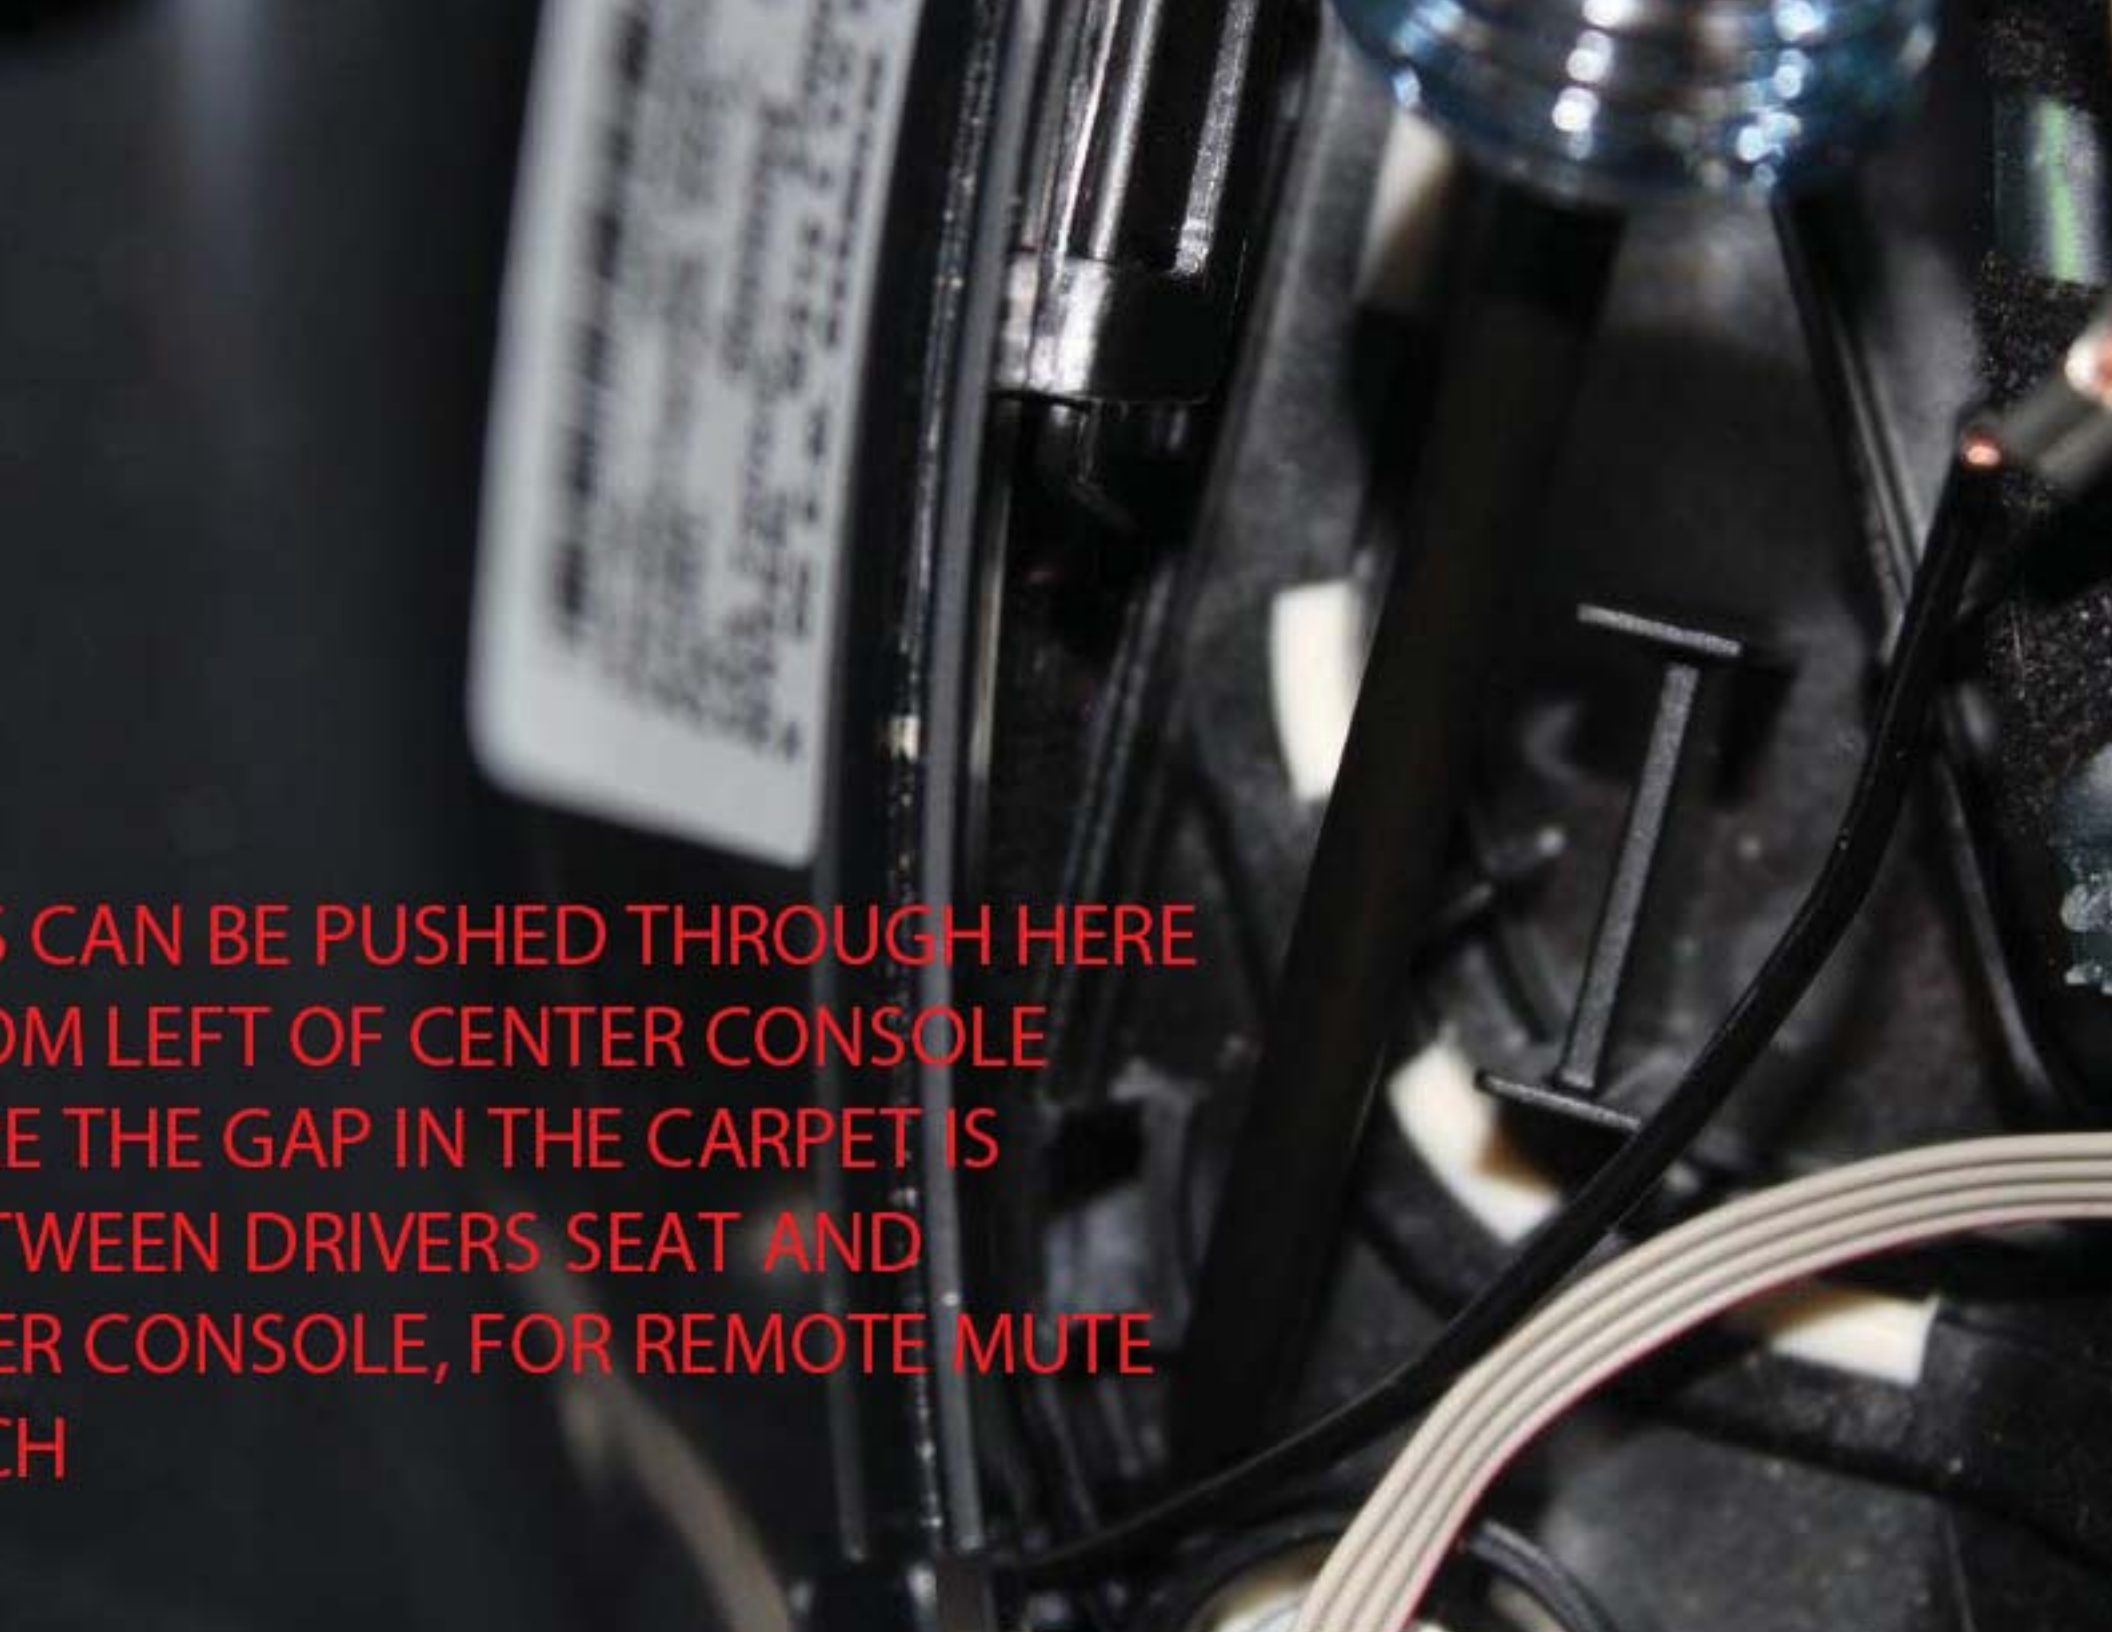
A close-up photograph of the interior wiring of a car, specifically the area under the center console. The image shows a complex arrangement of black and white wires, a blue screw, and a metal bracket. A white label with some text is visible in the upper left corner. The background is dark and out of focus.

Wires CAN BE PUSHED THROUGH HERE
FROM LEFT OF CENTER CONSOLE
WHERE THE GAP IN THE CARPET IS
BETWEEN DRIVERS SEAT AND
CENTER CONSOLE, FOR REMOTE MUTE
SWITCH

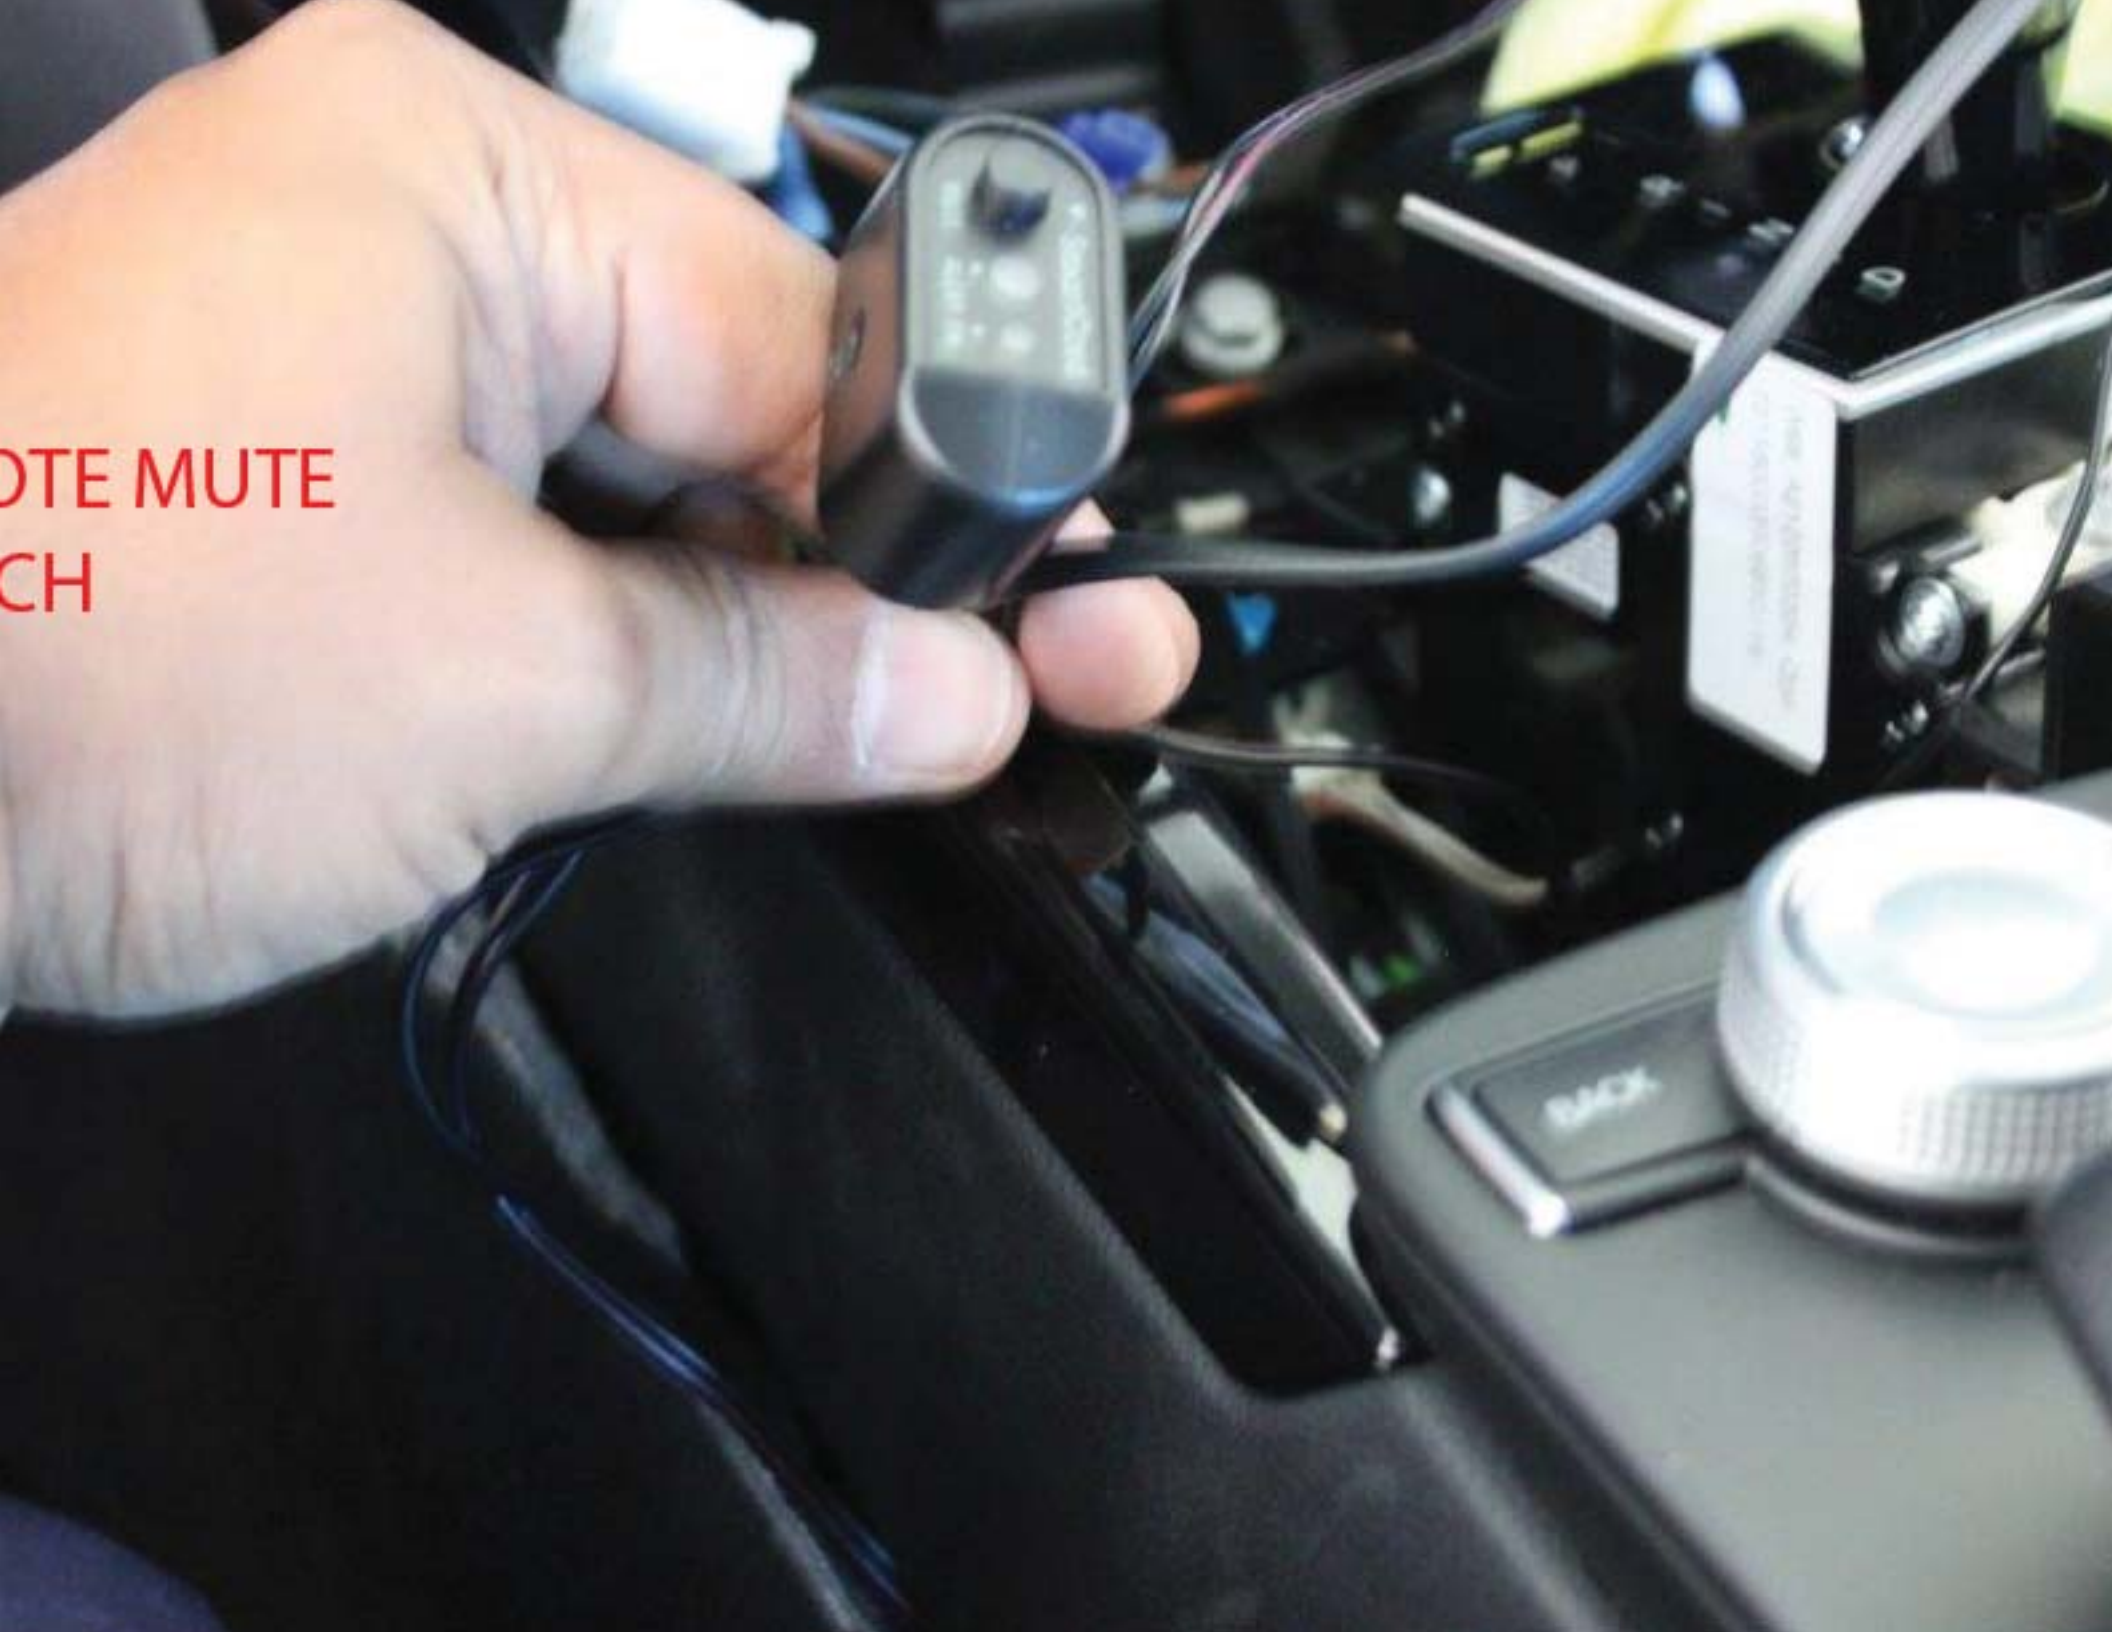
WIDER TO MOVE THIS FORWARD
WIFE MOVES THE SEAT UP
MASSAGE SEAT CONTROLS
HIT AND RIPP OF THE SWITCH
NO AND ALL

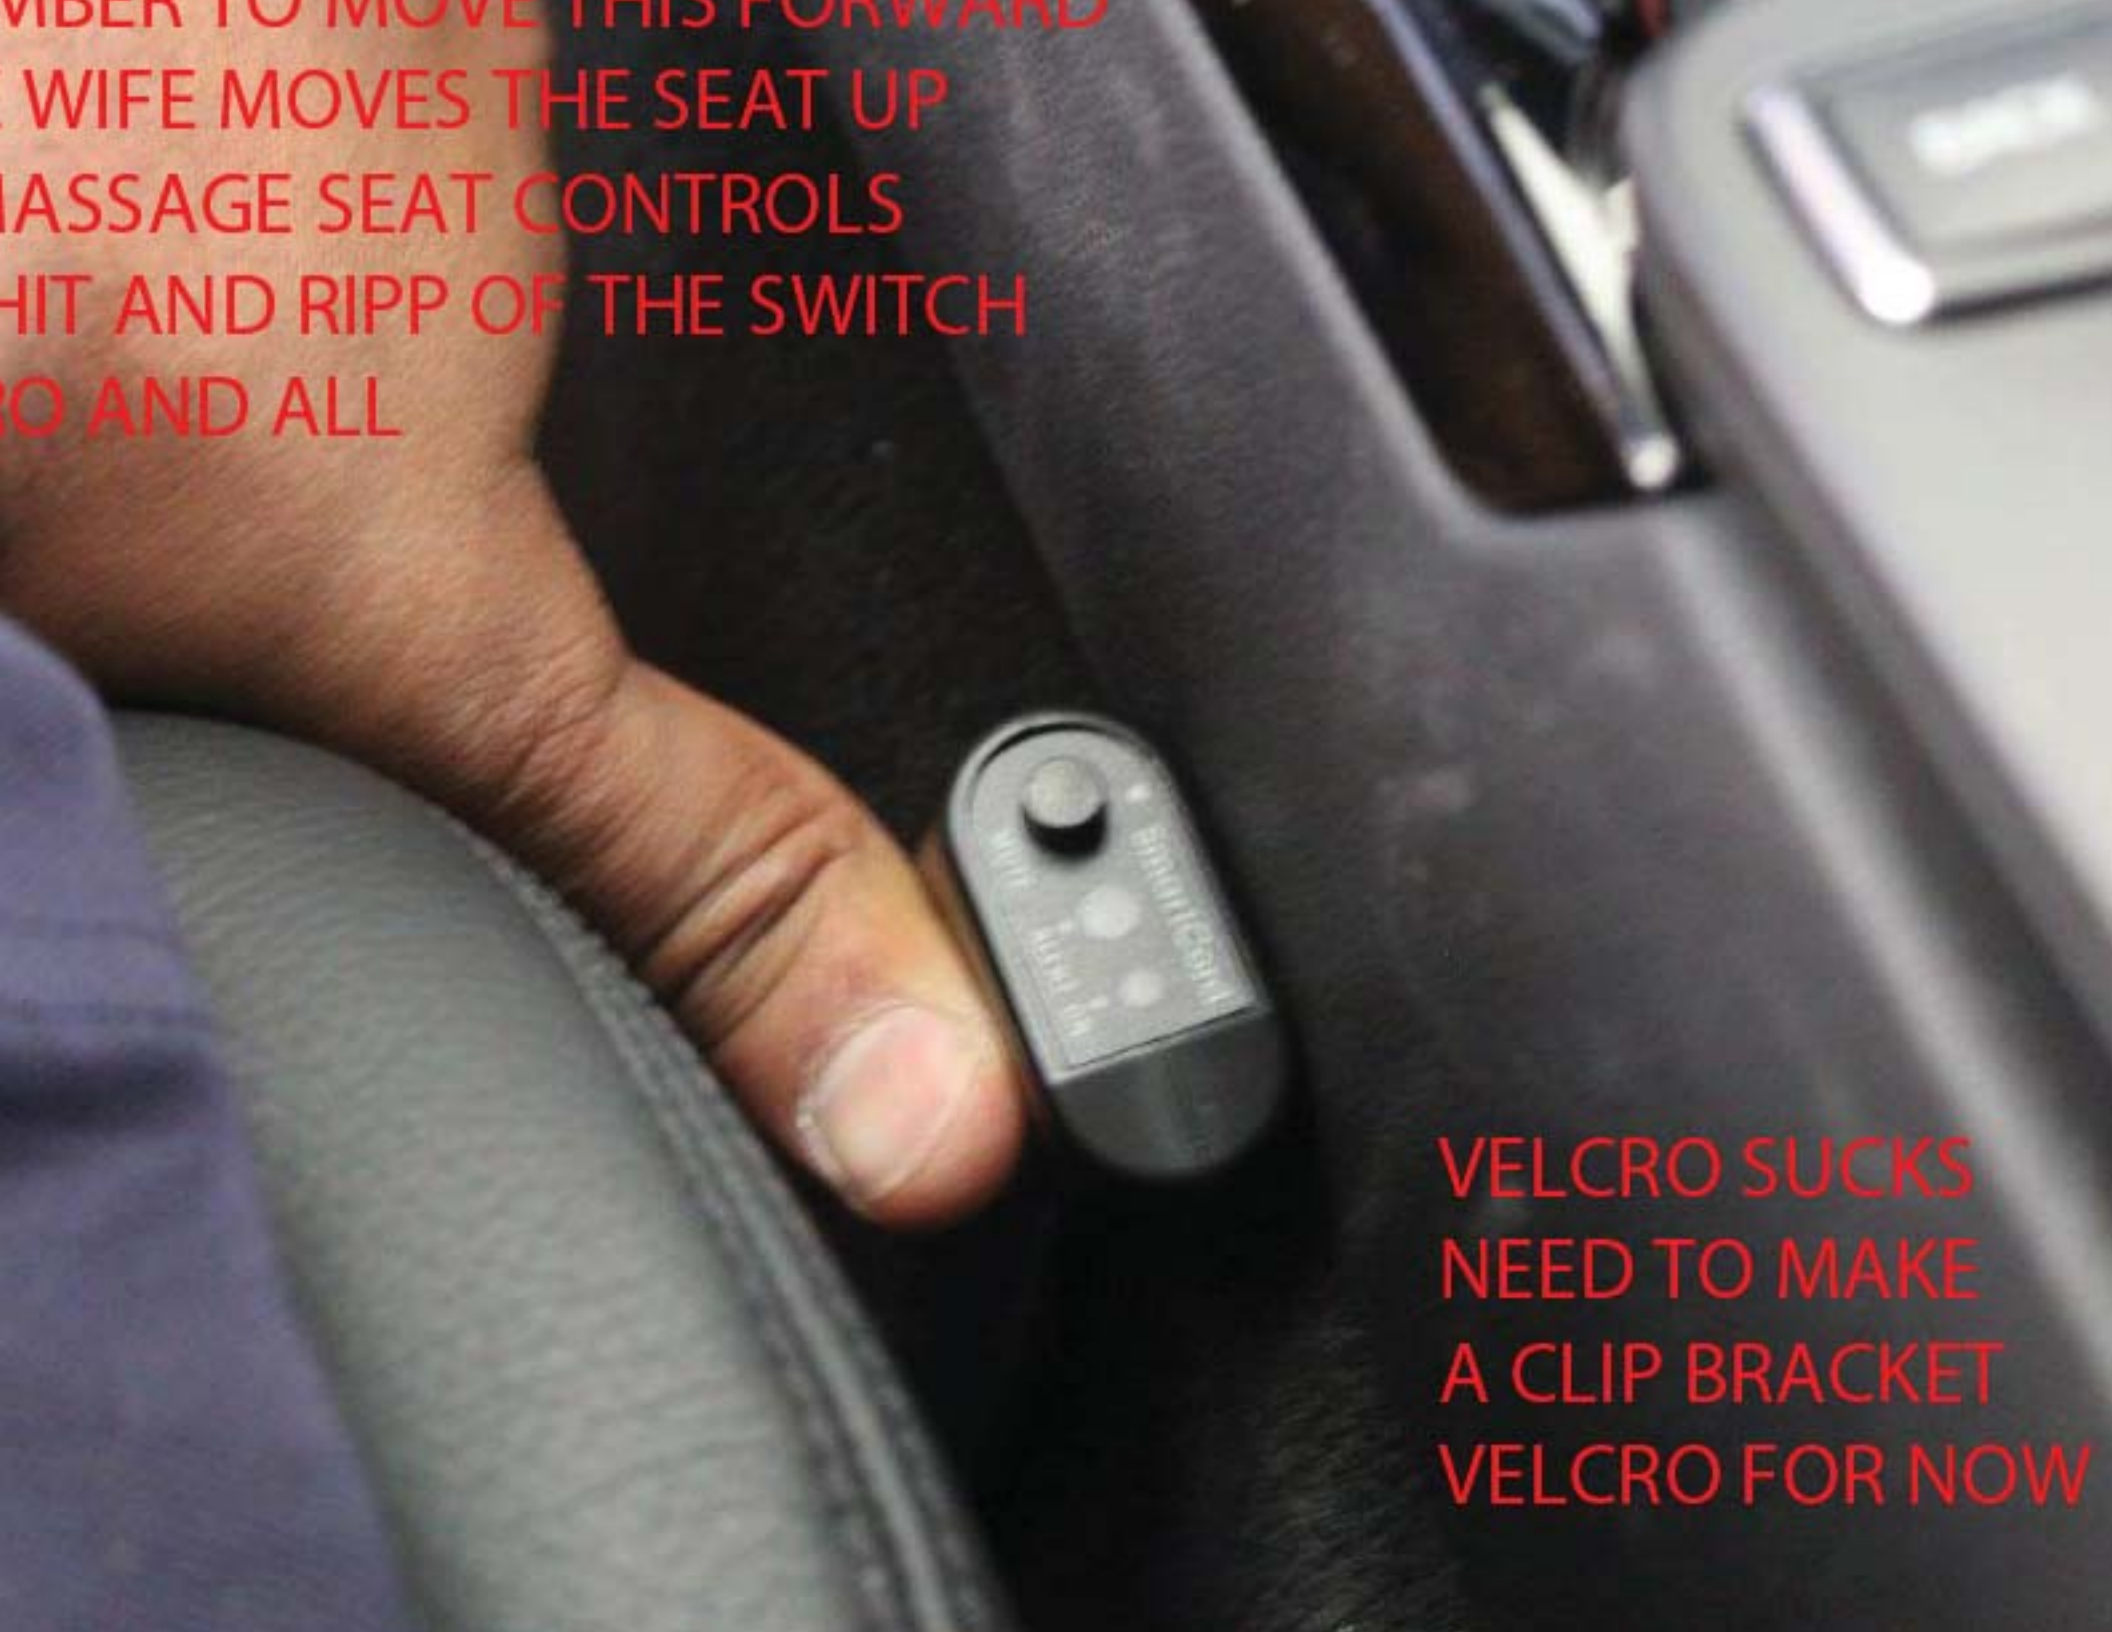
VELCRO SUCKS
NEED TO MAKE
A CLIP BRACKET
VELCRO FOR NOW

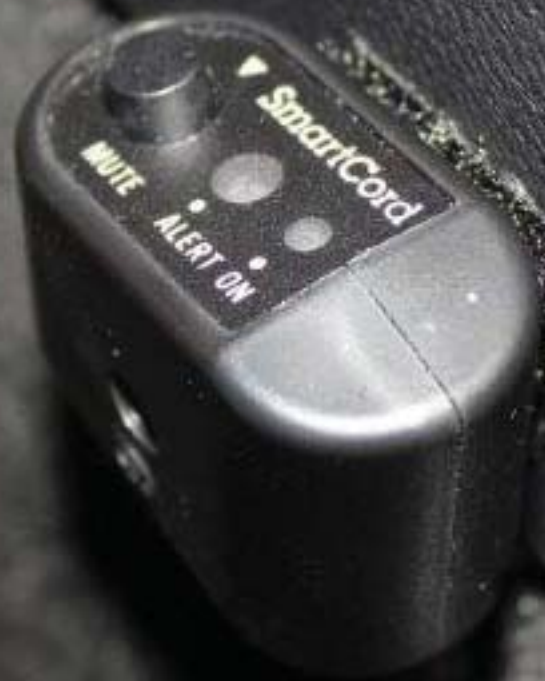
VELCROWED

GROUND TO THIS
RIGHT IN THE MIDDLE
