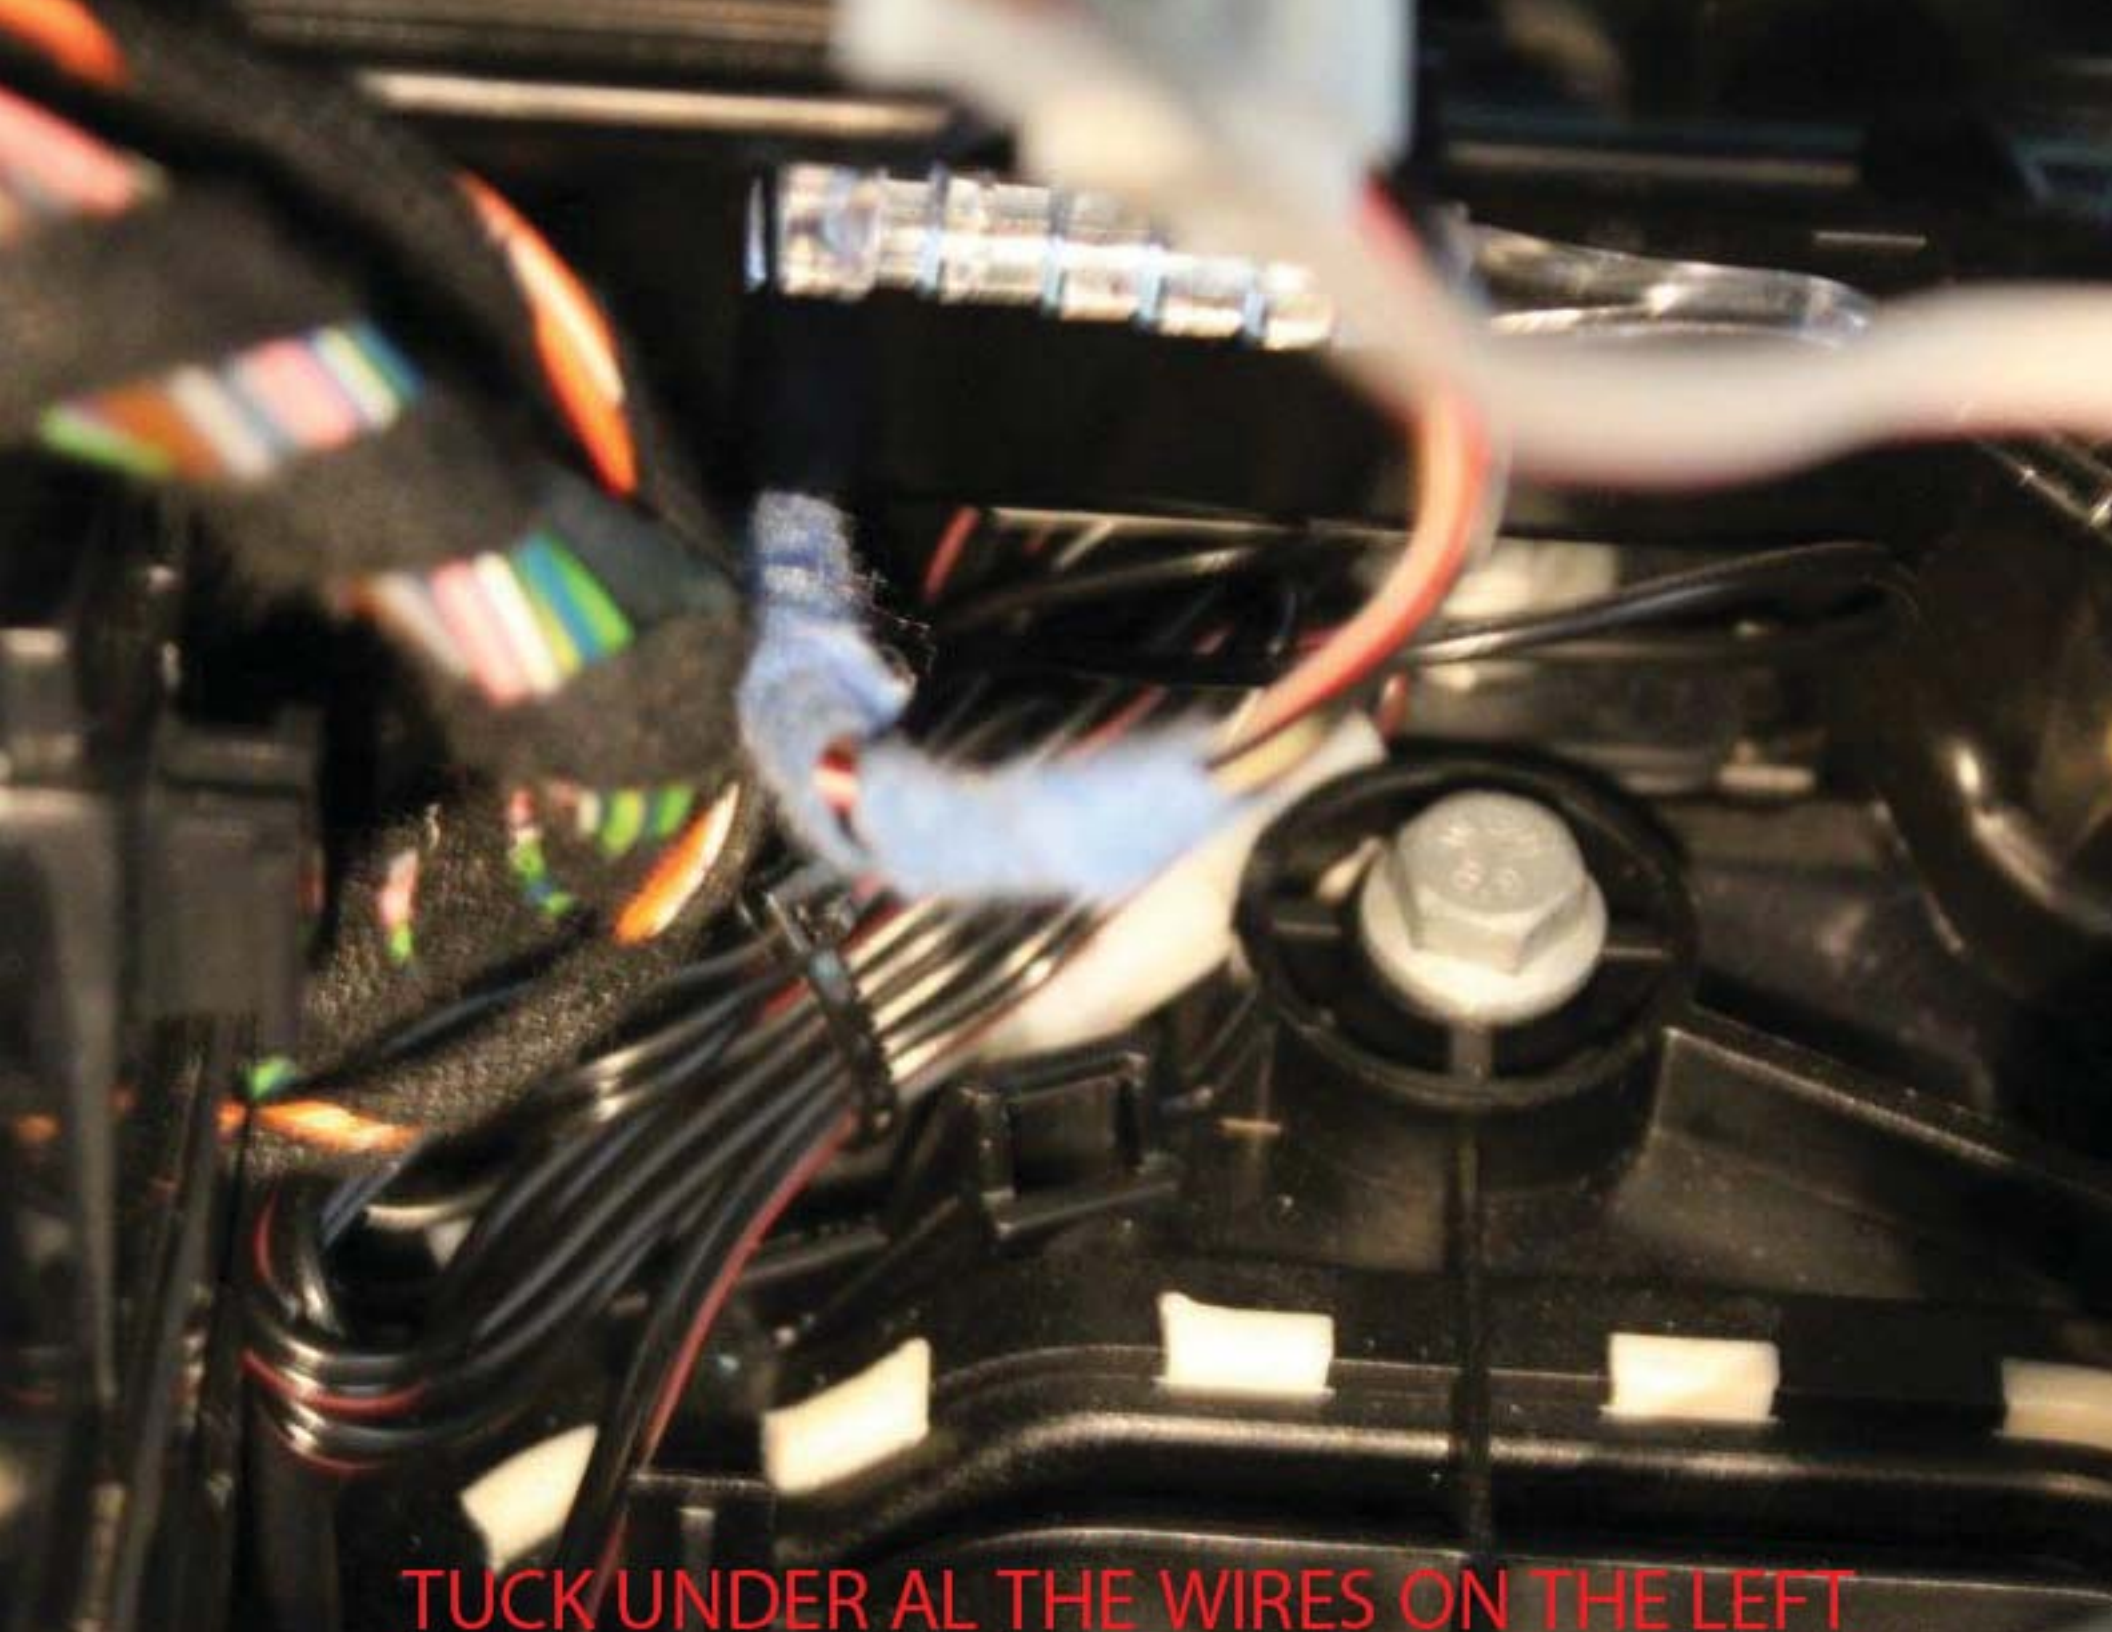
TUCK UNDER AL THE WIRES ON THE LEFT

TUCKING
UP THE SIDE

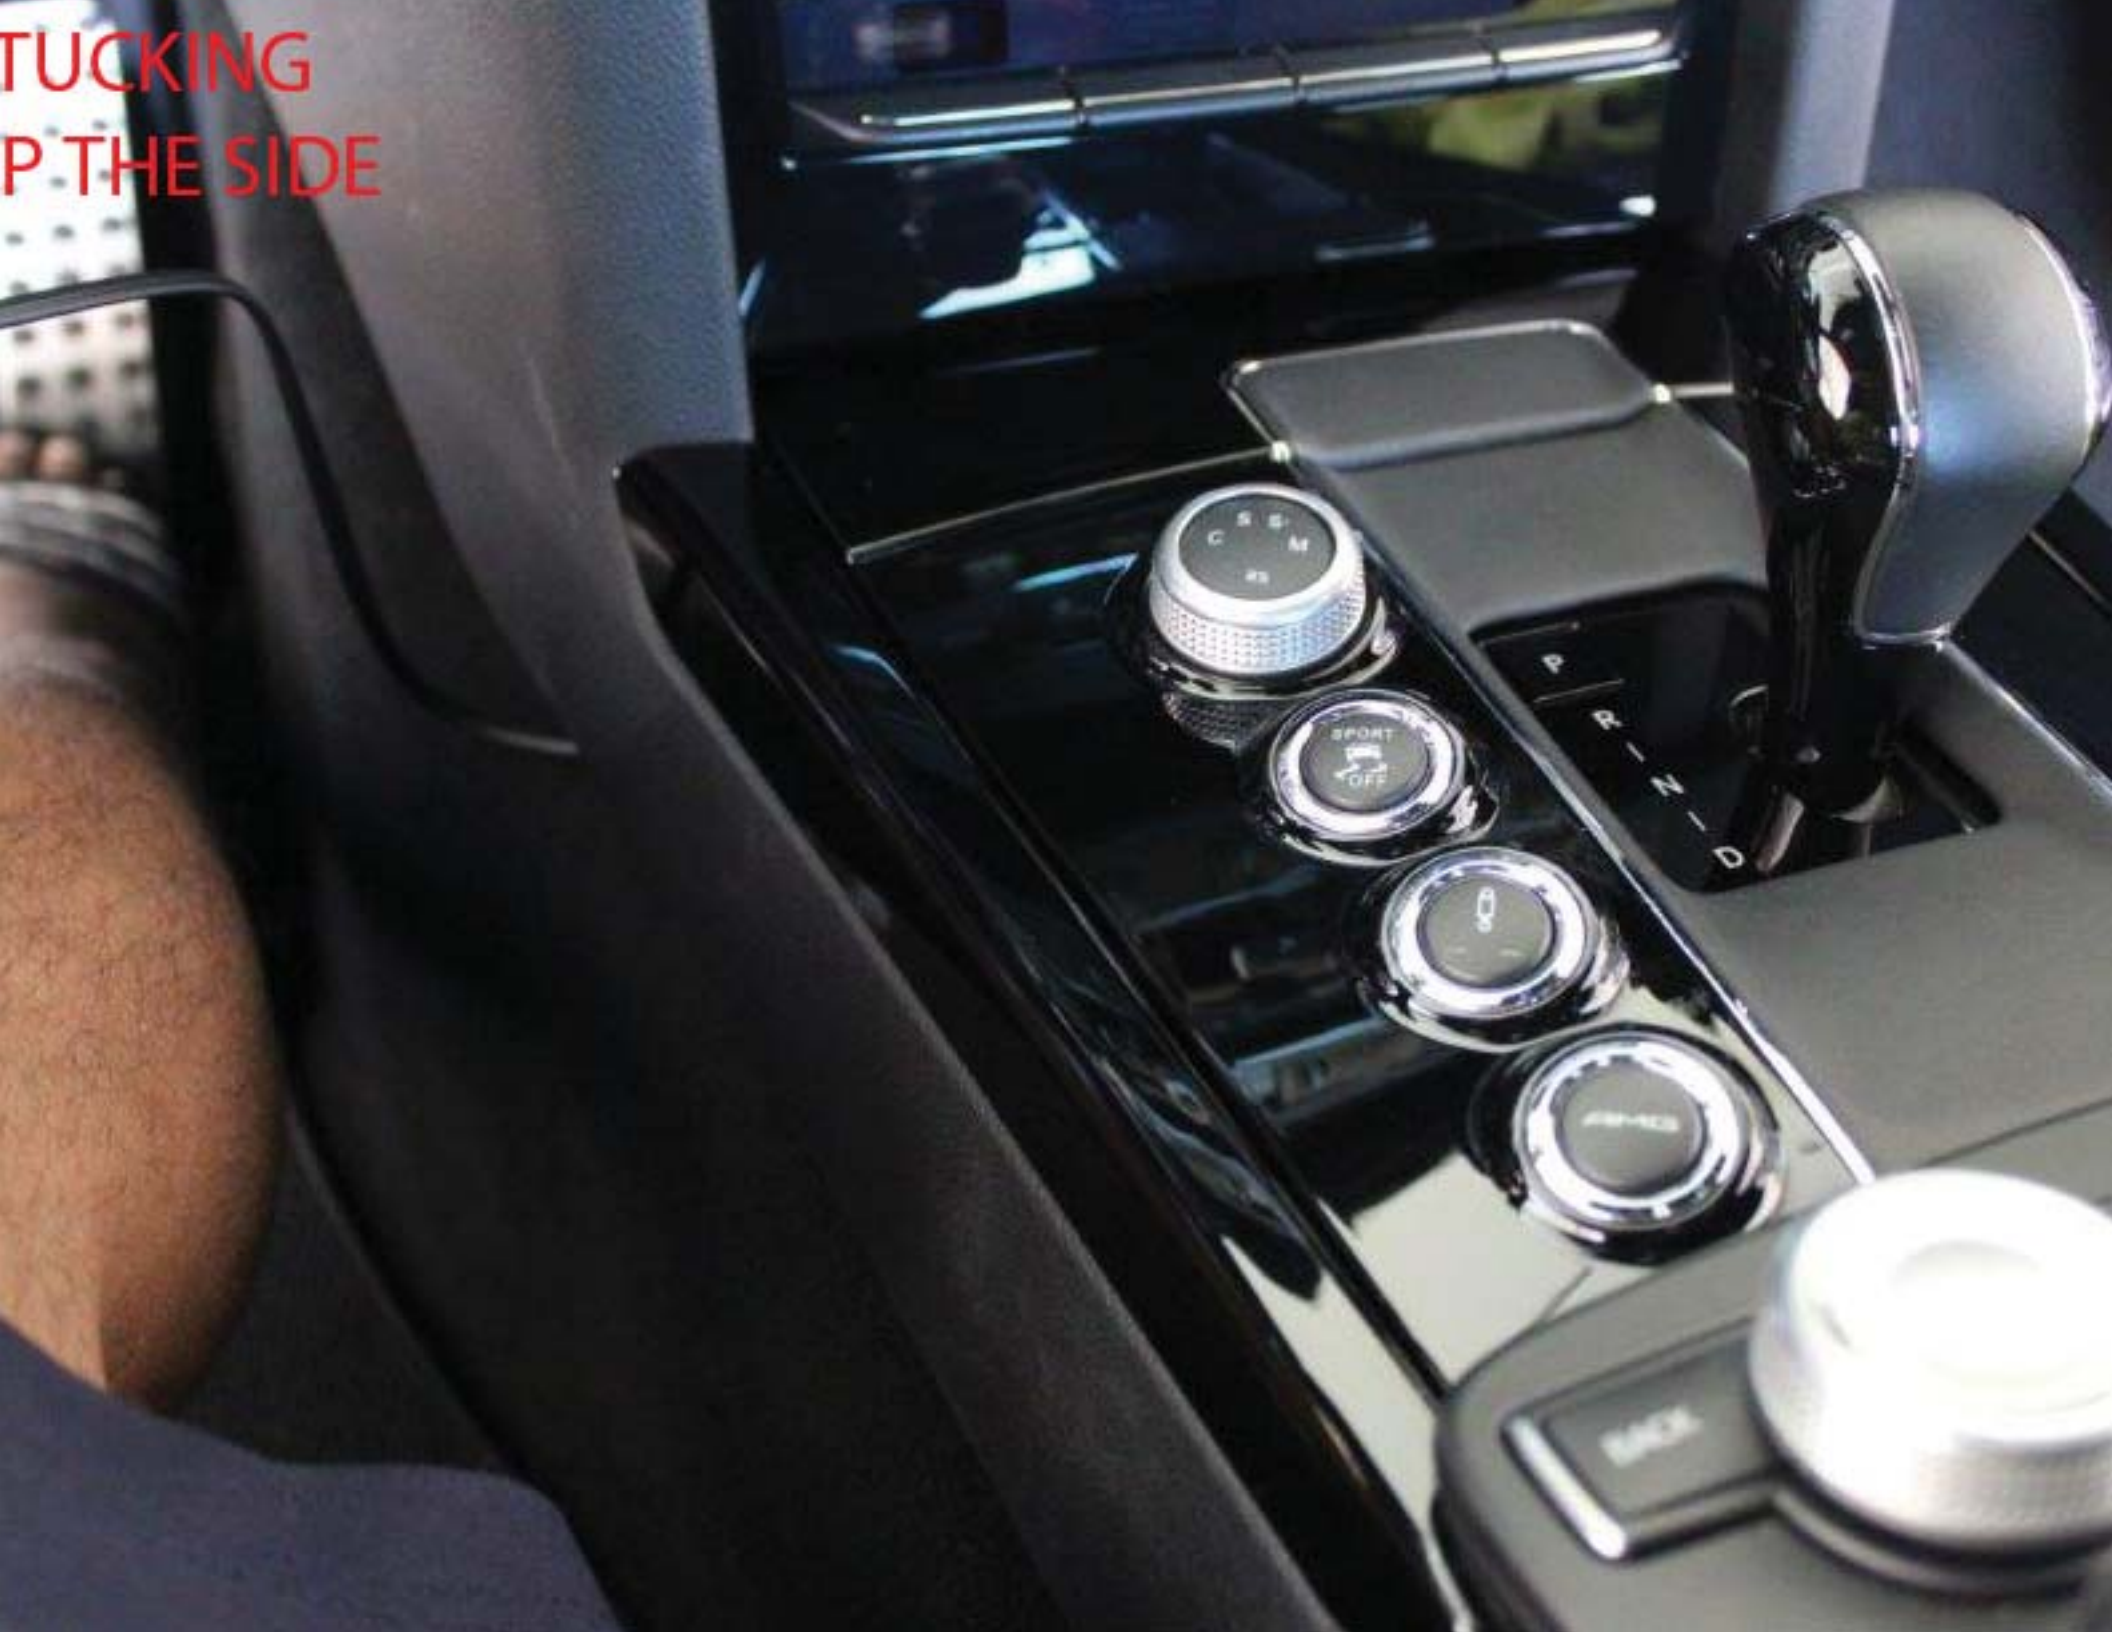
REMOVED 3 SCREWS AND PULL DOWN

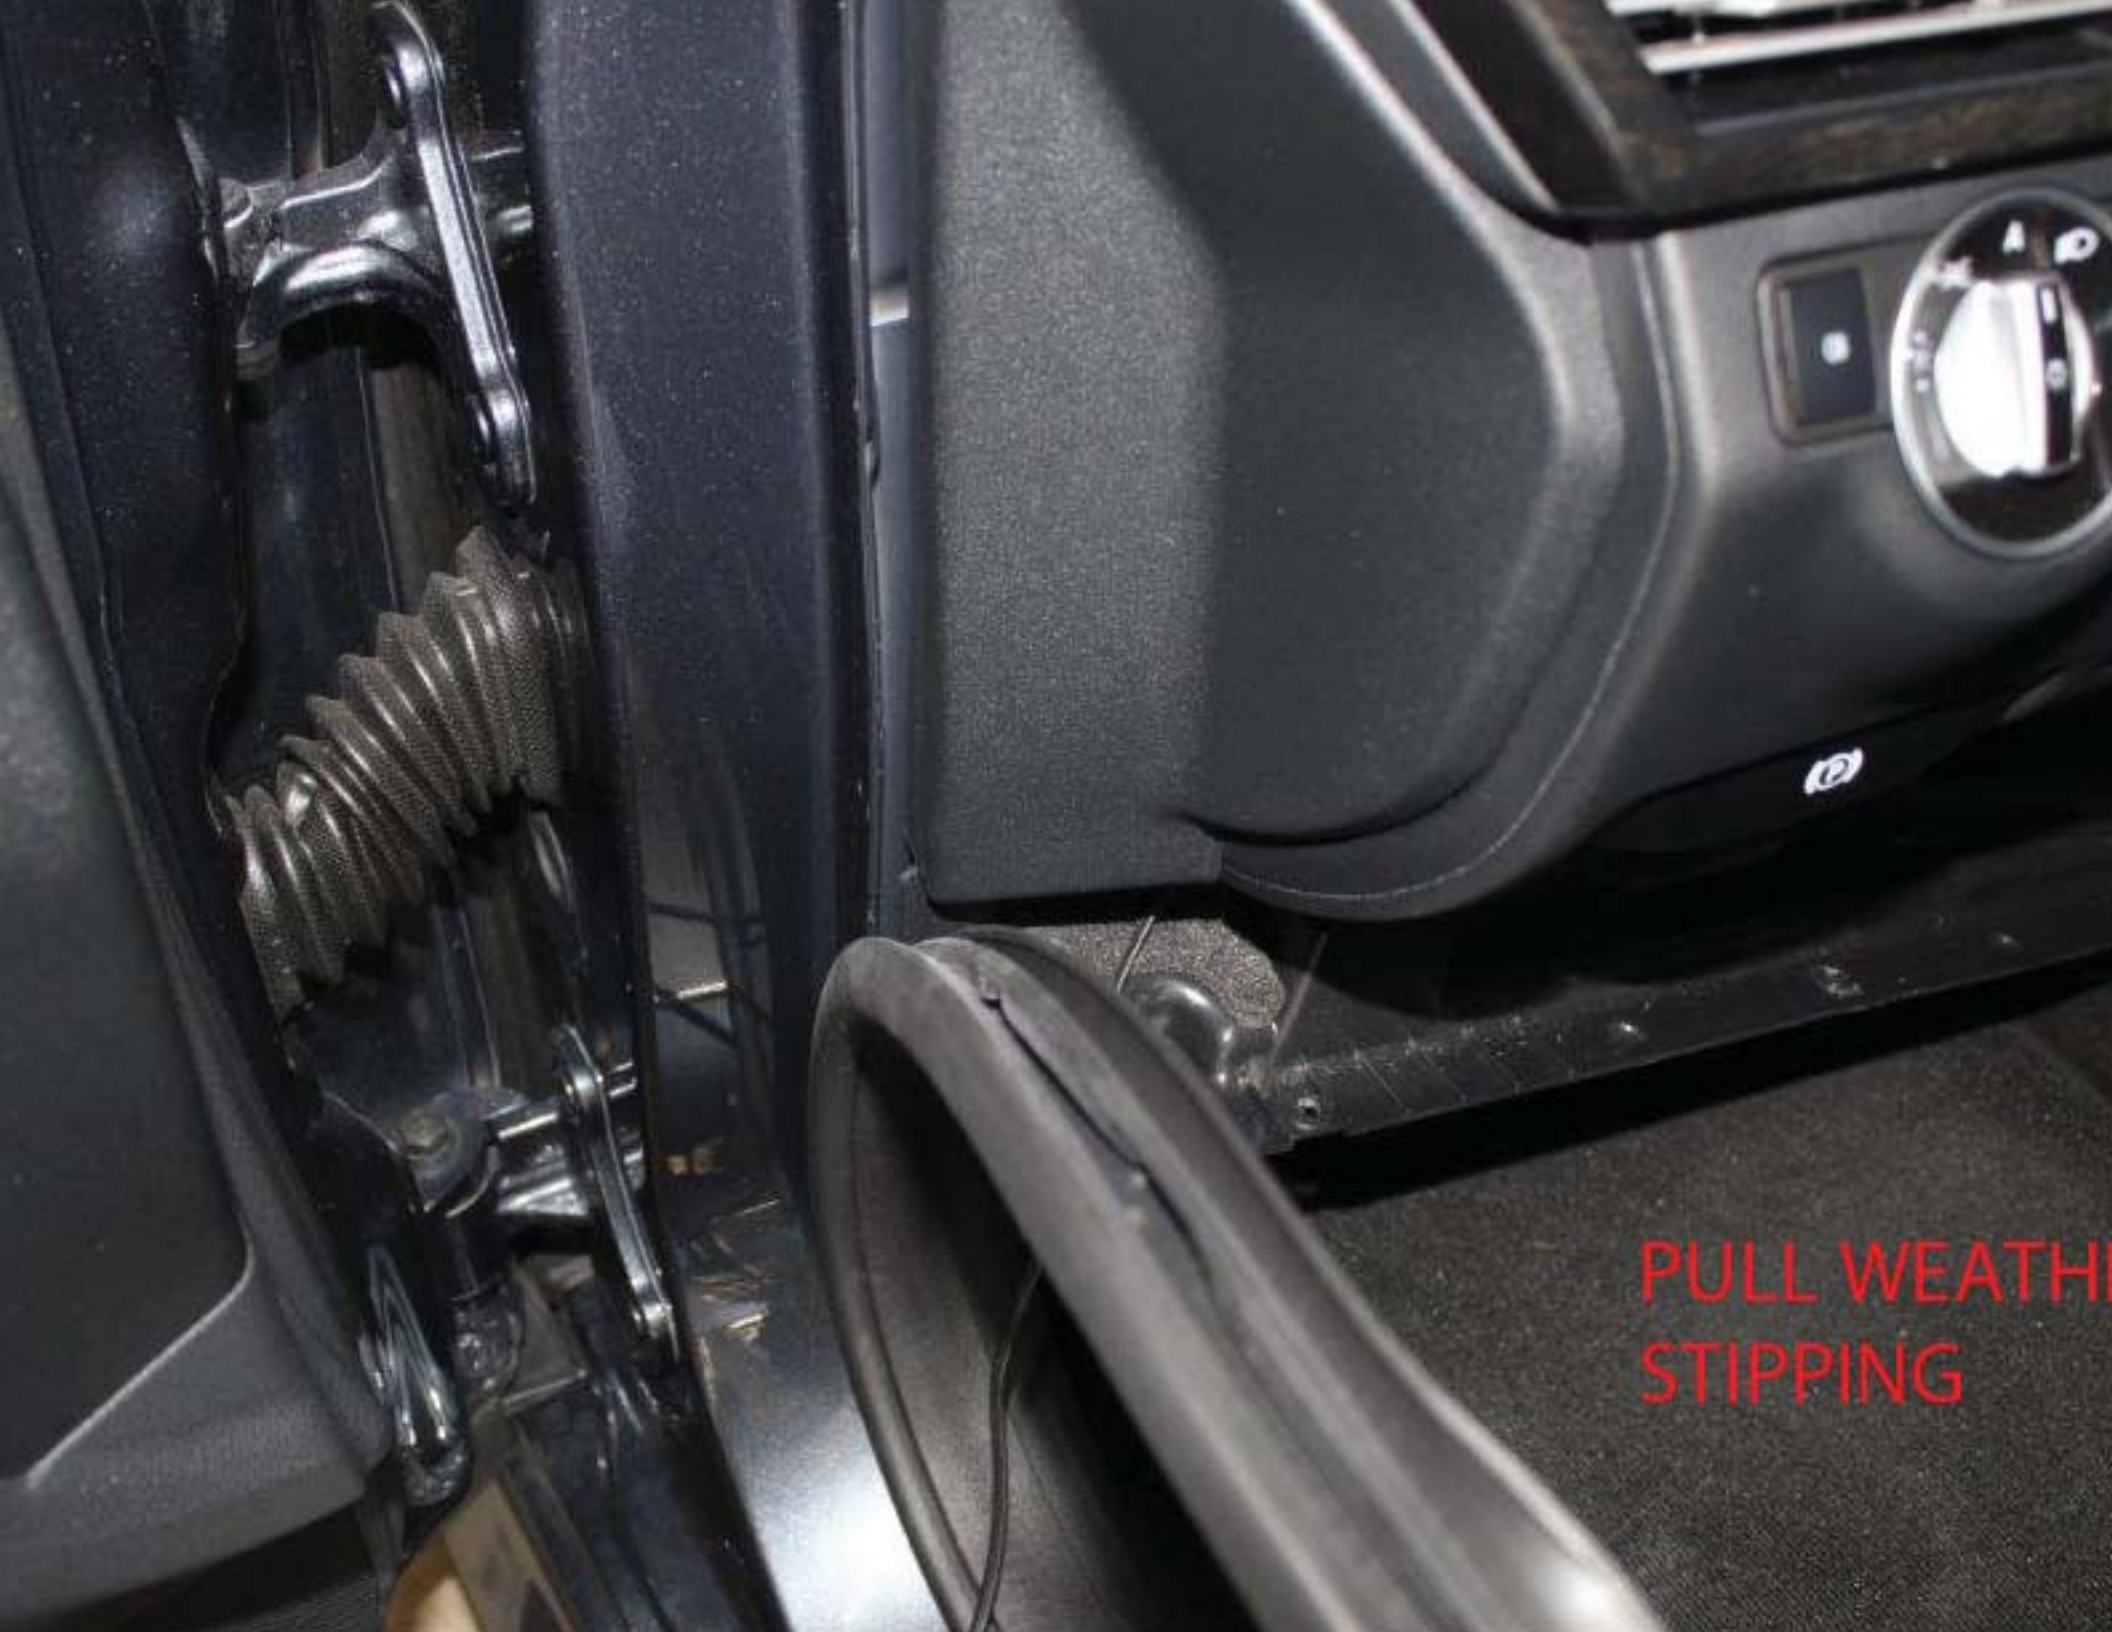
PULL WEATHER
STIPPING

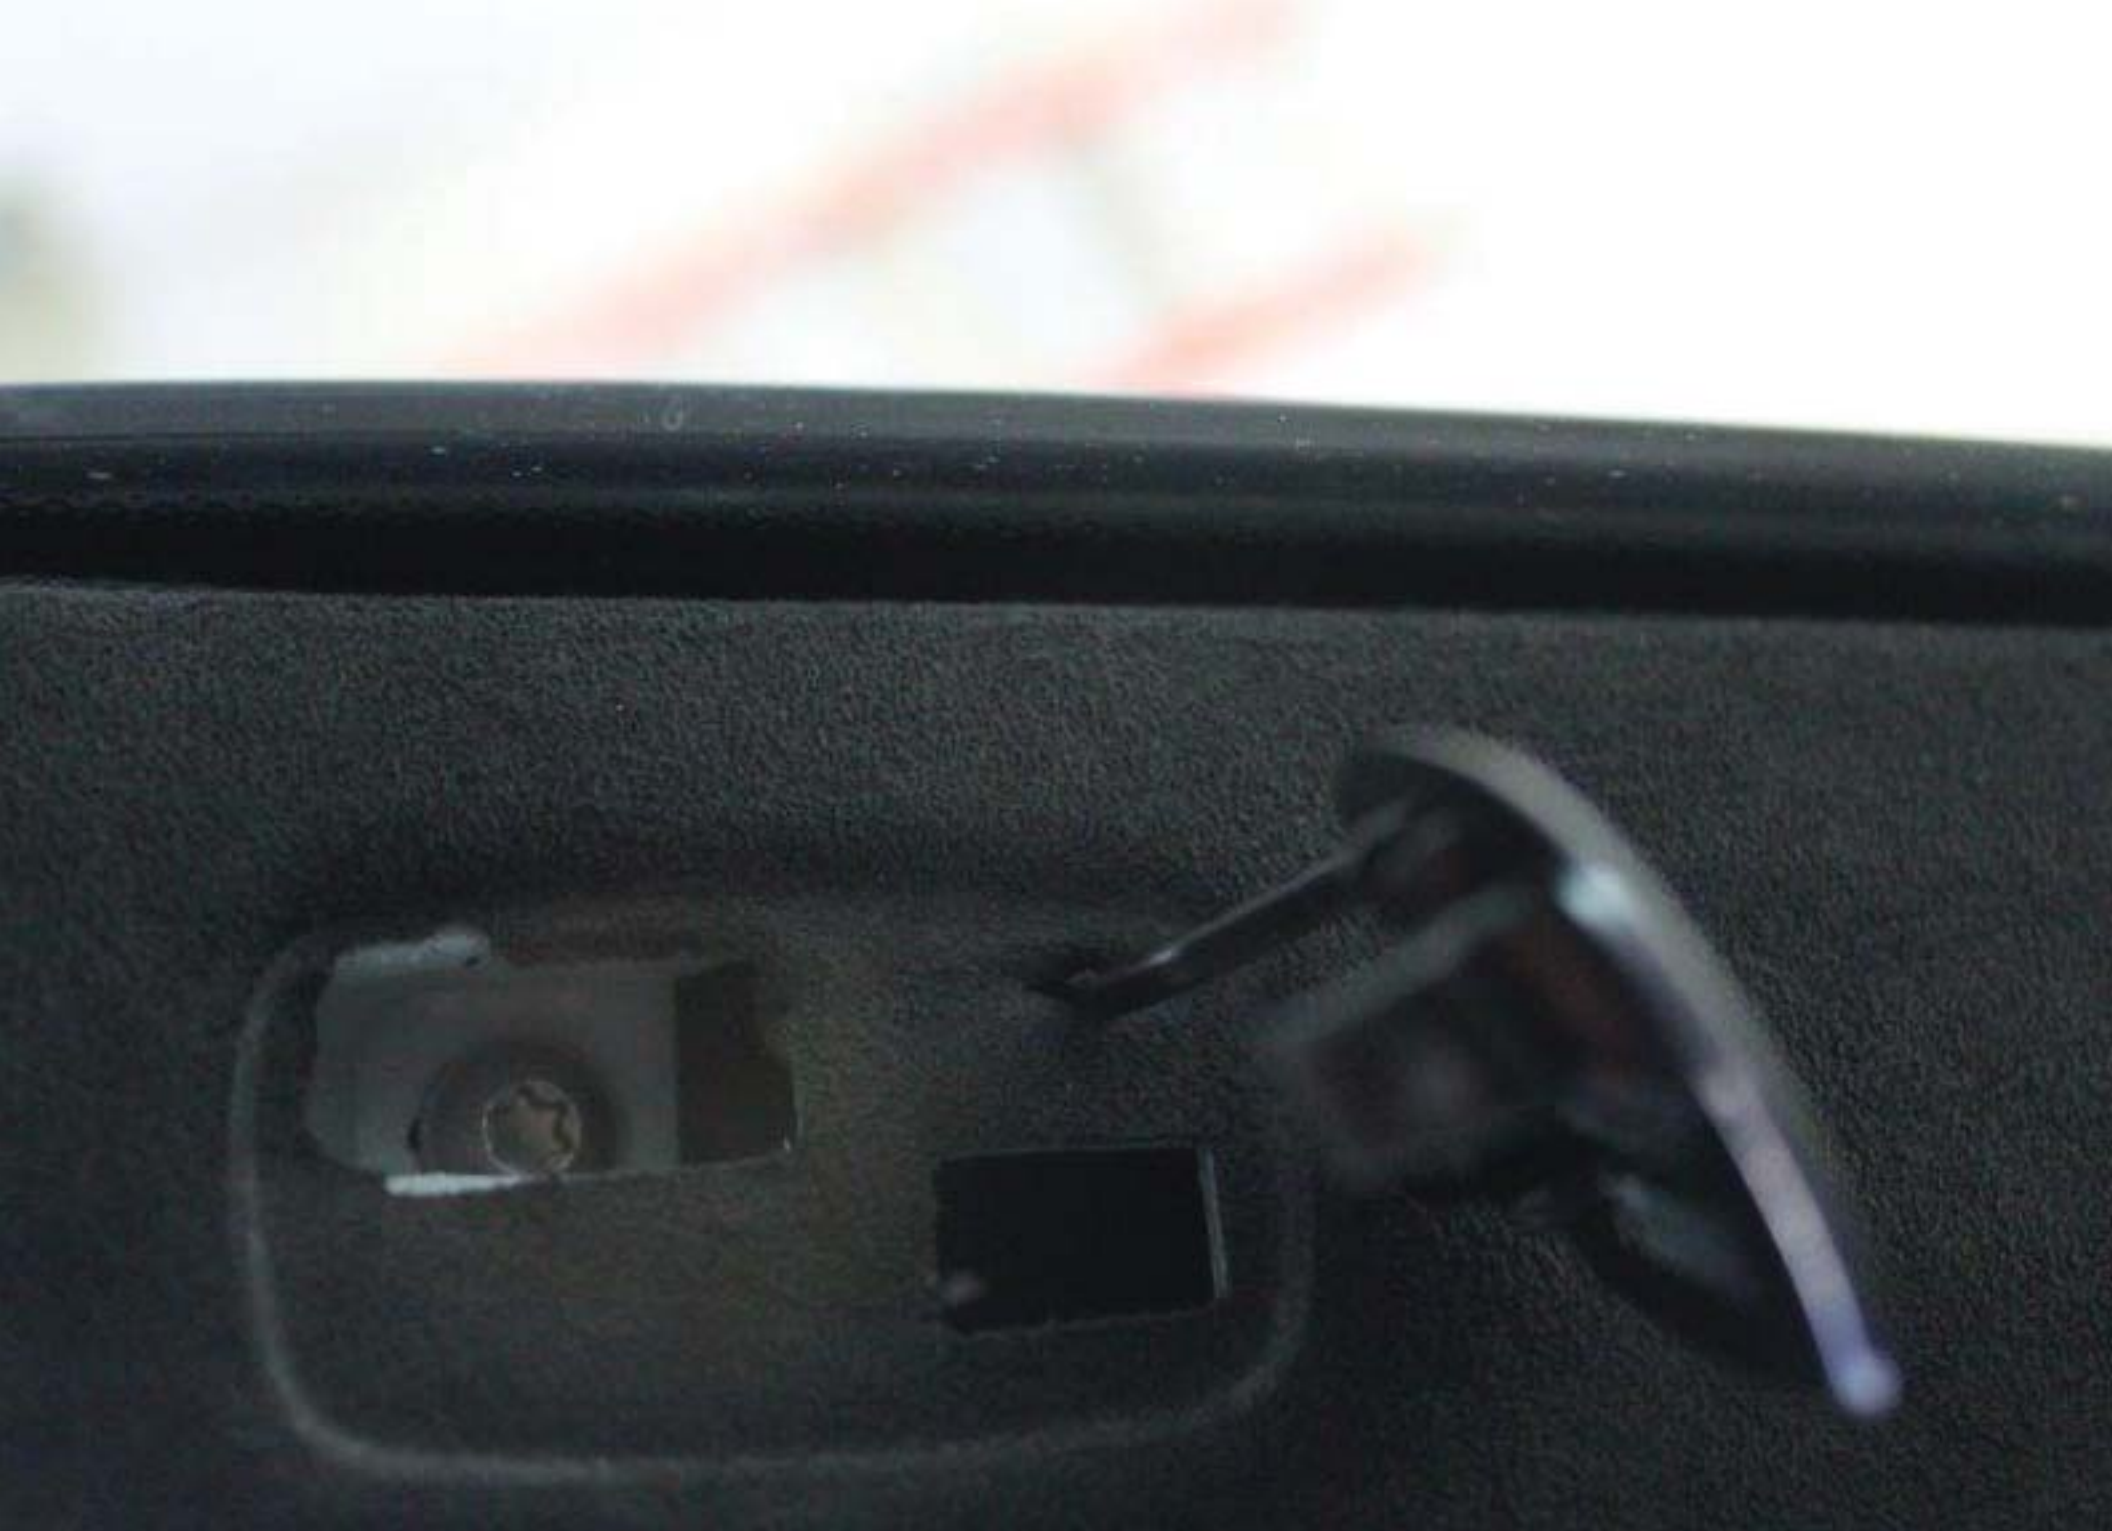
RY OFF PLASTIC AIR BAG LABEL AND REMOVE SCREW ON PIL

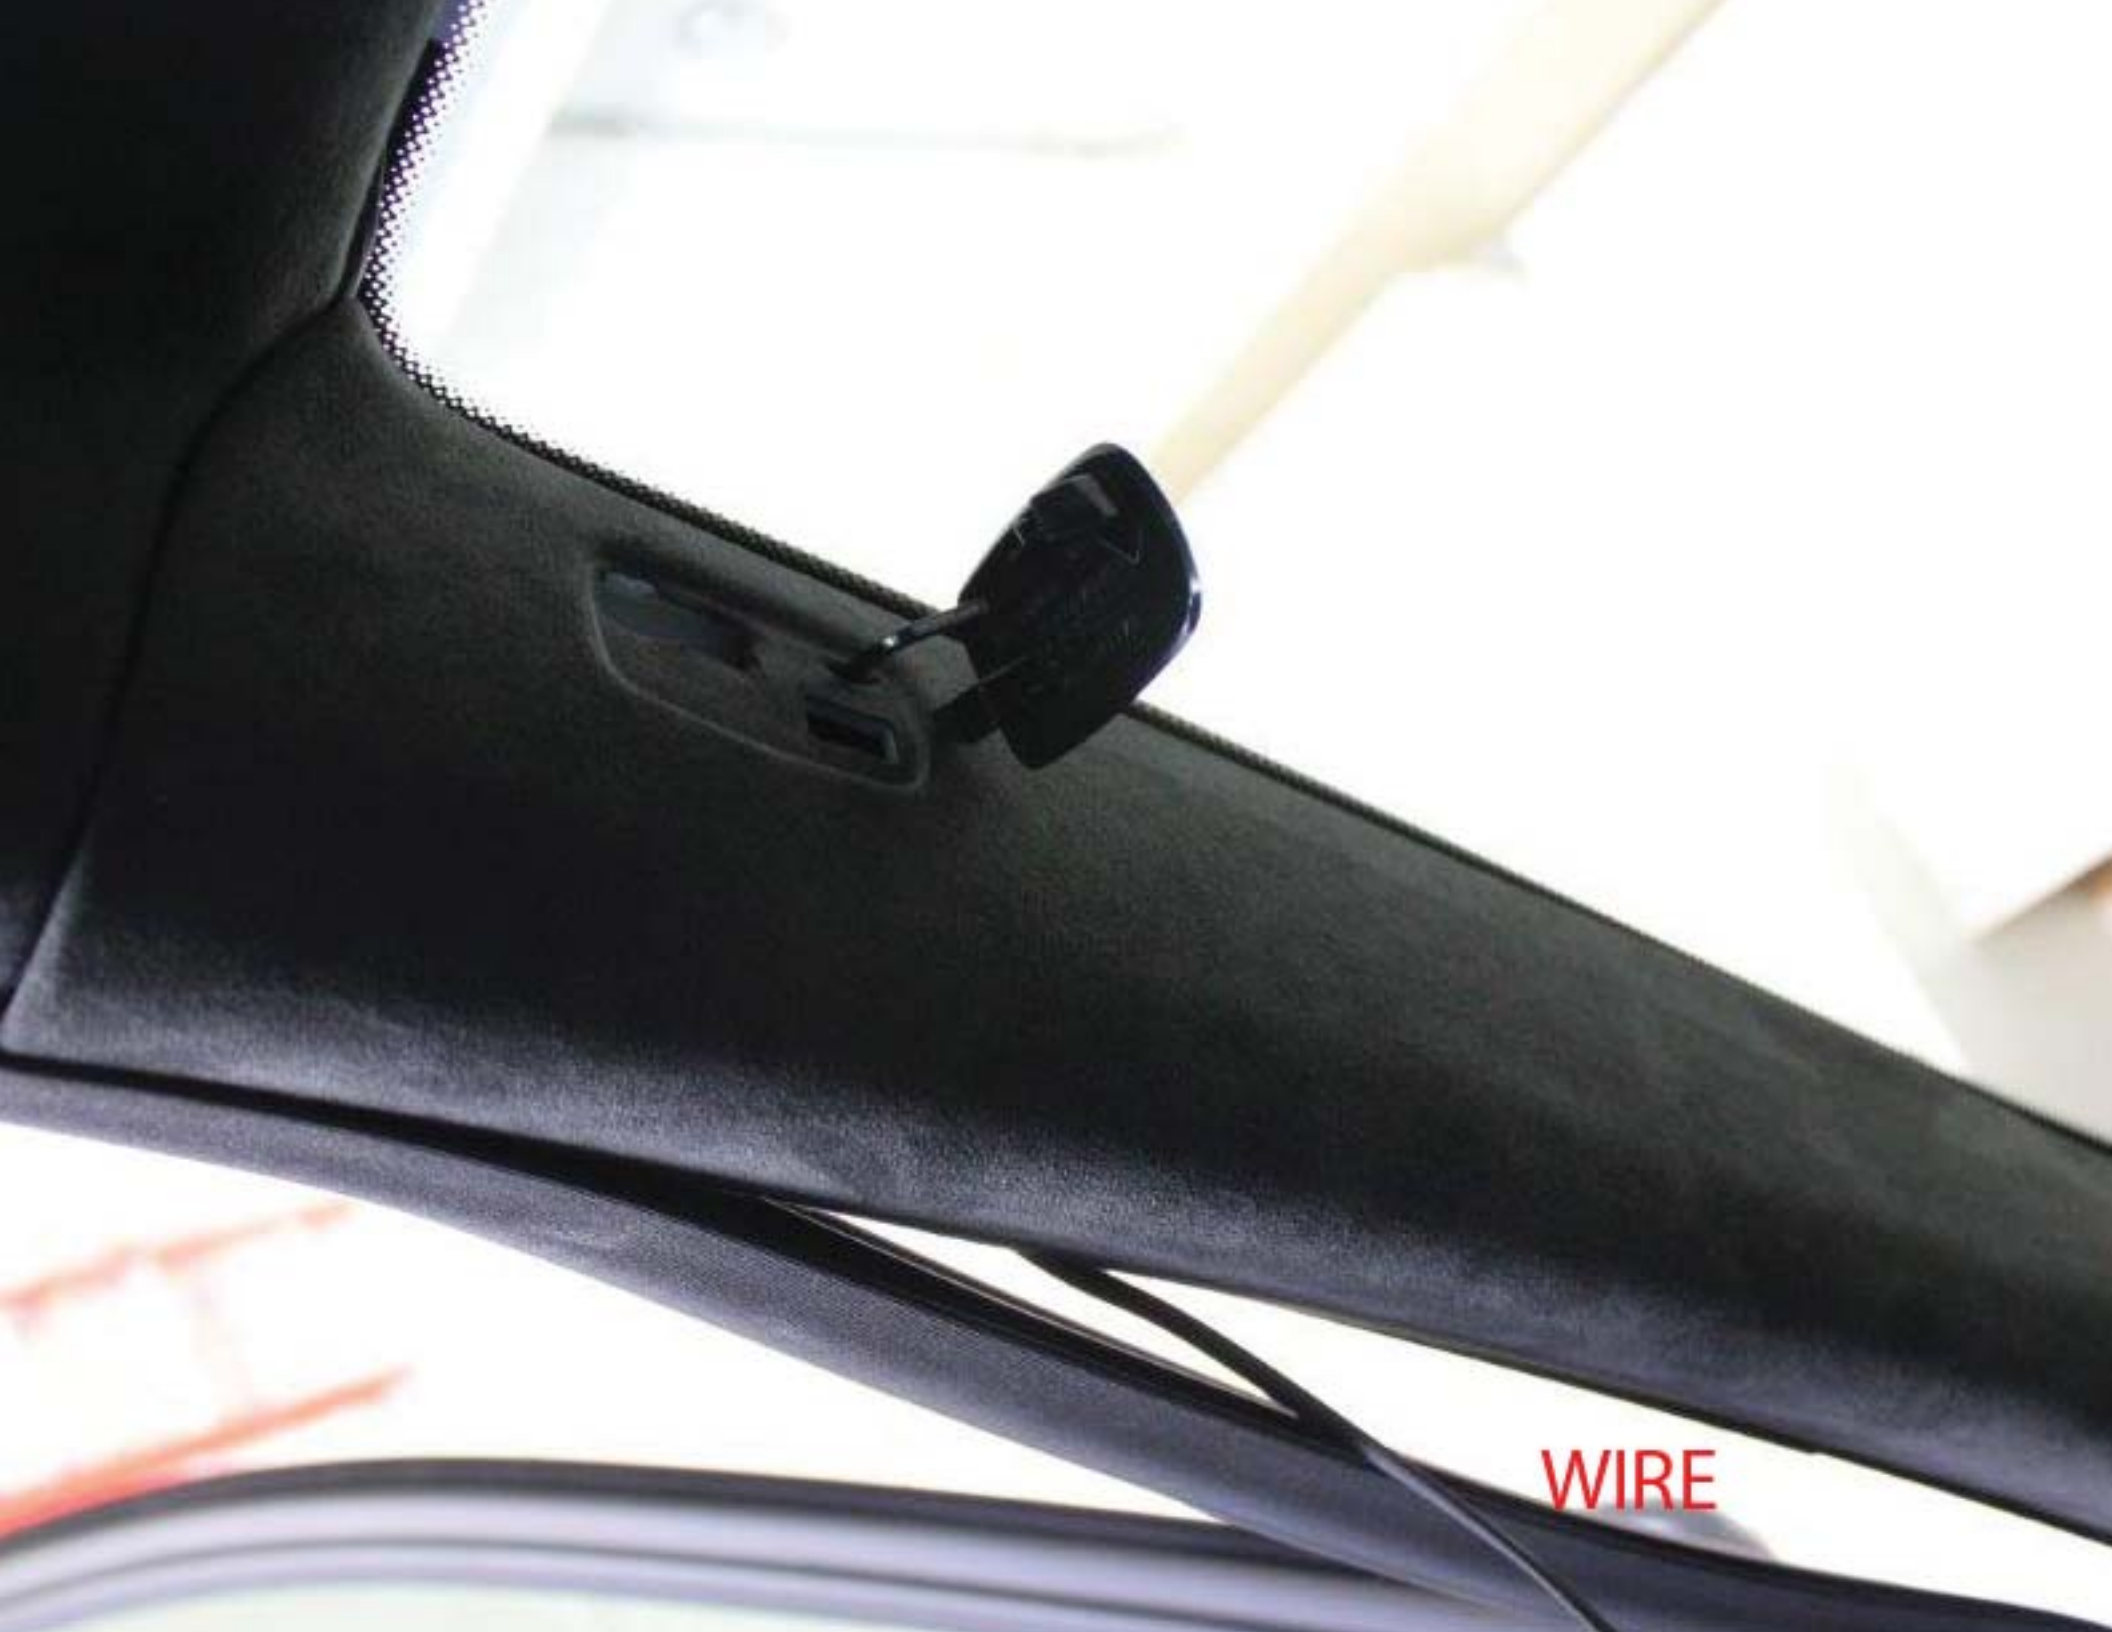
WIRE

TUCK THE WIRE HERE

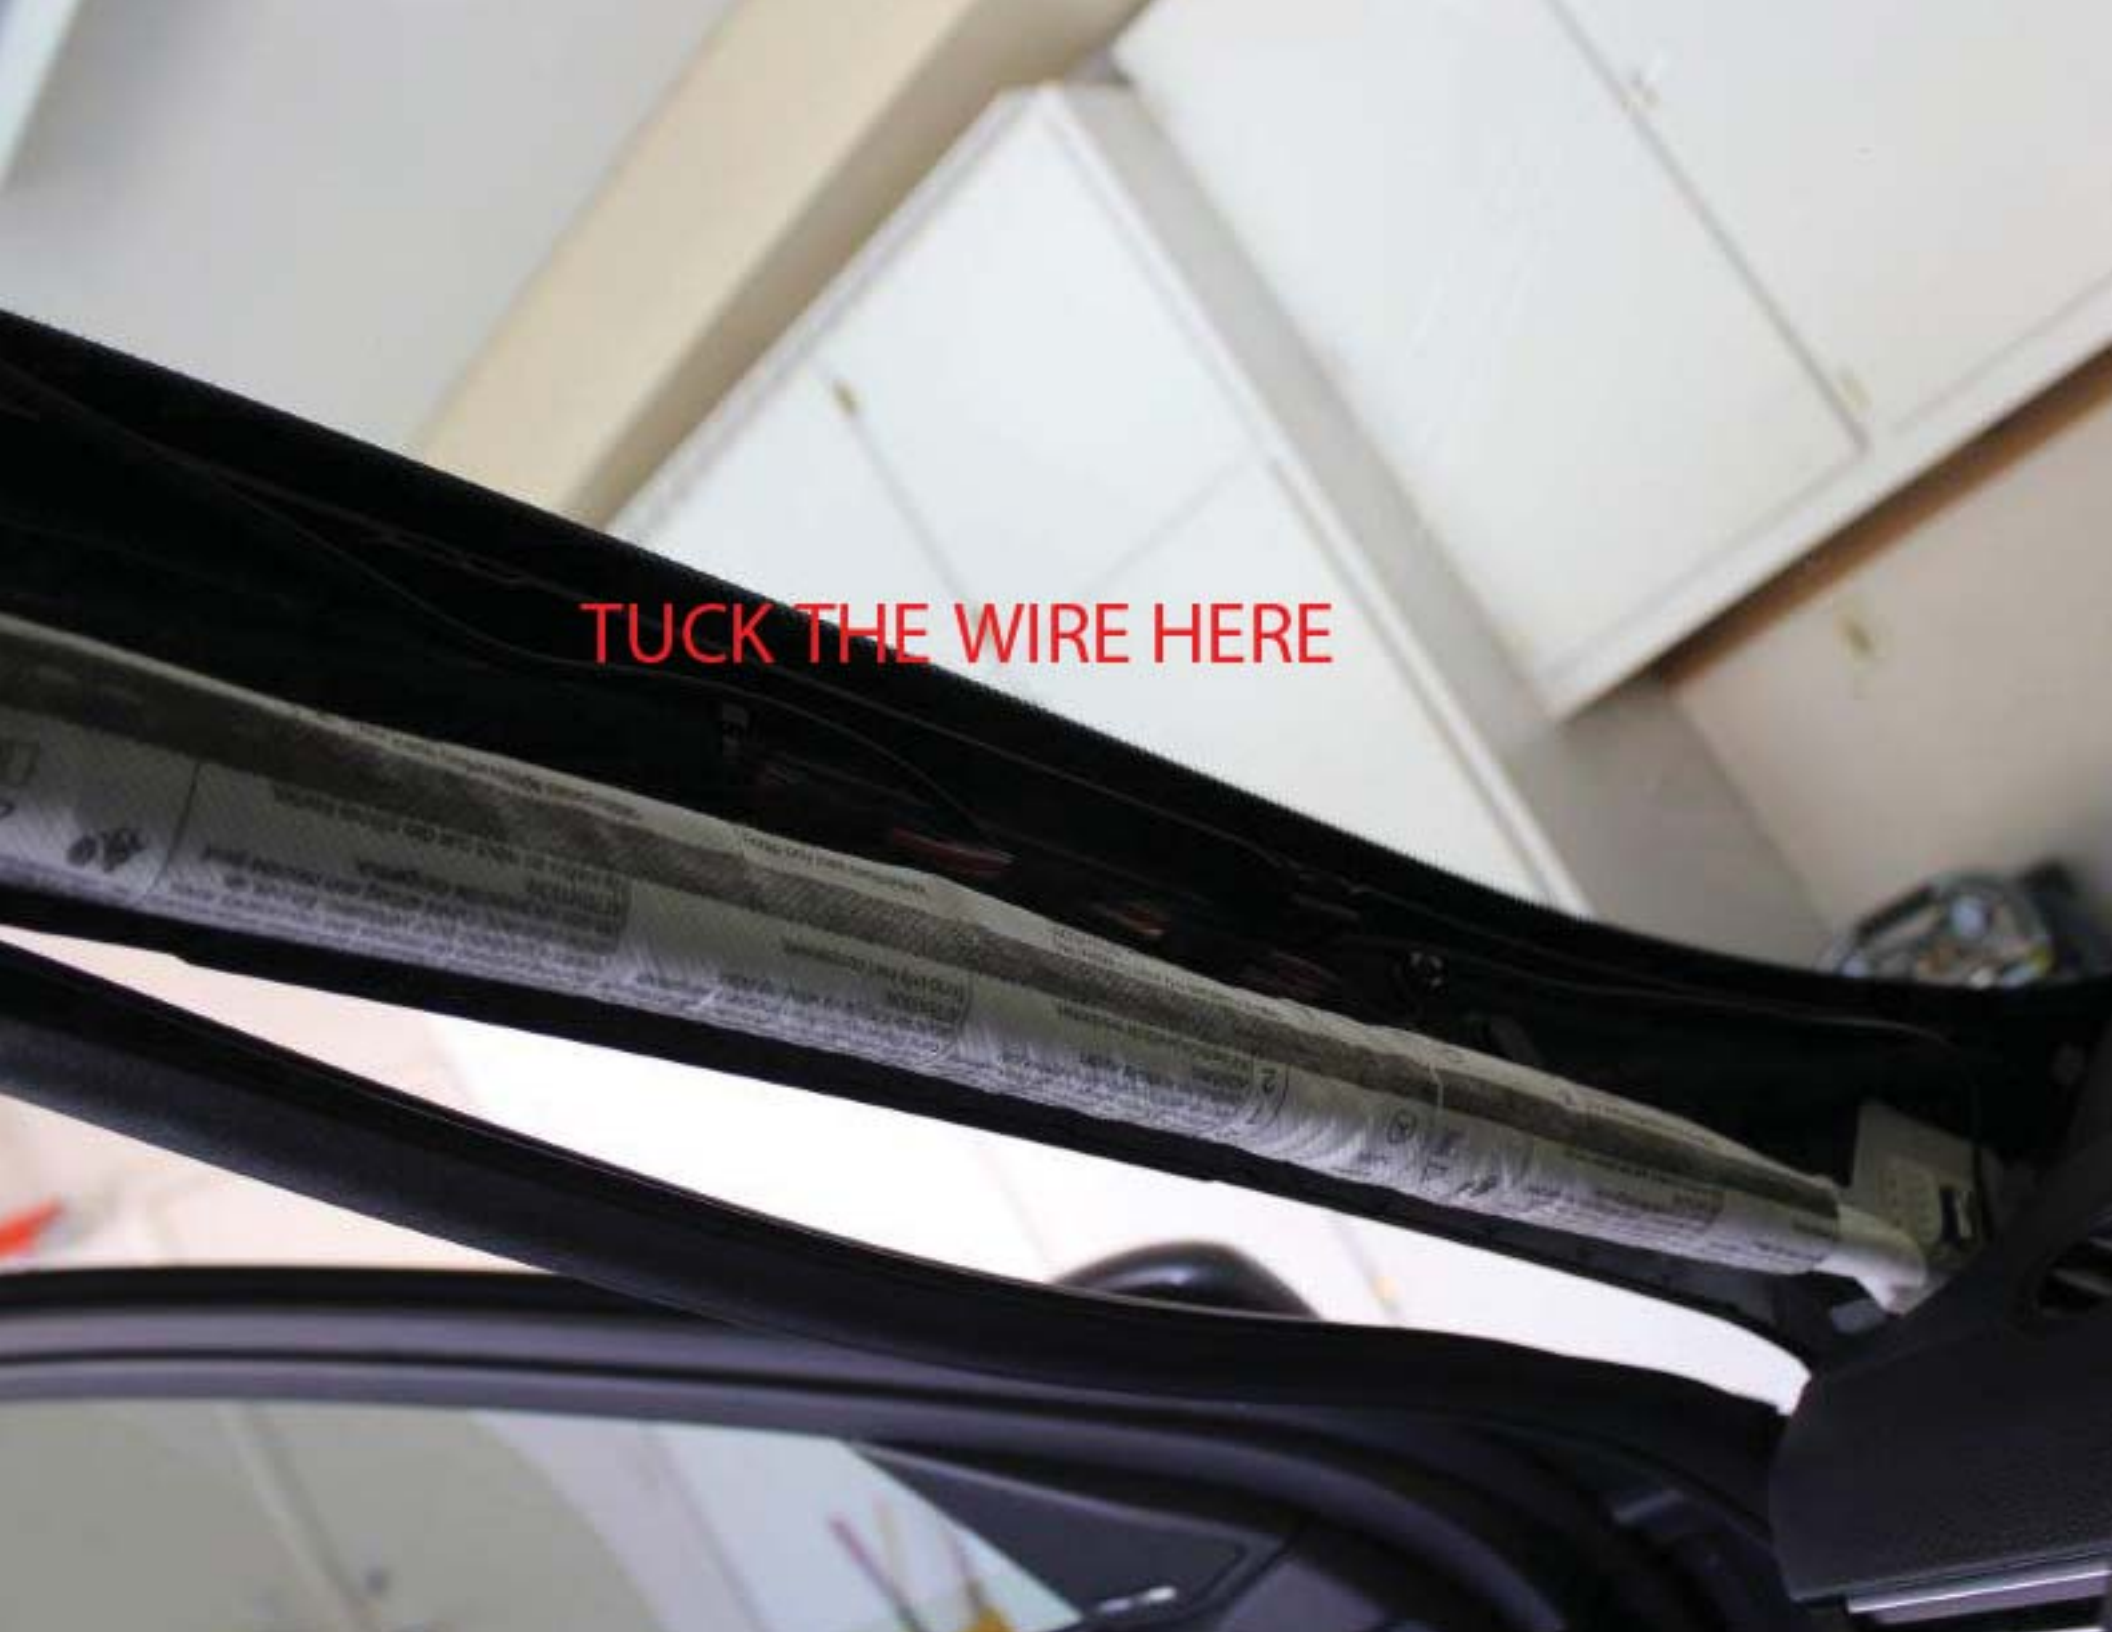
A close-up photograph of a black plastic component, likely a car's interior trim. A thin wire is tucked behind a brown plastic part on the left. A circular screw hole is visible in the black plastic. Red text is overlaid on the image.

WIRE TUCKED BEHIND BROWN BO

SCREW HOLE, SCREW IS HARD
TO PUT BACK ONLY GOES IN
A FEW TURNS
