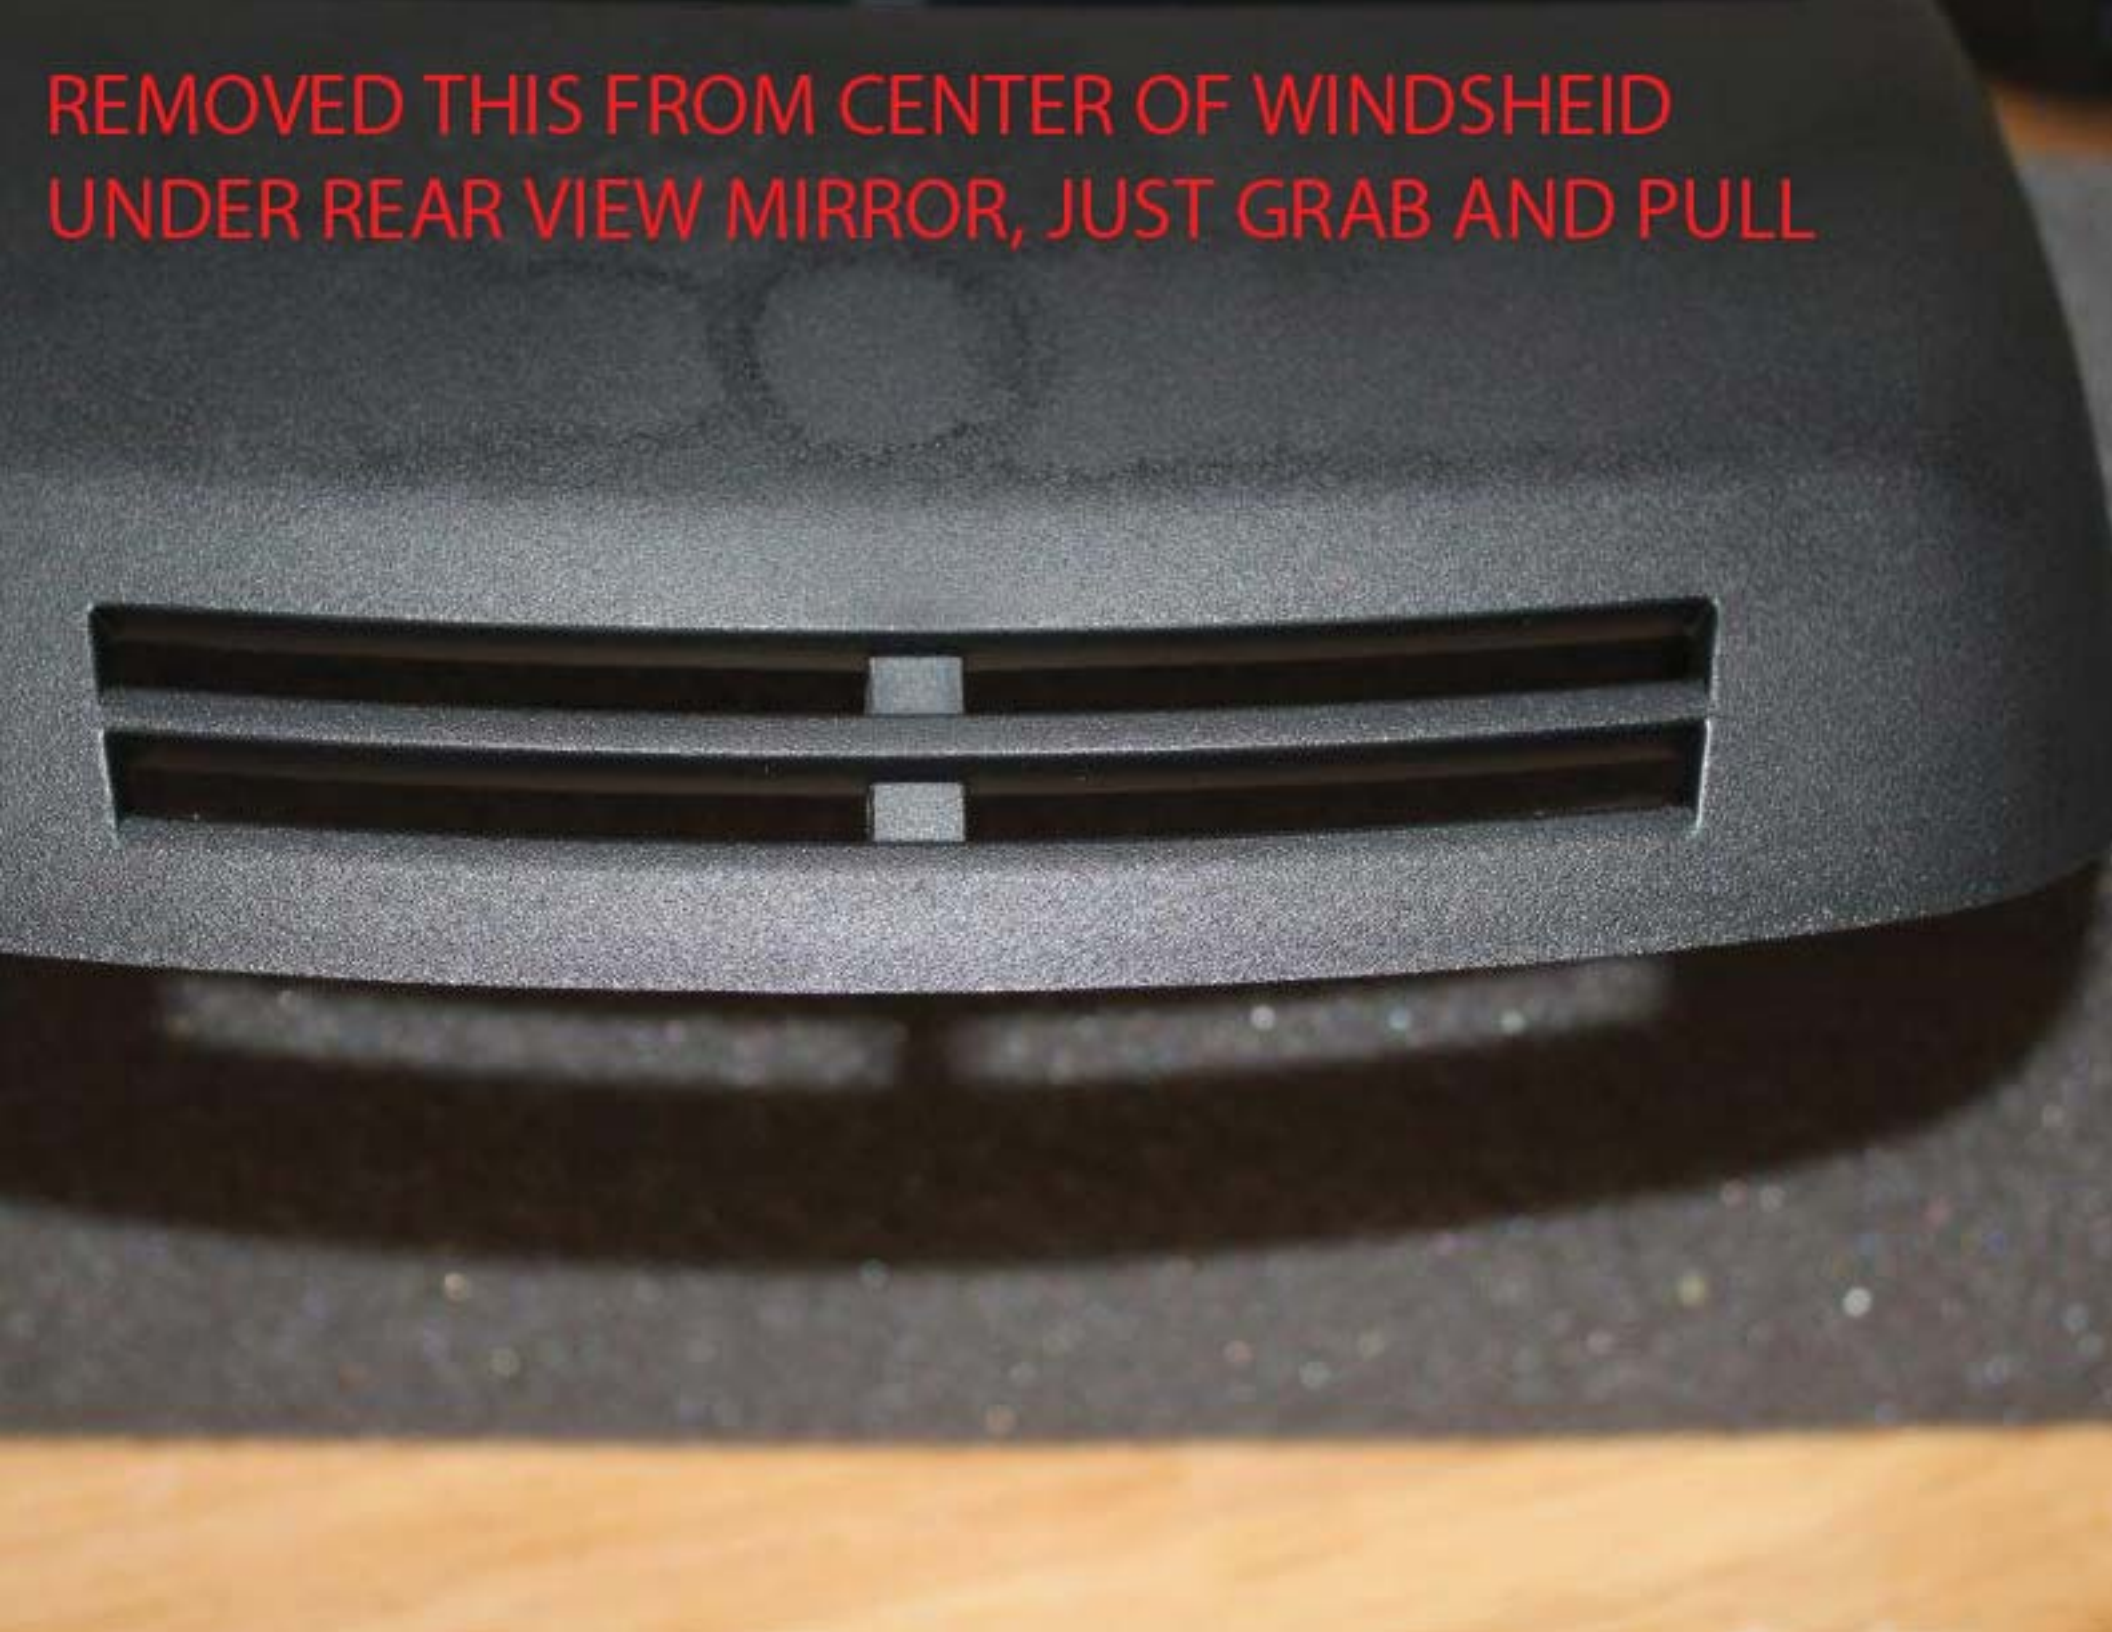
REMOVED THIS FROM CENTER OF WINDSHEID
UNDER REAR VIEW MIRROR, JUST GRAB AND PULL

A close-up photograph of a black metal grate, likely from a furnace or boiler. The grate consists of several horizontal bars. A notch has been cut into the middle bar, and a small piece of metal has been removed from the grate's surface below the notch. The background is a dark, textured surface.

I PUT A NOTCH IN MINE FOR THE WIRE

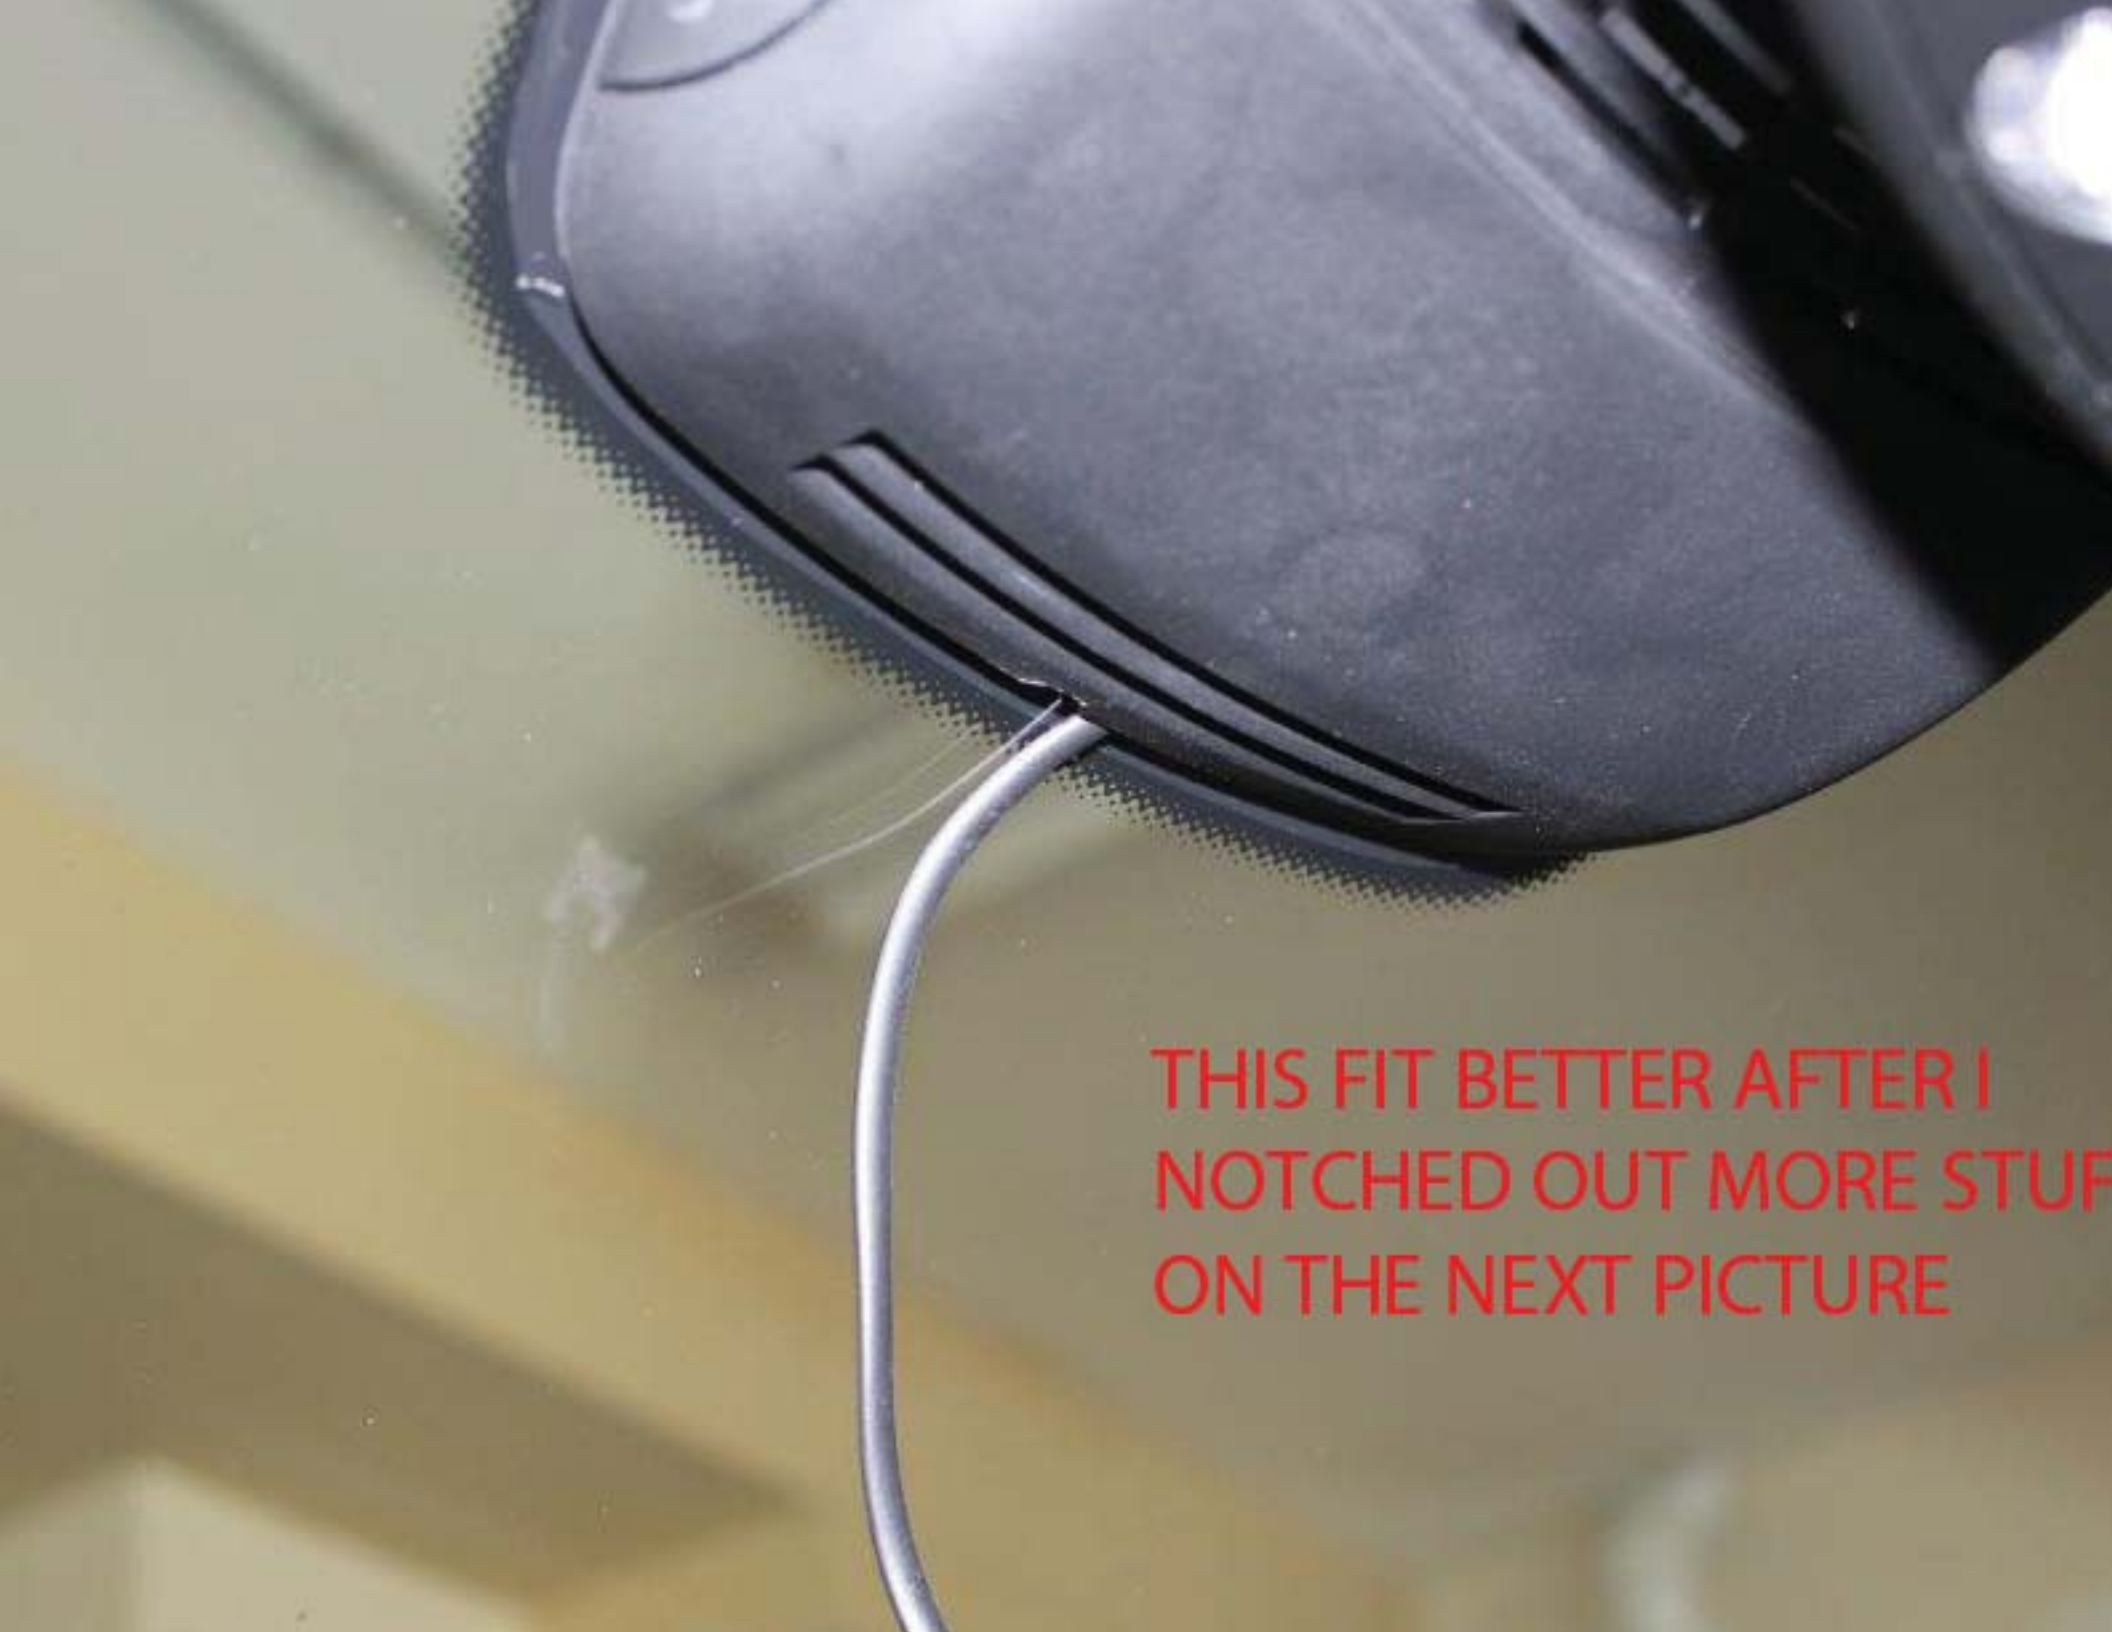
THIS FIT BETTER AFTER I
NOTCHED OUT MORE STUFF
ON THE NEXT PICTURE

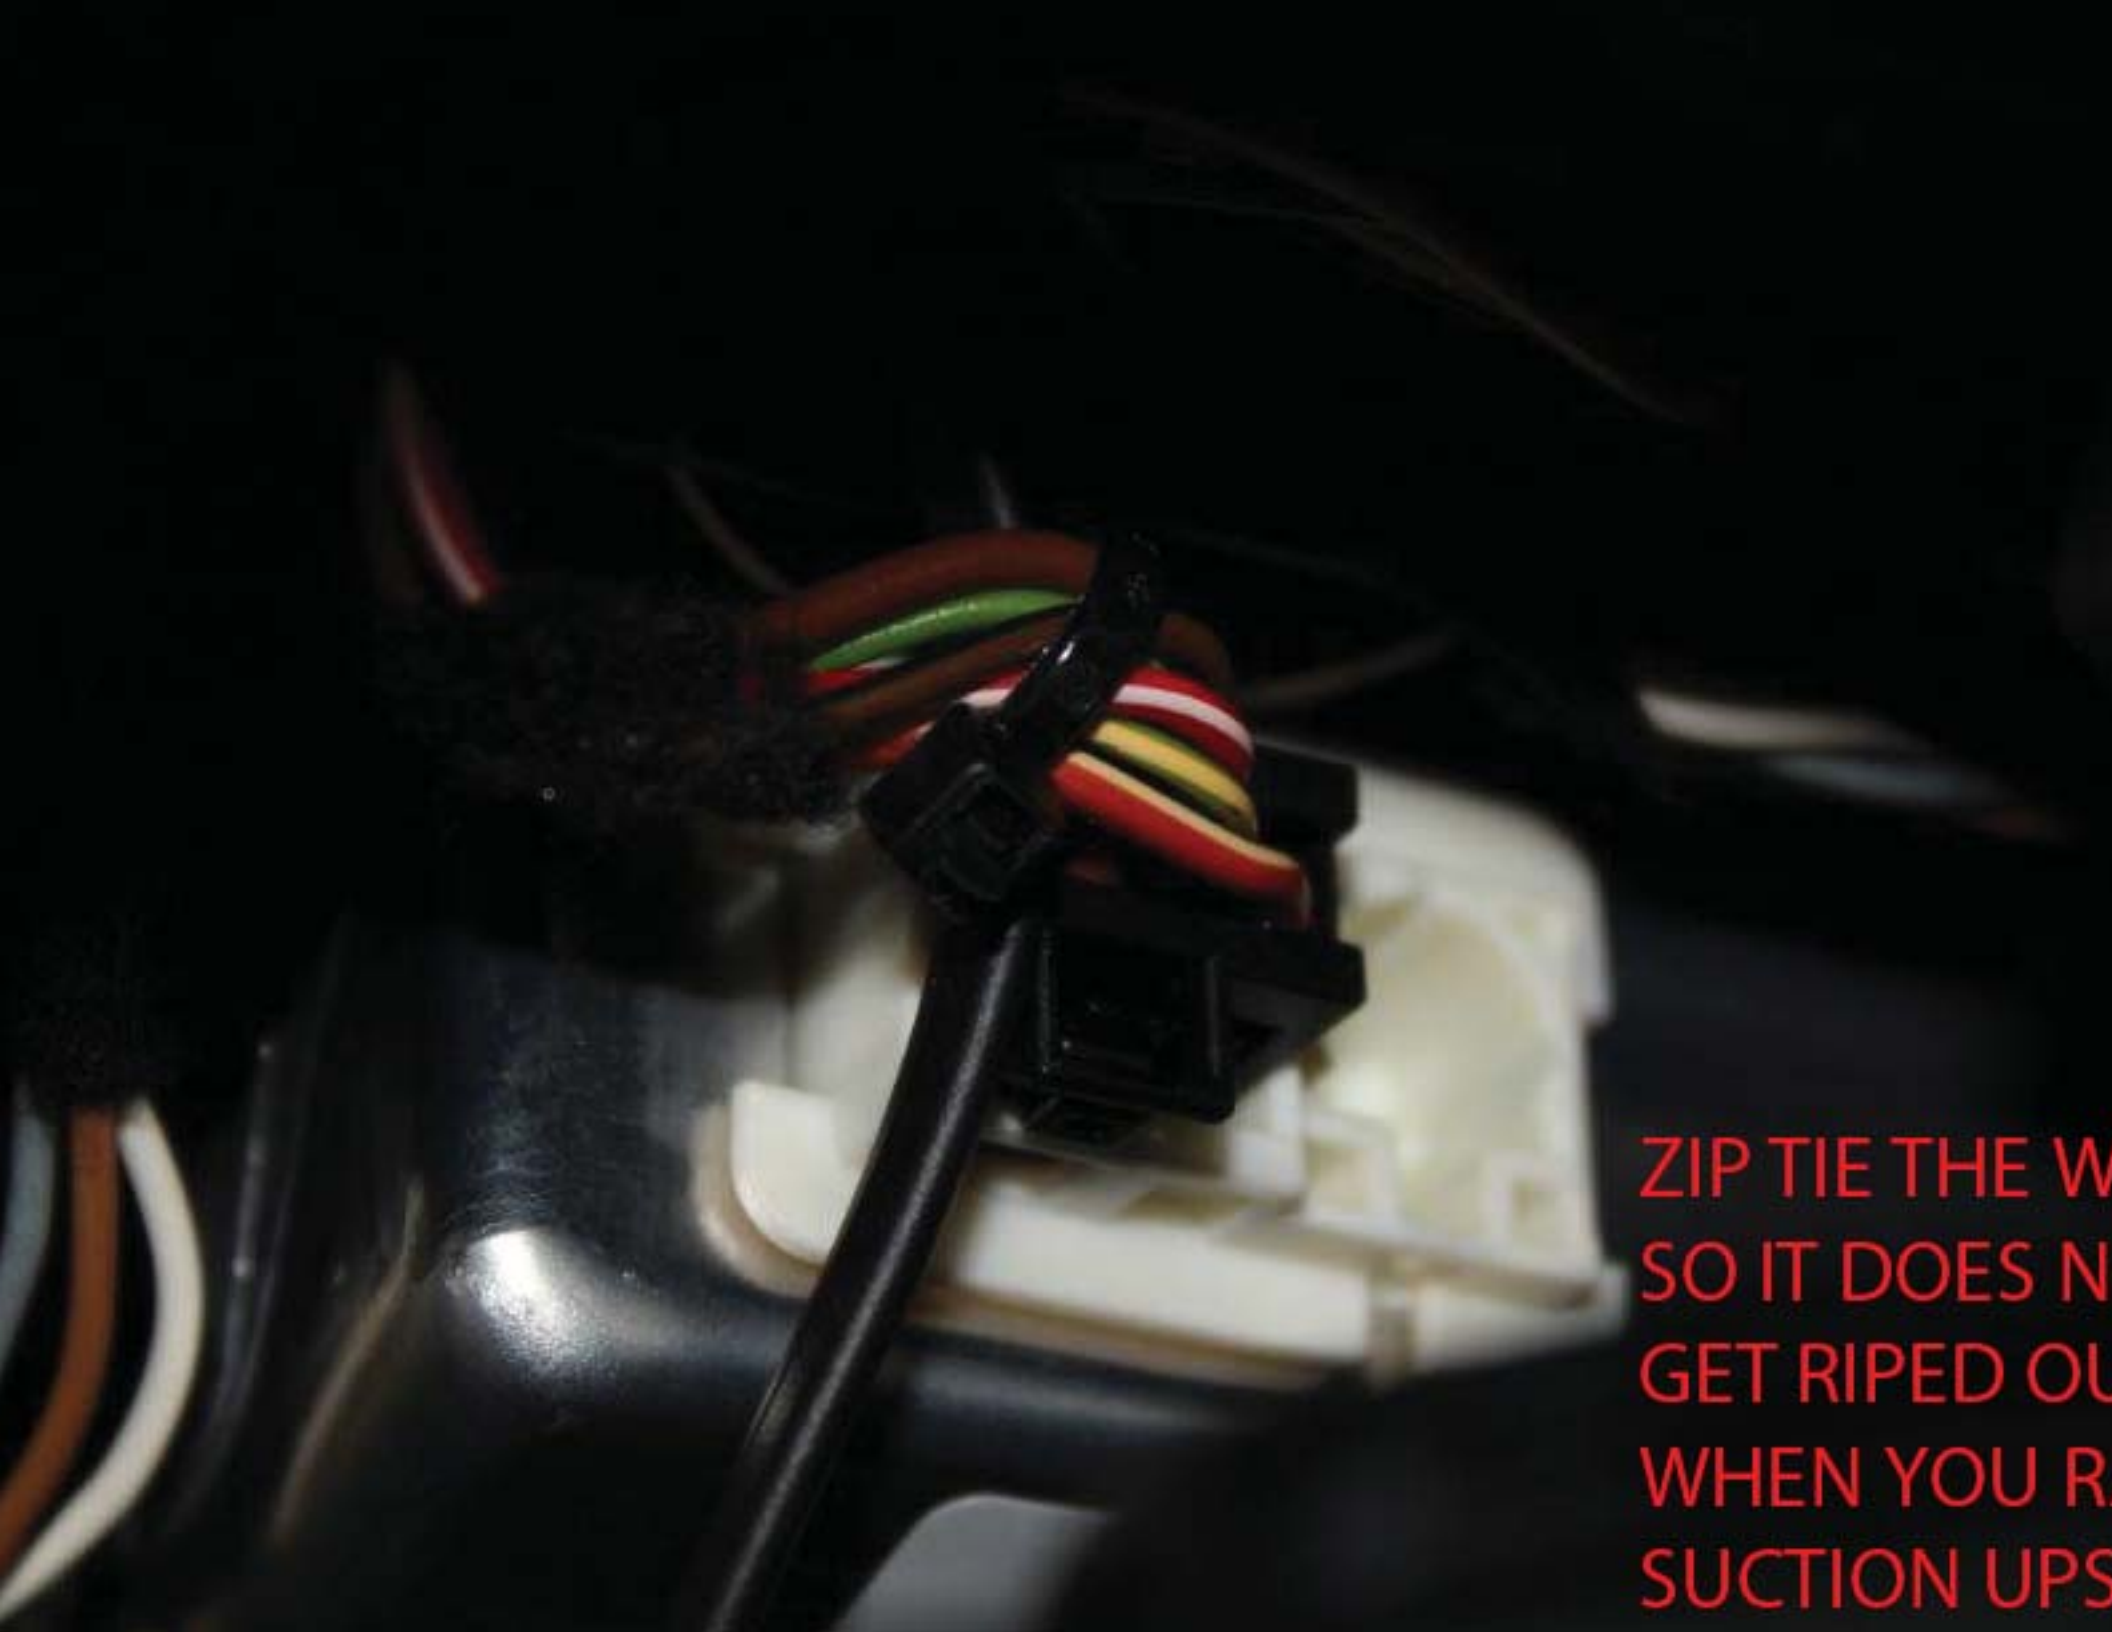
ZIP TIE THE W
SO IT DOES N
GET RIPPED O
WHEN YOU R
SUCTION UPS

NOTCHED THIS OUT
WITH NEEDLE NOSE
PLIERS TO GIVE THE WIRE
MORE ROOM
