Document title General information on inspecting cylinder walls

Document number ah0100p030001amg

Engine 133, 139, 156, 176, 177, 178, 254, 256.9, 276.8, 654, 656
Engine 159

General information for engines with twin-wire-arc-sprayed coating

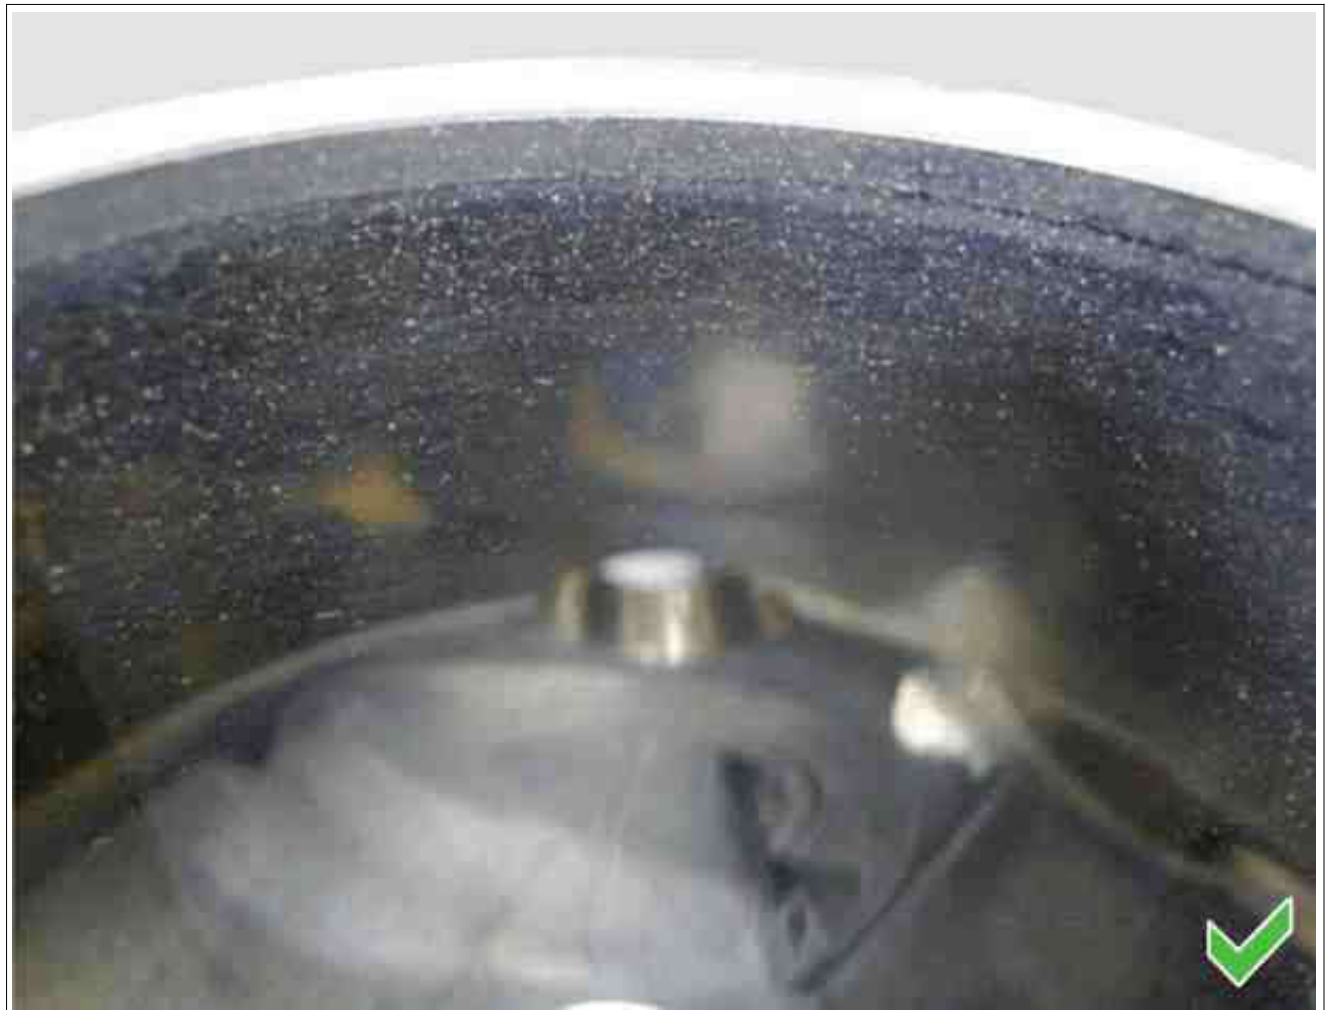
P01.00-3666-76

A crankcase with twin-wire-arc-sprayed coating

i In the case of crankcases with twin-wire-arc-sprayed coating, an electric arc is used to seal off iron-carbon wires, to then spray them through an inert gas stream onto the inside of the cylinder. The resulting characteristic pores generate a retained oil volume in the surface, which in turn enables the reliable use of an extremely smooth, reflective honing structure.

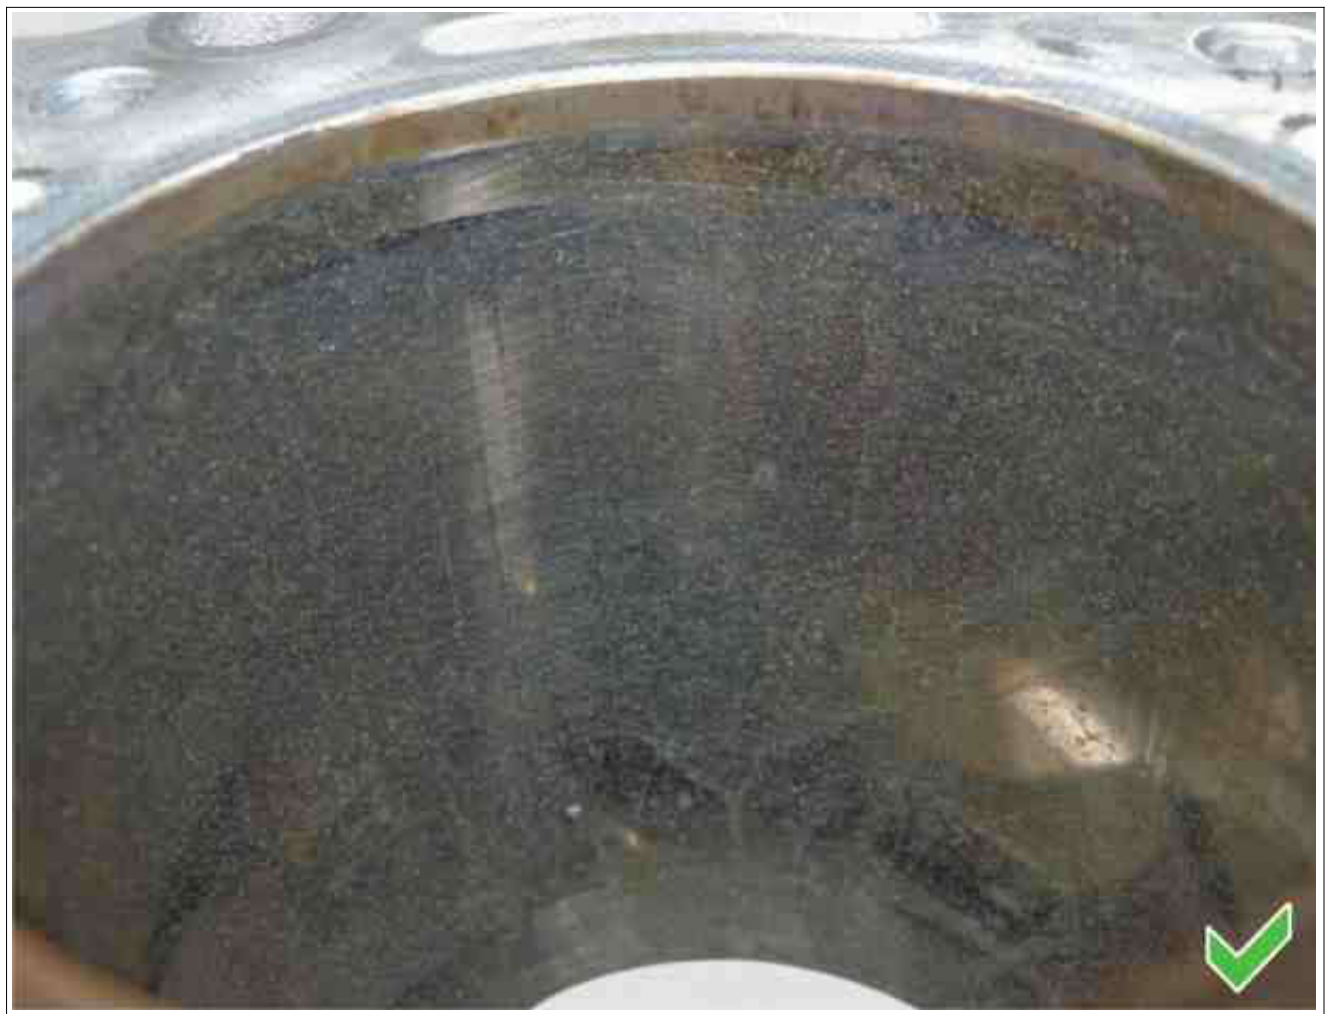
P01.00-3668-76

Ideal condition

Cylinder barrels with twin-wire-arc-sprayed coating can be recognized by their reflective surface with pores (see white dots in picture) and the honing pattern.

i The piston can be reflected in the barrel surface.

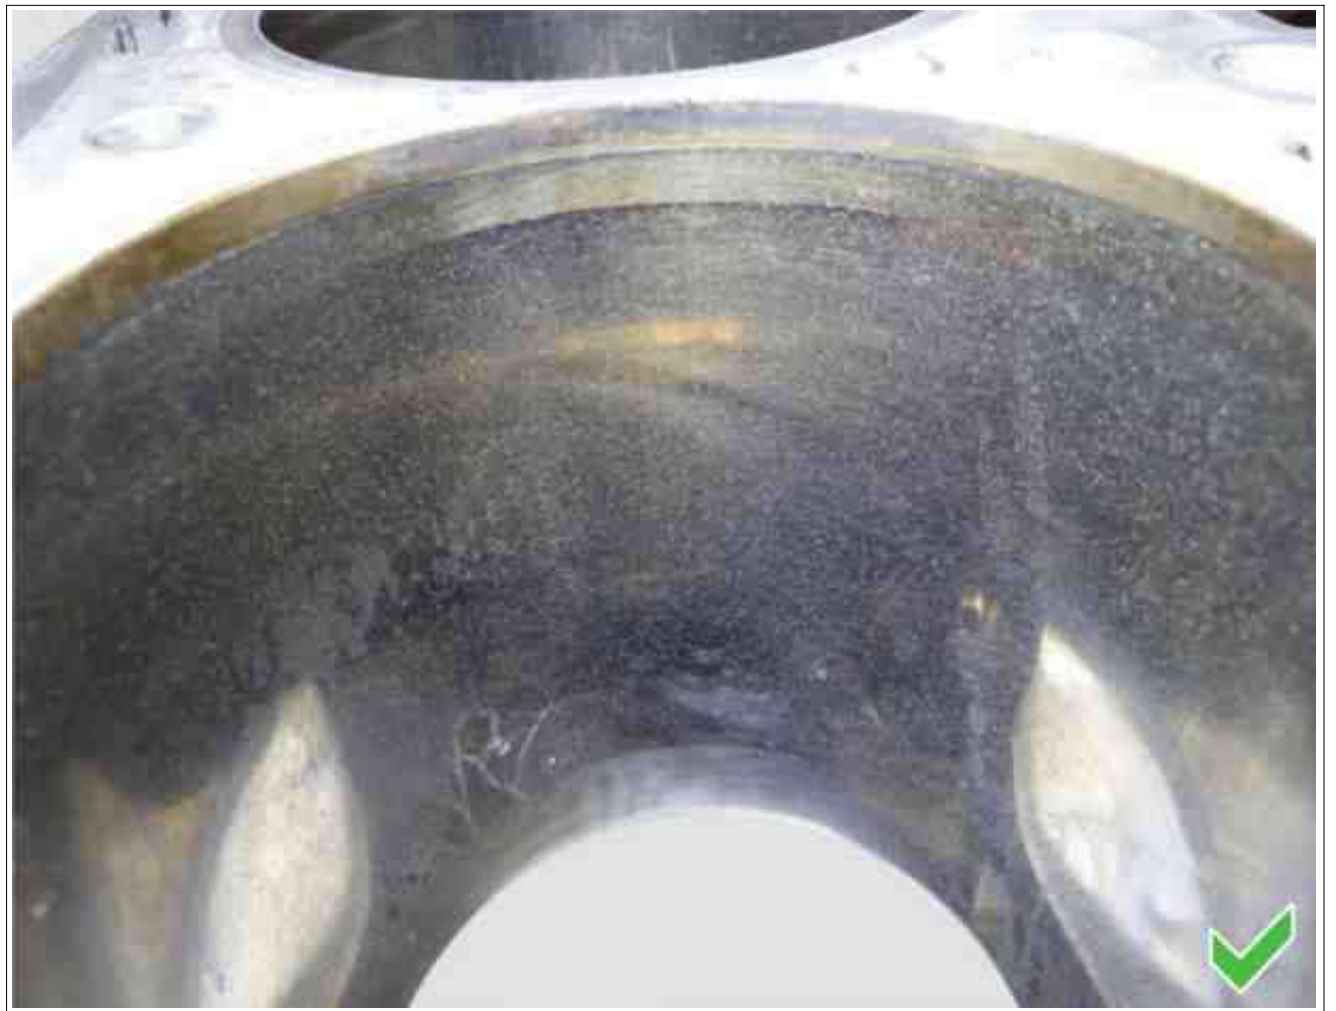
P01.00-3669-76

Visible pores (white dots)

White dots or pores distributed over the entire cylinder barrel are typical for cylinder barrels with twin-wire-arc-sprayed coating.

i Reuse crankcase.

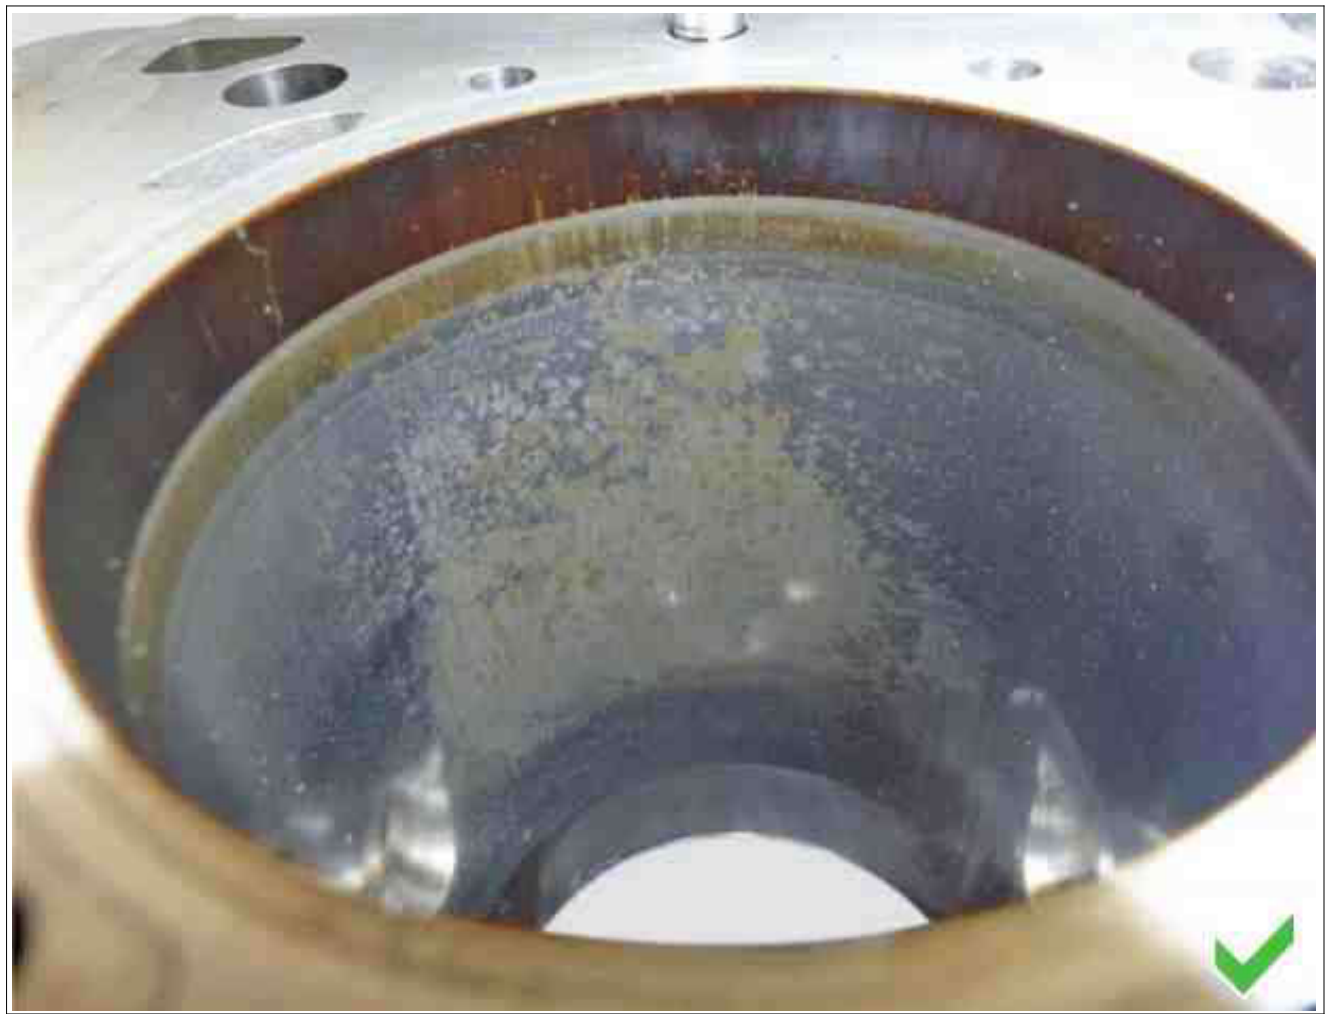
P01.00-3670-76

Large-area rust or corrosion spots

Appearance of rust in center of cylinder barrel.

Reuse crankcase.

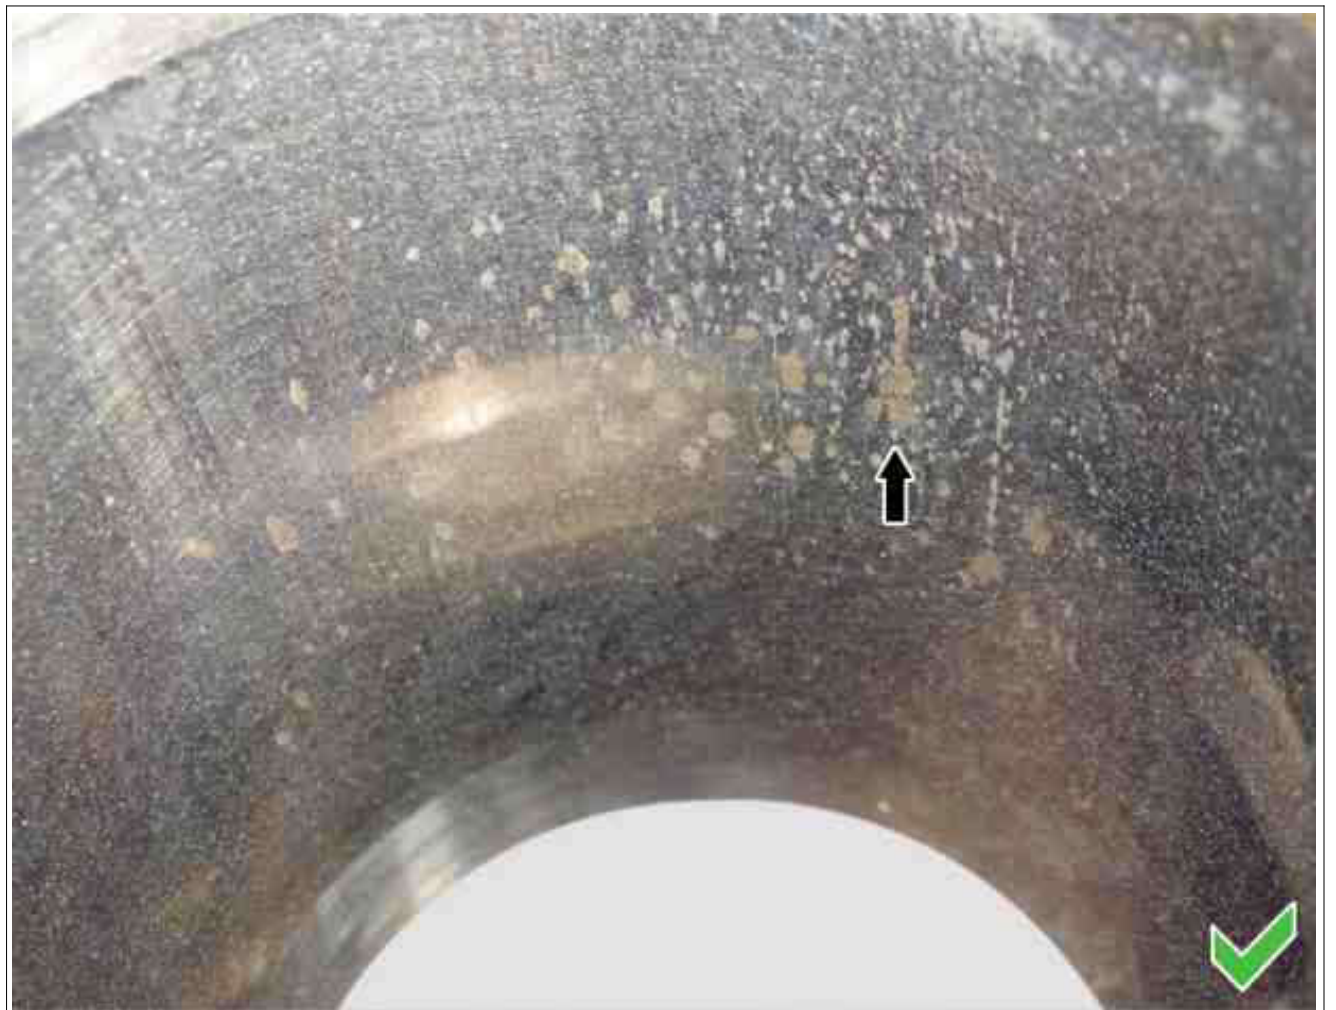
P01.00-3671-76

Individual corrosion spots

Individually occurring corrosion spots over entire cylinder barrel can also occur as cavities.

Reuse crankcase.

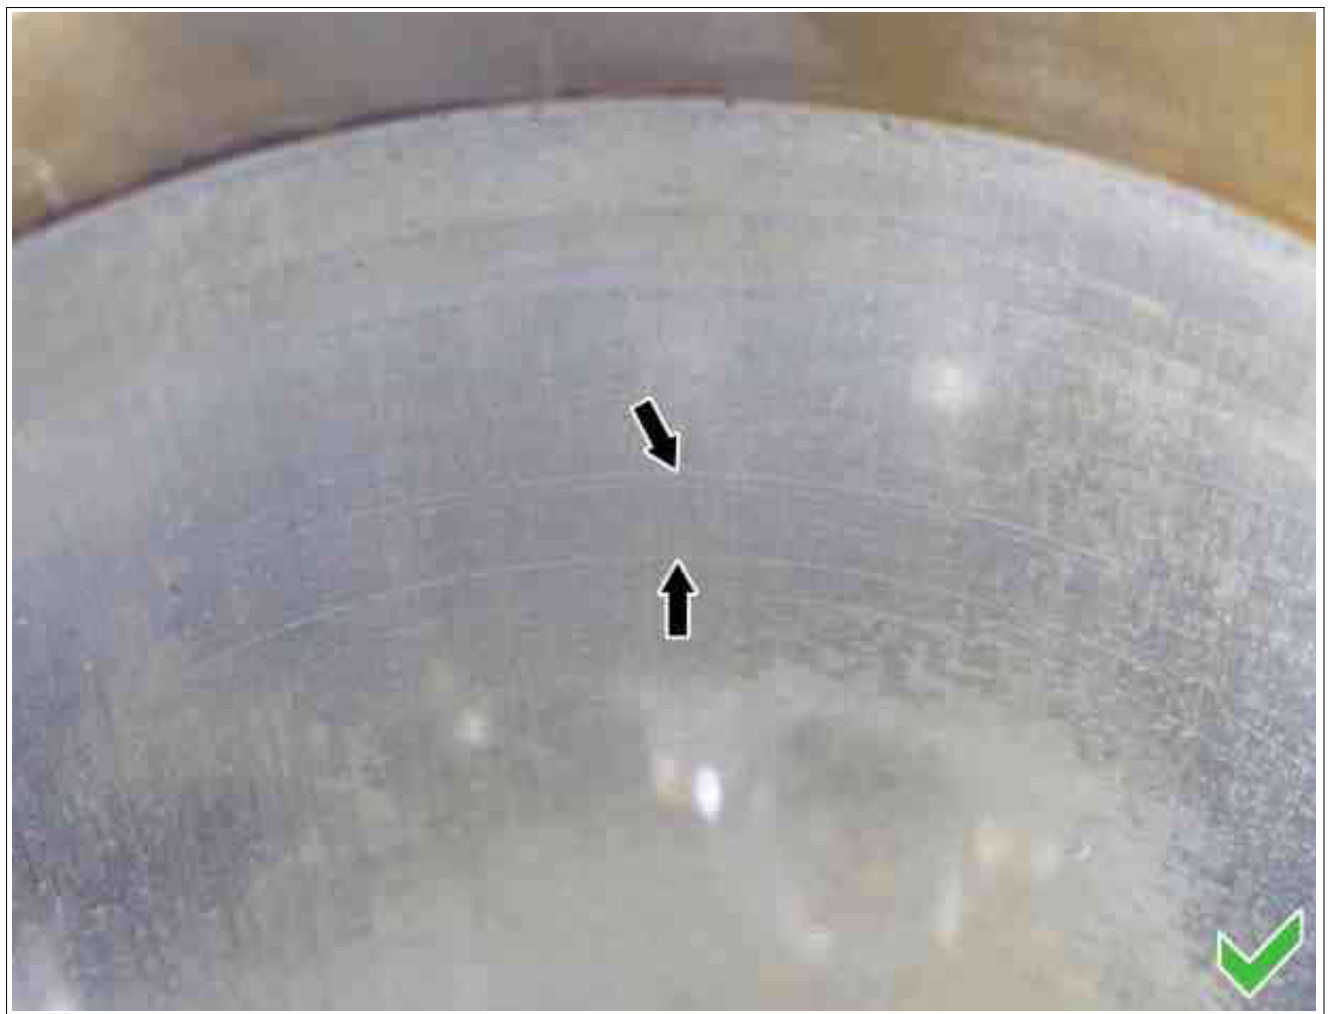
P01.00-3672-76

Honing marks in cylinder barrel

Honing marks, depressions in cylinder barrel running at honing angle, caused by machining without burring.

i Reuse crankcase.

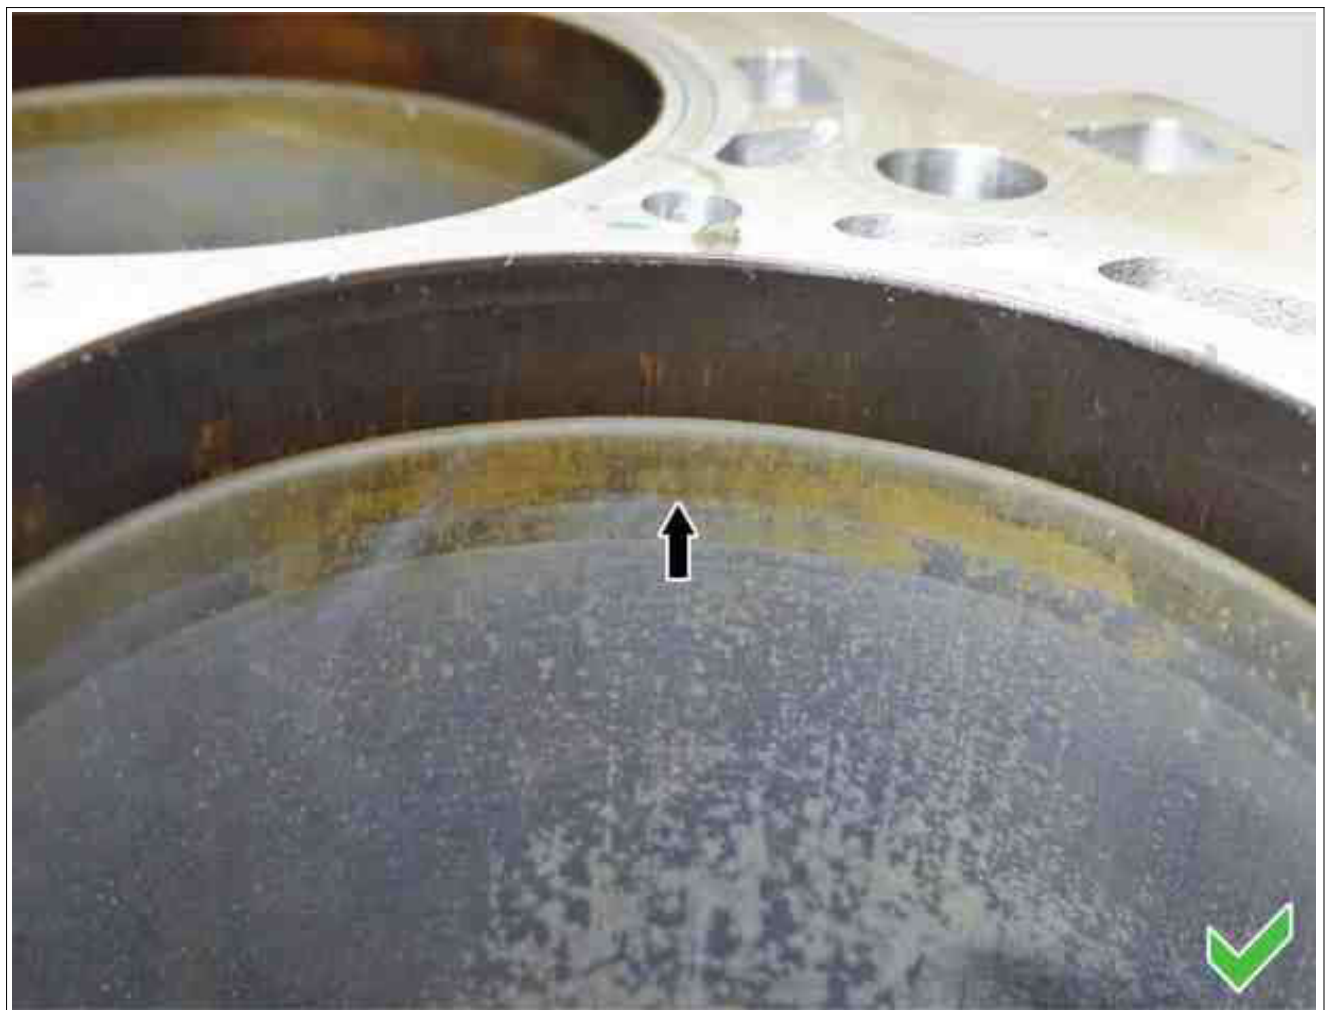
P01.00-3673-76

Optical strips and easily recognizable honing pattern

Visible rust strips in upper piston ring reversal area of cylinder barrel and clearly recognizable honing pattern.

i Reuse crankcase.

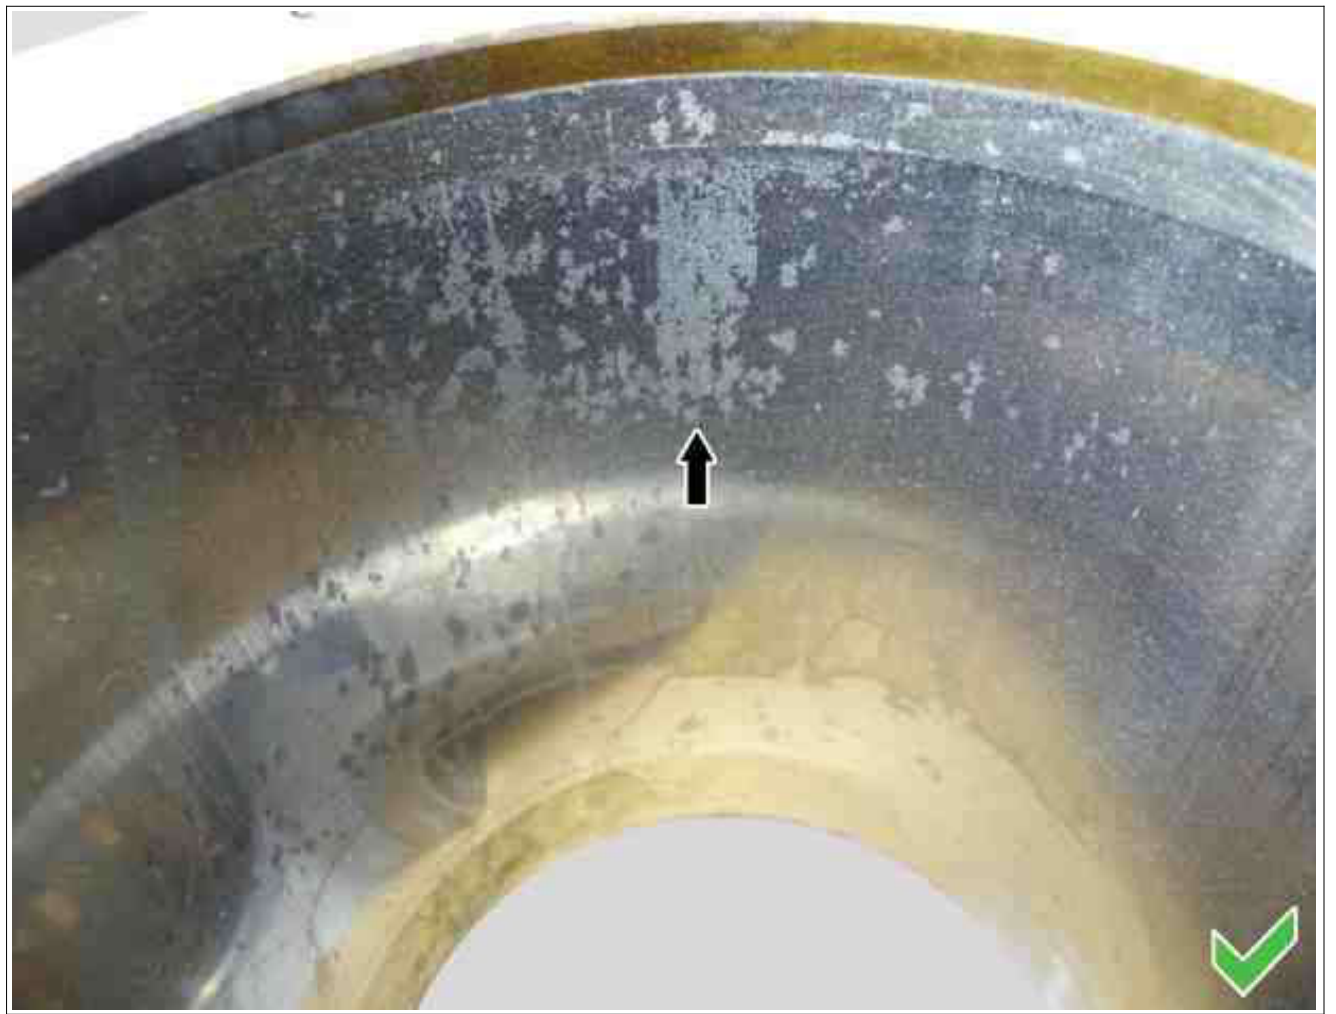
P01.00-3674-76

Partial corrosion in cylinder barrel

Partial corrosion in cylinder barrel.

i Reuse crankcase.

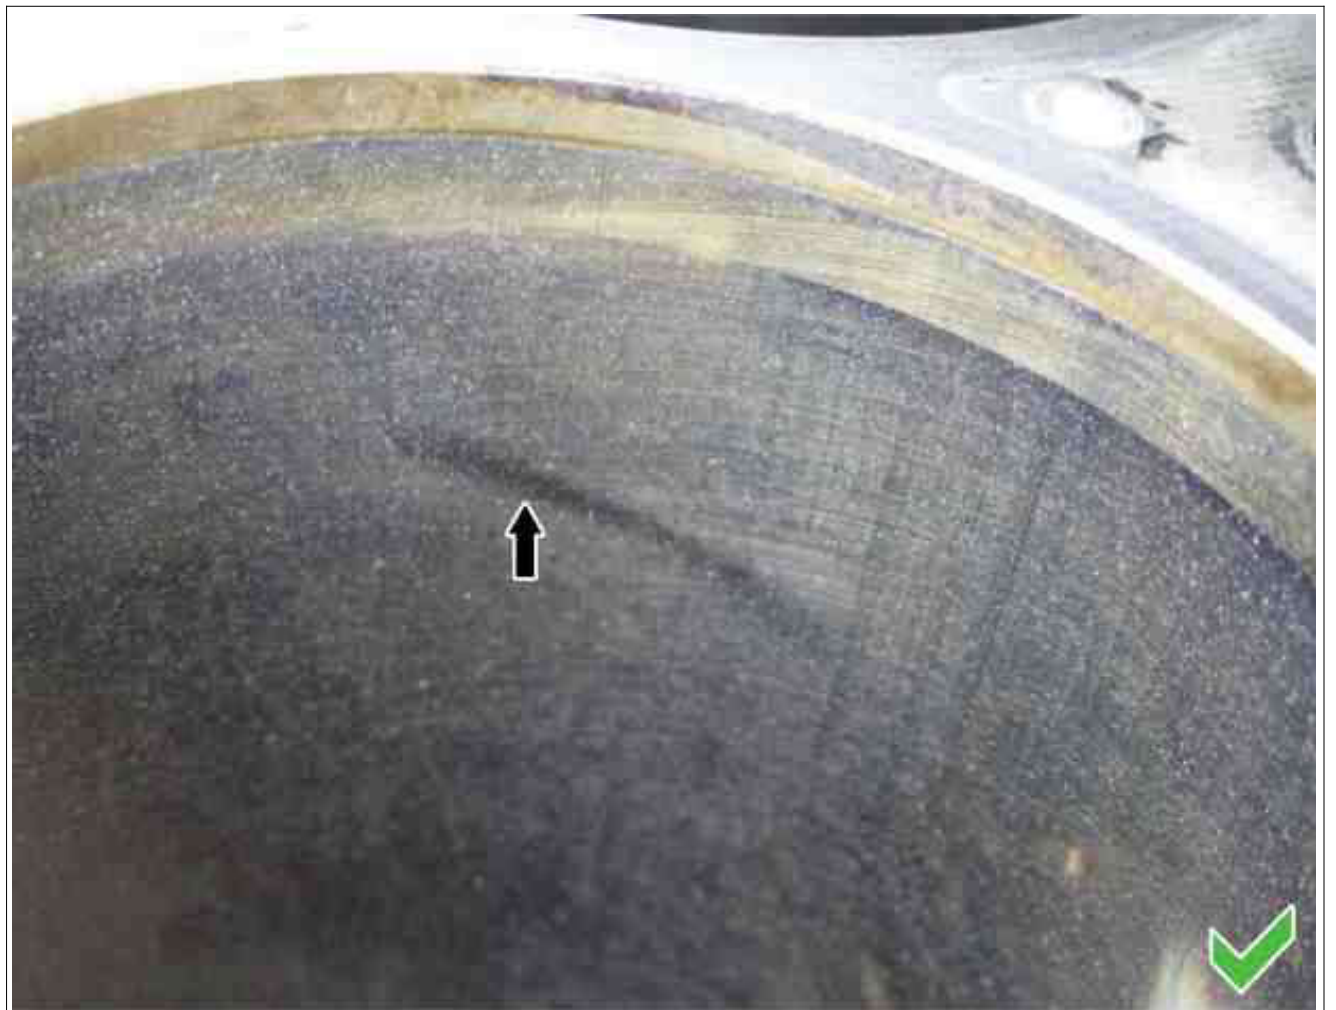
P01.00-3675-76

Figure showing valve cooling bore in cylinder barrel

Shading in cylinder barrel in cylinder wall area in development direction of valve cooling bore after runtime (score marks and honing pattern recognizable).

i Reuse crankcase.

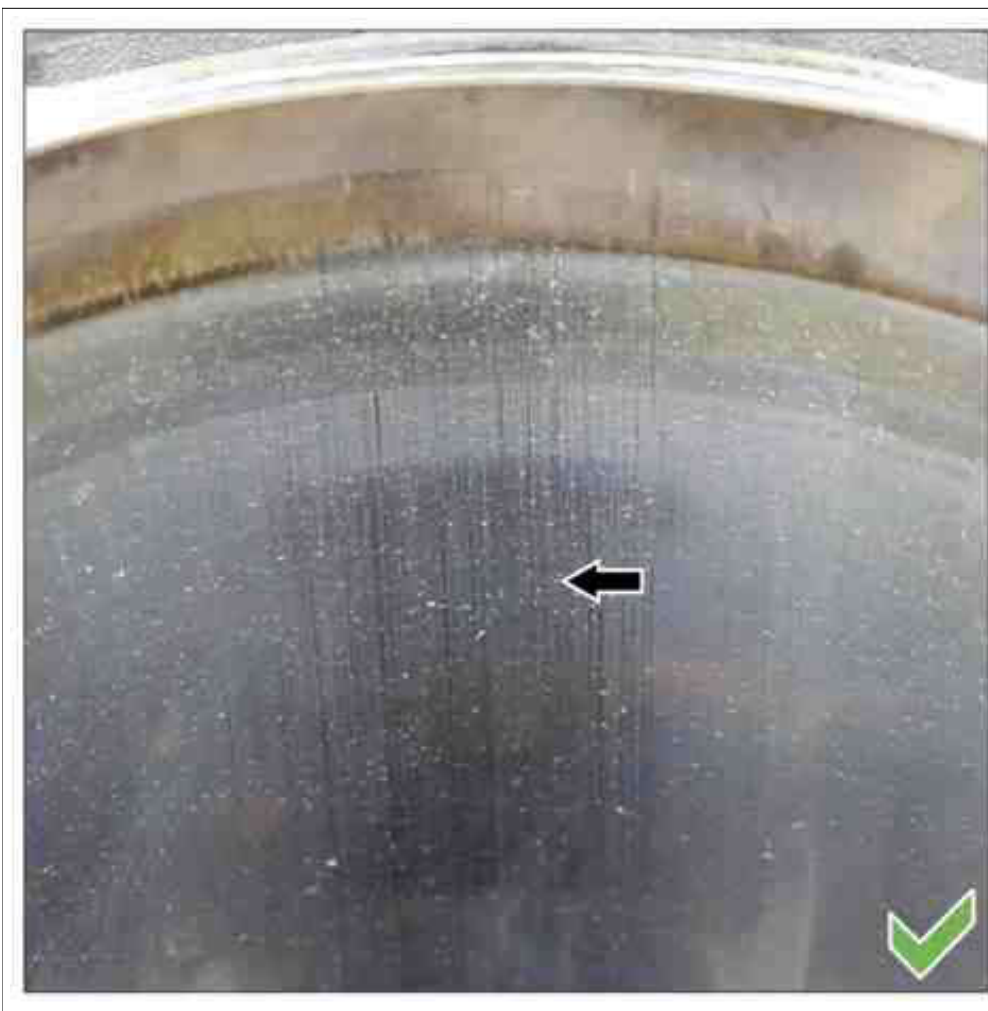
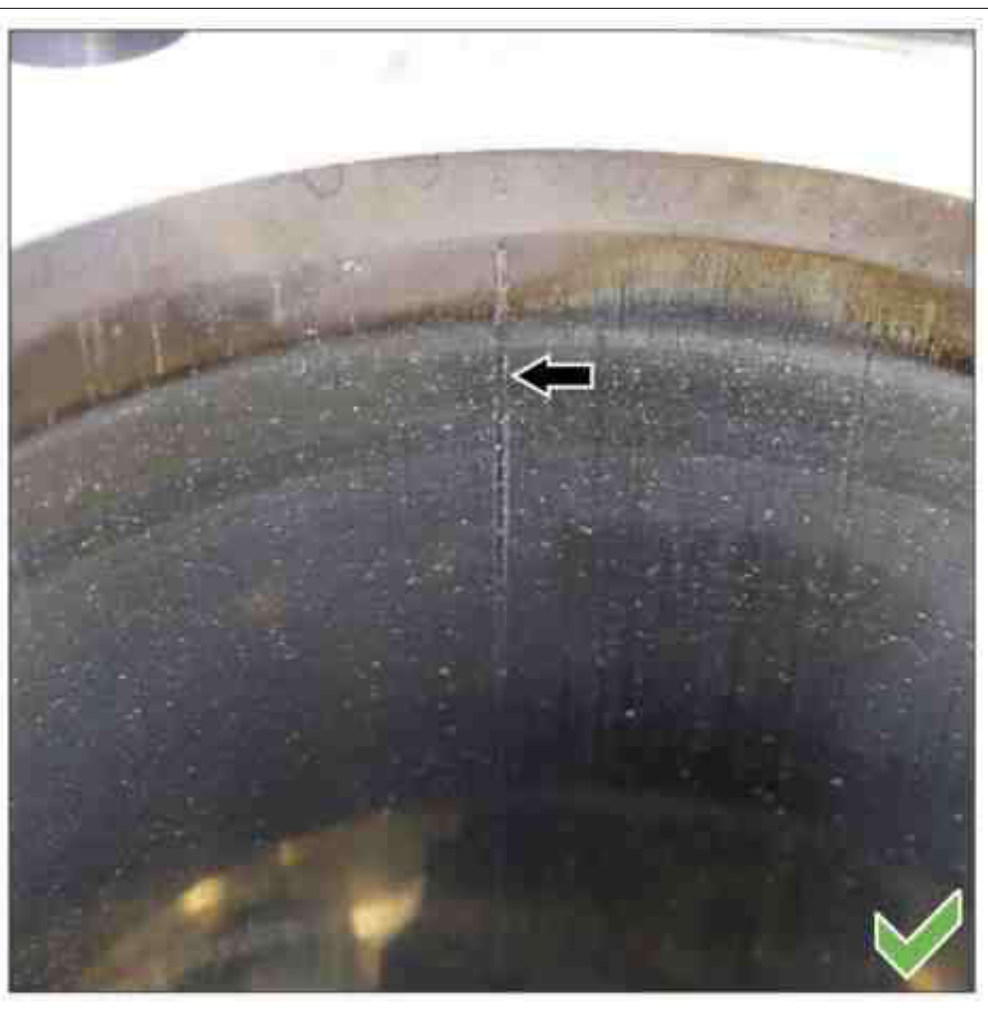
P01.00-3761-79

Individual score marks up to areas of score marks (not with engine 156, 159)

Caused by initial dirt or soiling during operation, e.g. through back pulsation of particles from the catalytic converter or the exhaust system.

i If the compression pressure is within the permissible range, use the crankcase again.

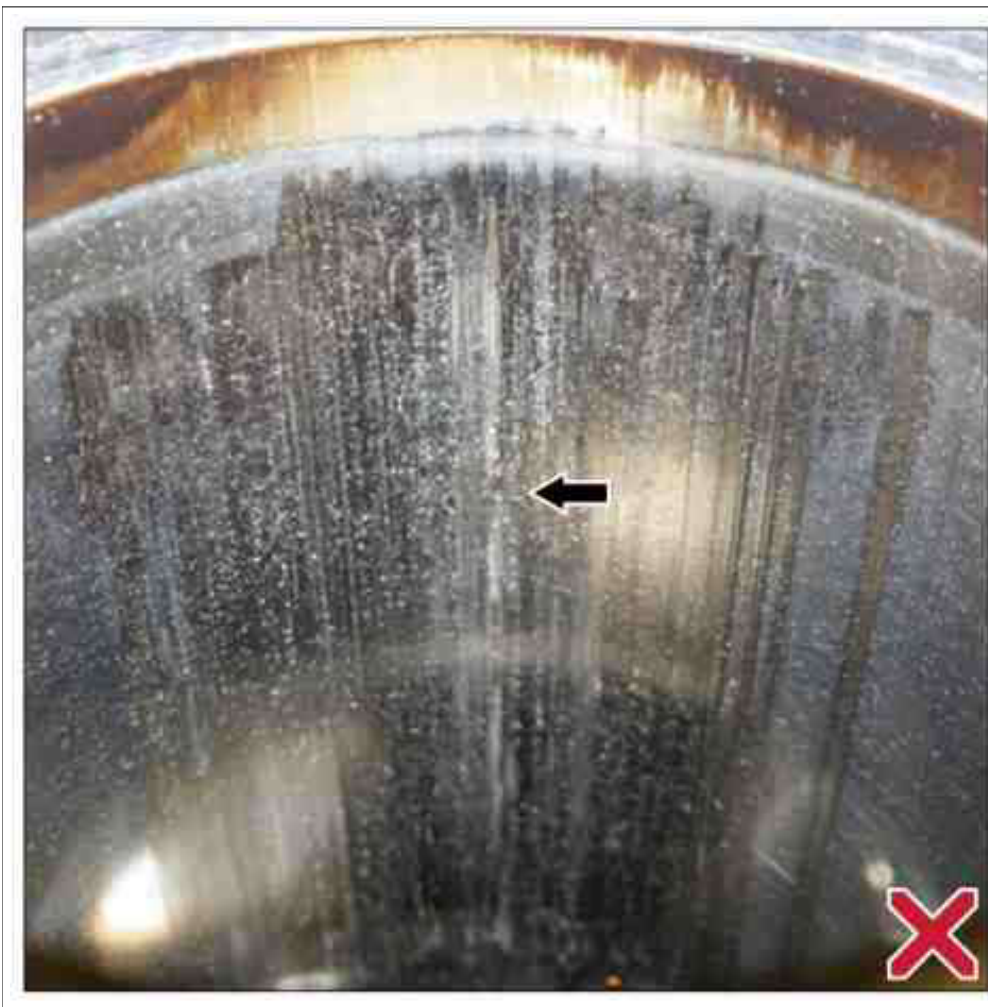
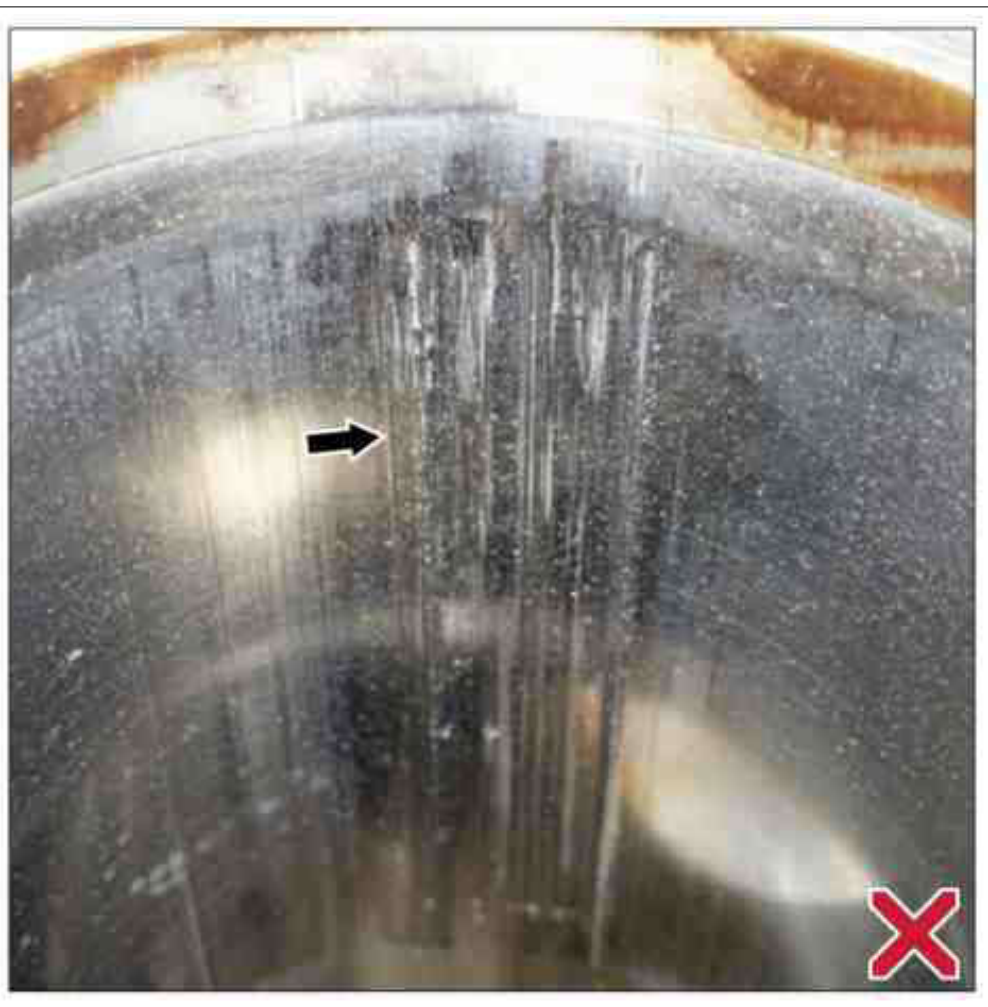
P01.00-3762-79

Piston seizure, ring seizure

Most of cylinder wall perceptibly roughened over the entire length and noticeable seizing marks, cylinder barrel unusable.

i Do not use crankcase again.
