## Cracking/Creaking Noises Coming From The Area Of The Mechanical Steering Column

Topic number	LI46.15-P-071669
Version	2
Function group	46.15 - Steering column adjustment
Date	3/7/23
Validity	Model 205 with mechanical steering column adjustment (without code 275)  Model 213 with mechanical steering column adjustment (without code 275)  Model 238 with mechanical steering column adjustment (without code 275)  Model 253 with mechanical steering column adjustment (without code 275)  Model 257 with mechanical steering column adjustment (without code 275)  Model 290 with mechanical steering column adjustment (without code 275)
Reason for change	Model series 290 added

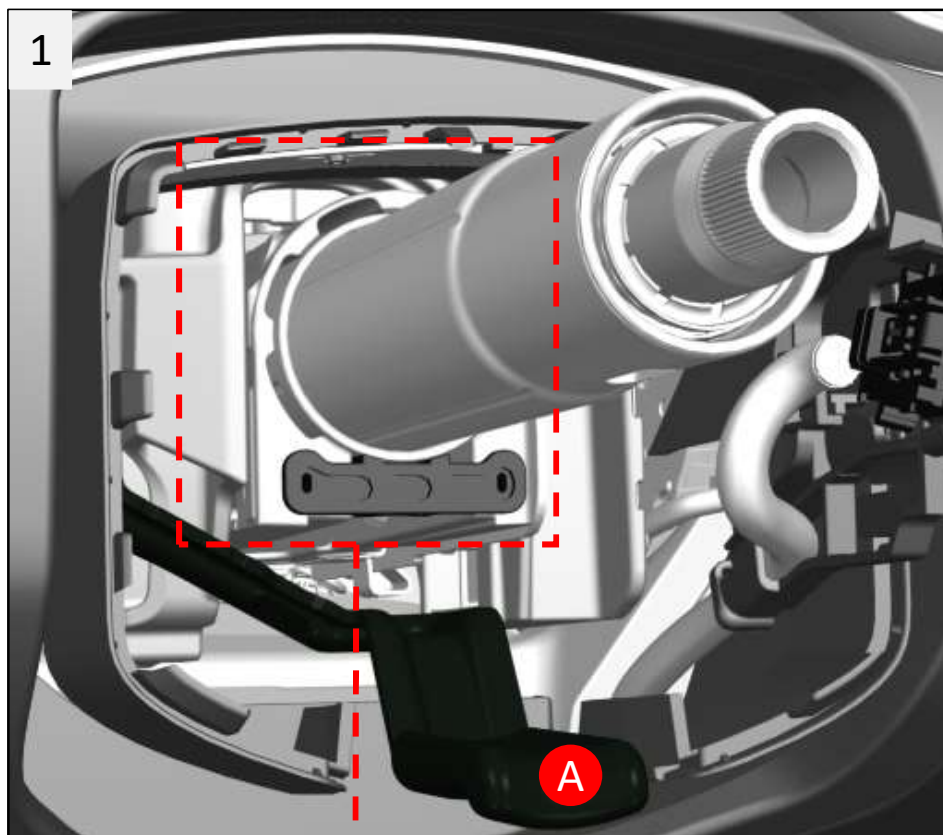
Loads induced at the steering wheel through pushing and pulling actions may cause creaking and cracking noises in the mechanical steering column.

Insufficient grease lubrication in the clamping area of the mechanical steering column.

- 1 Create access to the steering column (see picture 1).
  2. Open the steering column clamps (picture 1 / illustration A).
  3. Re-grease the area/gap marked in red (picture 2/3).
  4. Distribute the grease by operating the height adjustment.
  5. Carry out a noise test and repeat the greasing process if necessary.
-
