2018 Mercedes Benz E63S AMG 4MATIC Sed (213.089) V8-4.0L Turbo (177.980)

# - Center Caps on the Wheels May Have Surface Damage, Corrosion, or Fading -

Topic number	LI40.10-P-068659
Version	1
Function group	40.10 Wheels, tires
Date	08-14-2018
Validity	All Models
Reason for change

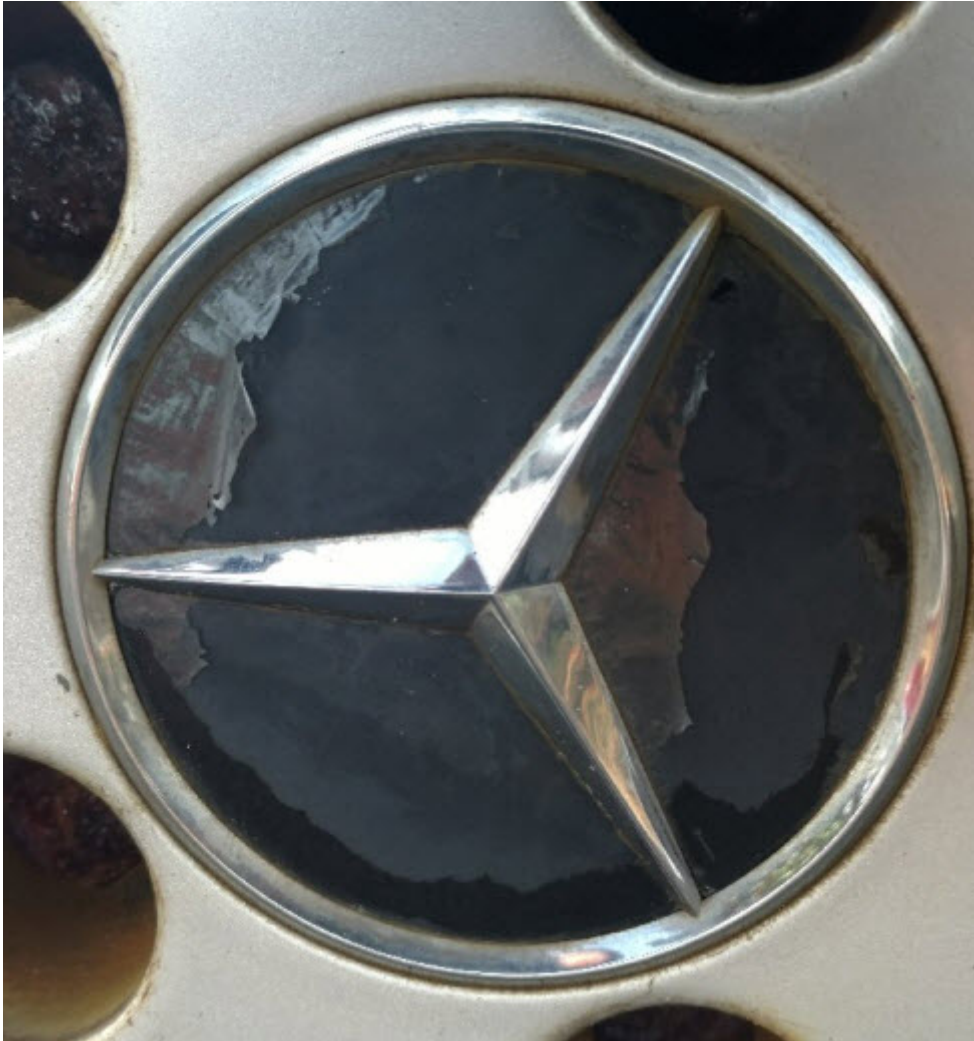
**A**

See pictures (A) and (B) for examples of damages you may see. The pictures are of the black center caps, but all types of center caps may be susceptible to this if the right conditions are met.

Center Cap Peeling and Corroded  
Center Cap Fading and Peeling

Accelerated aging of the center caps may be caused by long-term or continuous exposure to one or more of the following conditions;

- Unapproved, aggressive cleaning chemicals from car washes
- Abrasive washing techniques
- High temperatures
- High humidity
- Snowy/salted roads
- Dirt or gravel roads

If you would like to replace the center caps, this can not be claimed under warranty as the damage is due to natural causes and not manufacturer's defect.
