2018 Mercedes Benz E63S AMG 4MATIC Sed (213.089) V8-4.0L Turbo (177.980)

INDICATOR LAMP OF A/C BUTTON IN FRONT CLIMATE CONTROL OPERATING UNIT INOPERATIVE

Topic number	LI83.30-P-067427
Version	2
Function group	83.30 Air conditioning
Date	12-22-2017
Validity	Model series 205, 213, 238, 253
Reason for change	Damage code adjusted.

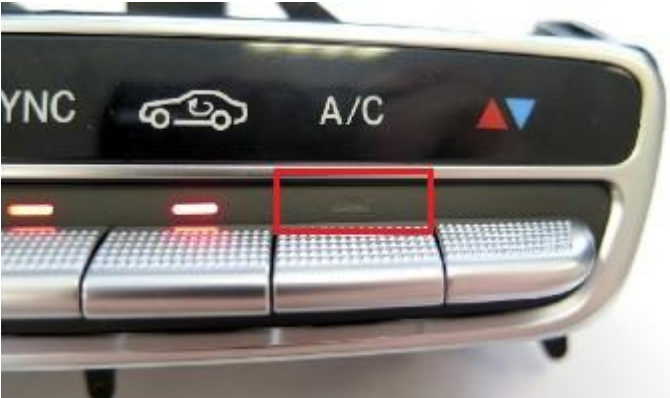
A

The indicator lamp of the A/C button in the operating unit of the front climate control is inoperative, although the air conditioning system is switched on. The air conditioning system functions correctly.

The LED in the A/C control panel may be damaged.

Part number	ES1	ES2	Designation	Quantity	Note	EPC
					Reference EPC for A/C control unit part number.	
File						Designation
A.jpg						Picture

Replace the A/C control panel.
