2018 Mercedes Benz E63S AMG 4MATIC Sed (213.089) V8-4.0L Turbo (177.980)

LOWER CONTROL PANEL: LEFT/RIGHT SWITCH BLOCK IS LOOSE/NOT ENGAGED

Topic number	LI54.25-P-064053
Version	1
Design group	54.25 Switches
Date	05-11-2016
Validity	Model series 213 up to VIN end number A025655
Reason for change

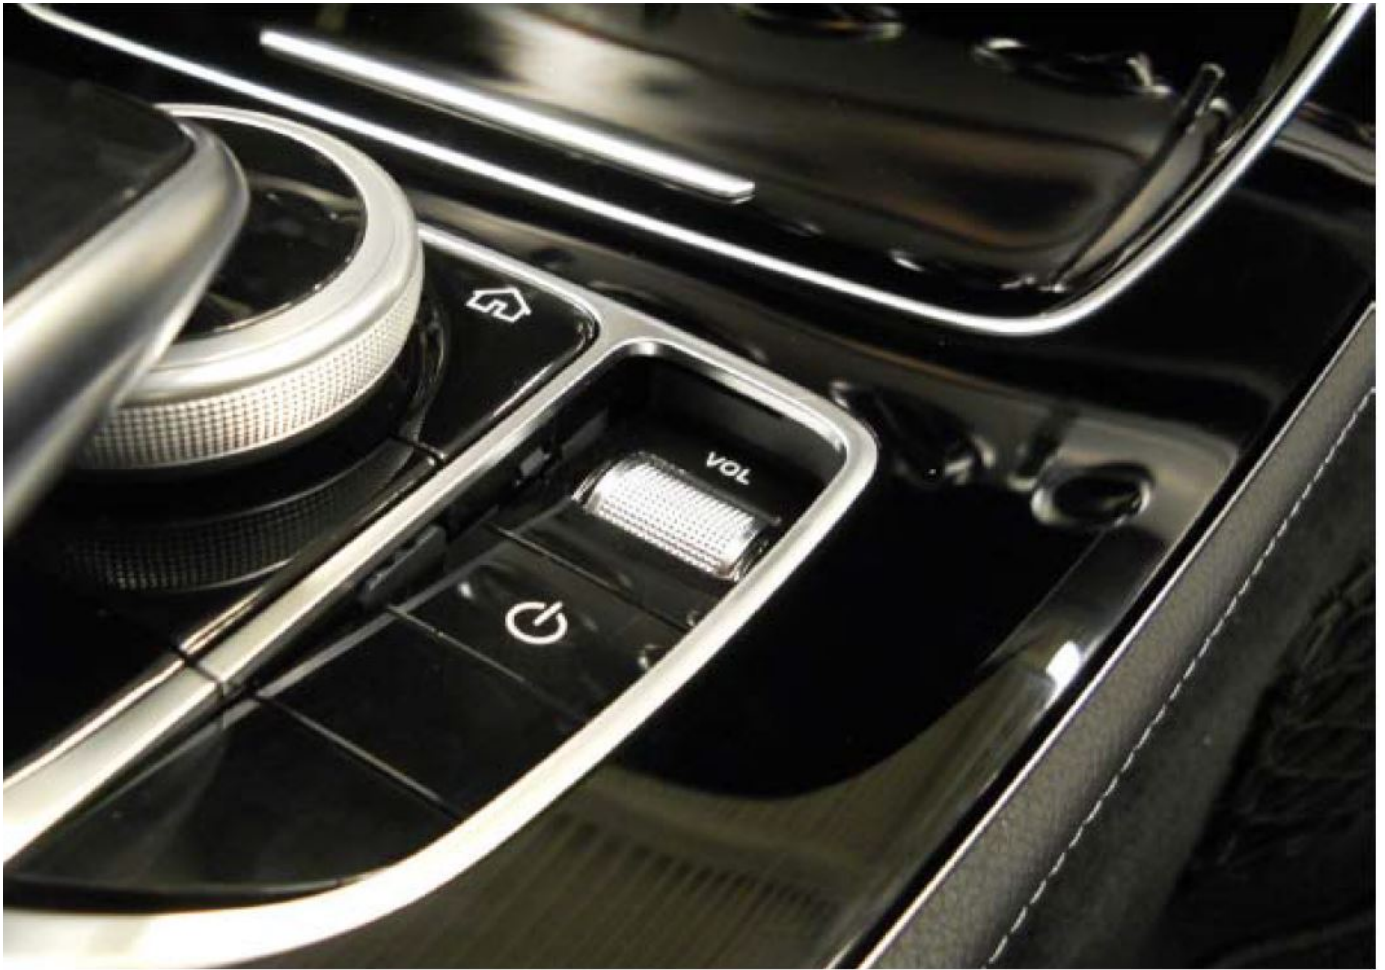
File	Designation
Schalterblock.JPG.jpg	Figure 1

The left or right switch block on the lower control panel is loose or not correctly engaged

Switch block mounting (See picture 1 in attachment).

Remove lower control panel and mount switch block correctly from rear, make sure while doing so that both catch hooks (front/rear) are engaged.
