2018 Mercedes Benz E63S AMG 4MATIC Sed (213.089) V8-4.0L Turbo (177.980)

MOBILE PHONE AND VCS: POOR CALL QUALITY AND/OR VOICE CONTROL MISUNDERSTANDS COMMANDS

Topic number	LI82.70-P-064726
Version	5
Function group	82.70 Telephone, Voice-control-system(VCS)
Date	01-08-2020
Validity	Model series 213, 238, 177, 167, 118, 247 Model series 253 Facelift
Reason for change	Validity expanded, cause and remedy adapted

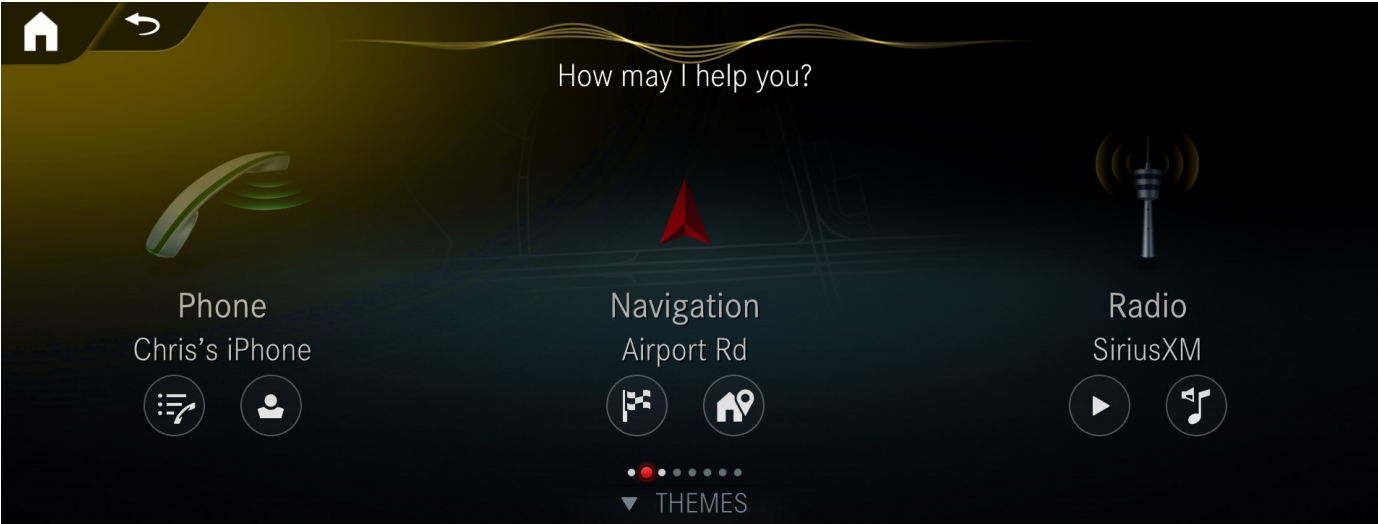
MBUX VCS directionality cue.jpg

Screenshot of MBUX VCS directional graphic (yellow shading at the top left of display)

MBUX VCS directionality cue

- Perform a bluetooth call on a mobile device from both passenger and driver's seats and note any difference in call quality as noted by the external "called" party
- On NTG6 vehicles with E420.5 or newer MBUX multimedia system (A26/17) software activate the voice control system (VCS) using "Hey Mercedes" and change the climate control setting by stating "I'm hot" or "I'm cold". This will prompt the climate control temperature setting to go up or down on the side of the vehicle where you are seated. Also the ambient lighting will change color (red or blue dependings on temperature change) on that side of the vehicle and the head unit display will have a graphical indicator noting which side the function was activated from (see attached). The success of this test is a good indicator of microphone functionality.
- In some instances both microphones may be affected
