2018 Mercedes Benz E63S AMG 4MATIC Sed (213.089) V8-4.0L Turbo (177.980)

REPLACE COVER FOR POSITIVE POLE ON STARTER BATTERY

Campaign No. 2018110002, November 2018

SUBJECT: **Models C-Class (205 platform) and E-Class vehicles (213 platform)**
Model Year 2018
Replace cover for positive pole on starter battery

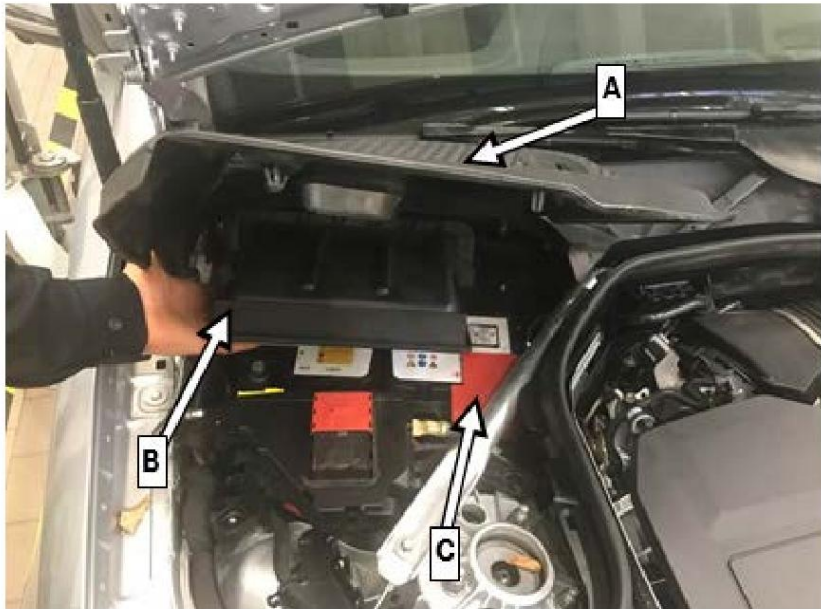
Figure 1

Daimler AG ("DAG"), the manufacturer of Mercedes-Benz vehicles, has determined that on certain Model Year ("MY") 2018 C-Class (205 platform) and E-Class vehicles (213 platform), an incorrect cover for the starter battery may have been installed which provides insufficient cover for a live electrical wire. Therefore, in the event of a crash which results in substantial deformation of the strut brace above the battery, the strut brace could contact an uncovered live electric wire which could lead to a short circuit. A short circuit could lead to an increased risk of fire. In this case, the on-board electrical system might not be able to support post-crash functions (e.g. emergency door unlocking or activation of hazard warning lamps may not be available). However, unlocking and opening of the doors from the inside are not affected. An authorized Mercedes-Benz dealer will replace the battery cover on the affected vehicles.

1. Lift cover (A, Figure 1).
2. Lift interior air filter (B, Figure 1).
3. Replace cover for positive pole (C, Figure 1) on starter battery.

4. Assemble in reverse order.
