2018 Mercedes Benz E63S AMG 4MATIC Sed (213.089) V8-4.0L Turbo (177.980)

MESSAGE "MERCEDES ME CONNECT SERVICES LIMITED. SEE OWNER'S
MANUAL" IN INSTRUMENT CLUSTER MULTIFUNCTION DISPLAY

Topic number	LI54.30-P-066410
Version	3
Function group	54.30 Instrument cluster, display instruments, hazard warning device
Date	05-30-2019
Validity	Model 117, 118, 156, 176, 177, 242, 246, 247, 172, 190, 231, 205, 253, 166, 167, 292, 213, 218, 238, 222, 217, 257, X290, 293, 463 with HERMES communication module (code 360, 362, 364)
Reason for change	Extension: Model series validity and distribution (worldwide)

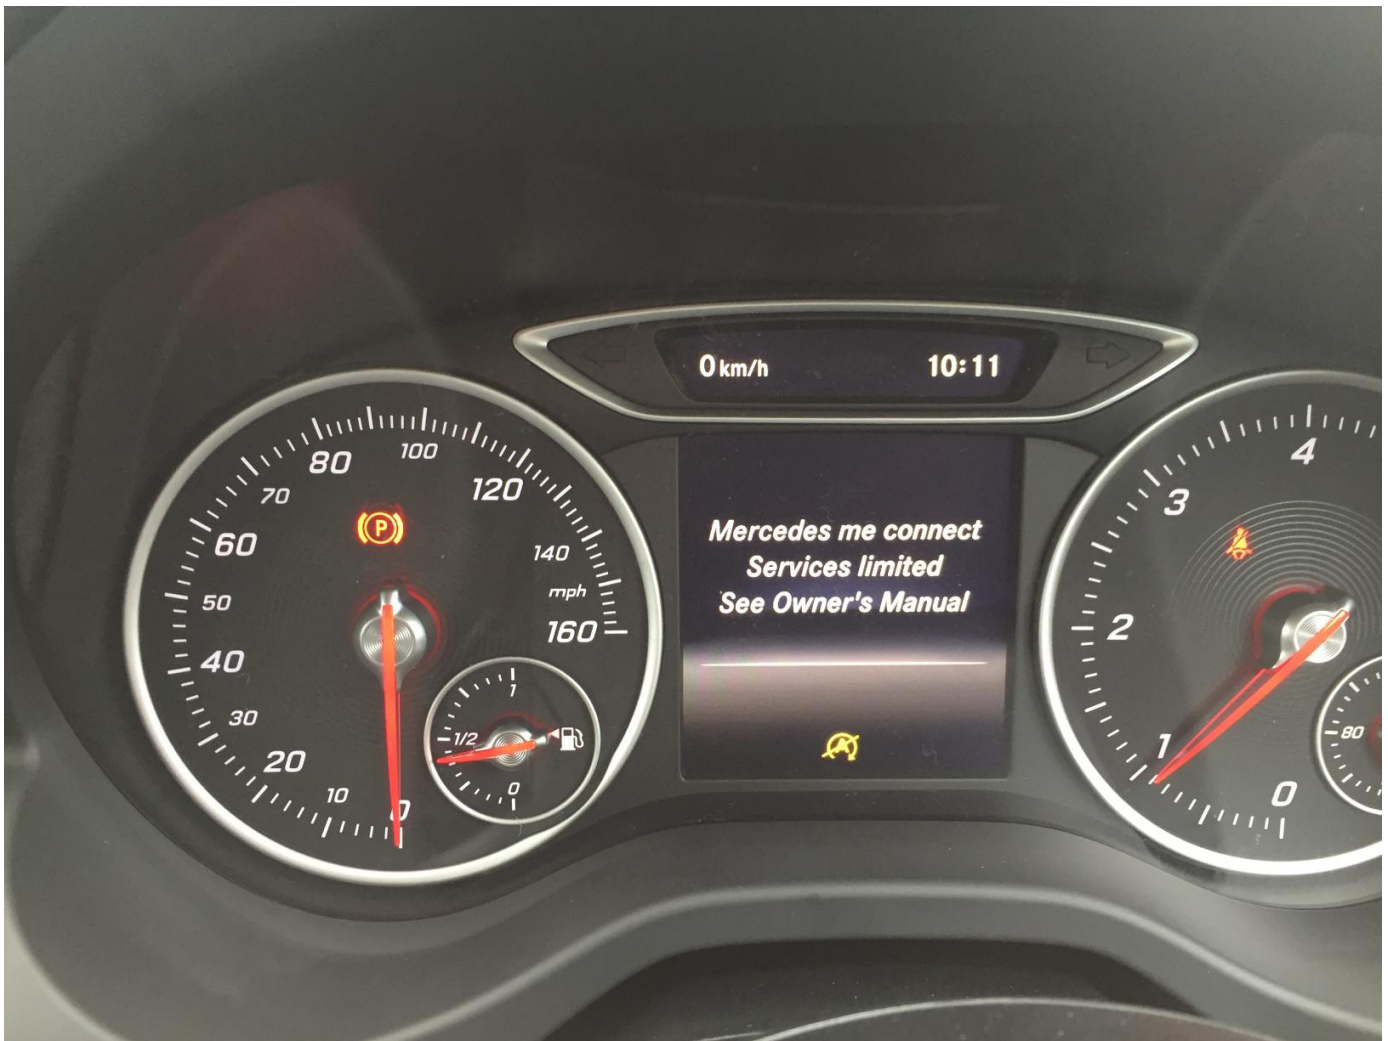
picture limitedservices

After every ignition cycle, the multifunction display in the instrument cluster may show the message **"Mercedes me connect services limited. See owner's manual"** (see picture in attachment).

Picture: Limited service message in instrument cluster

This is a status message. It appears whenever a diagnostic unit, e.g. XENTRY Diagnostics or a third-party adapter is connected to the on-board diagnosis (OBD) interface, triggering queries on the diagnostics CAN. The message informs the driver that in this state the Mercedes me connect basic services, such as maintenance management, telediagnosis and other services, no longer function or function only to a limited extent. In addition, the vehicle owner's manual provides information about further possible vehicle problems under "General information" and the heading "Diagnostics connection". When the diagnostic unit or the third-party adapter is removed and the bus is idle, the message no longer appears.

Check whether a third-party adapter is being used in the vehicle. In fleet vehicles specifically it is normal for a third-party adapter to be installed (e.g. insurance requirements, fleet management, etc.) If a third-party adapter is being used in the vehicle, explain the reason for the message to the customer.

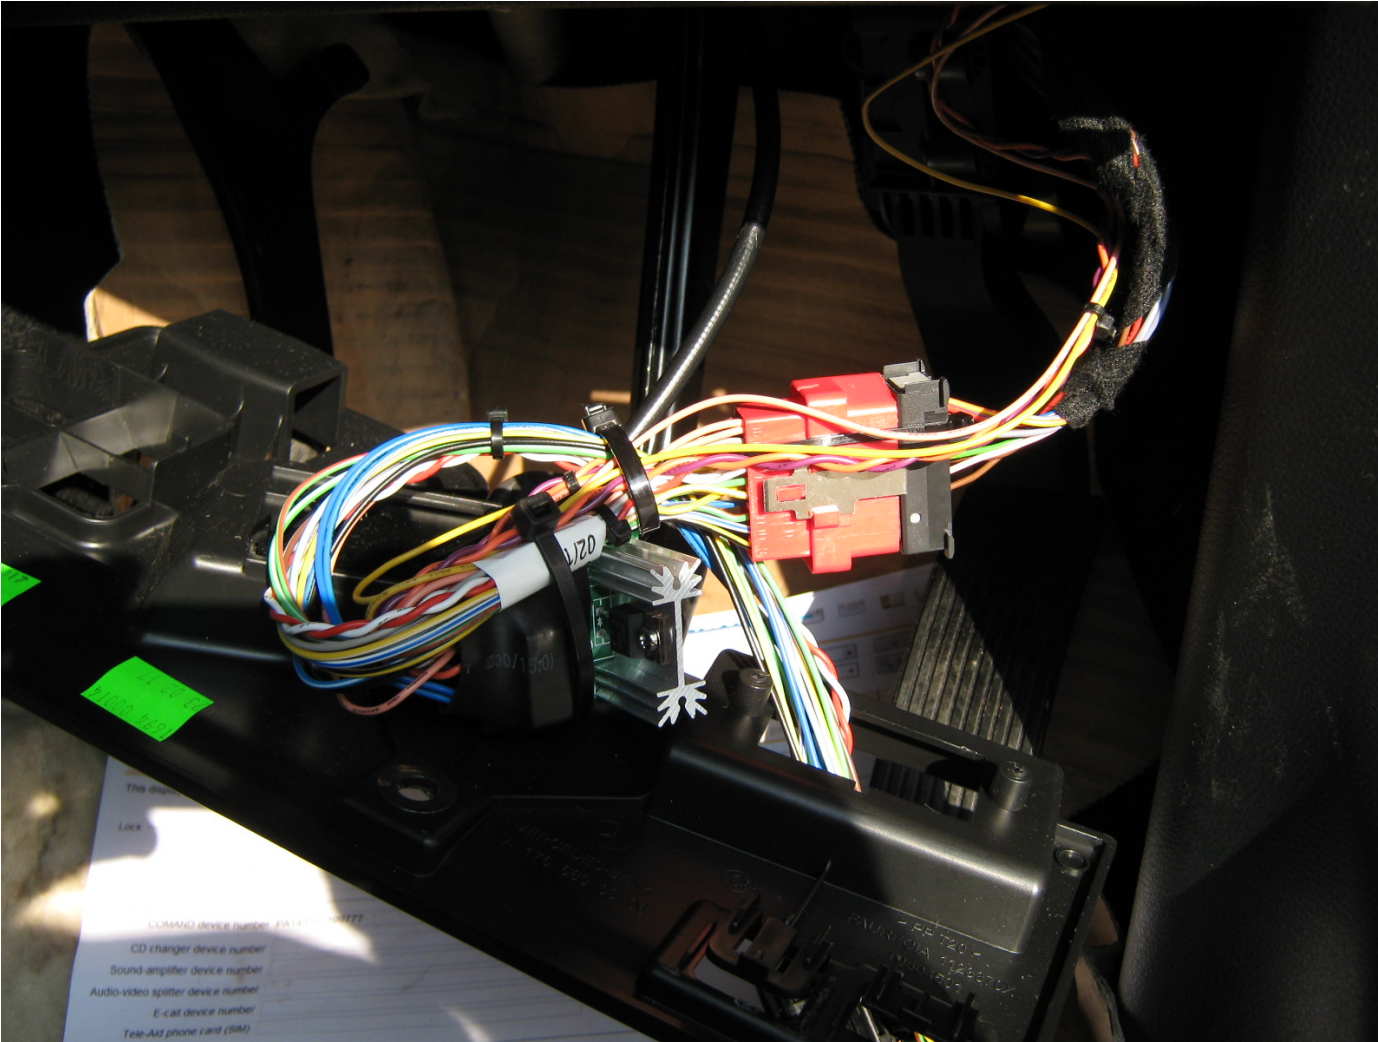
picture_adapter

NOTE: In some cases, third-party adapters may also be connected in series with the OBD socket behind the paneling (see picture in attachment). In seldom instances a third-party hardware is detected, although none is installed in the vehicle. There is no impairment to the vehicle function with one-time detection. In this case, the message is no longer shown after bus idle (ignition off, vehicle locked for approx. 30 minutes).

Picture: Third-party adapter installed behind paneling
Picture: Third-party adapter installed behind paneling.
