2018 Mercedes Benz E63S AMG 4MATIC Sed (213.089) V8-4.0L Turbo (177.980)

## REPLACE BOTH SEATBACK MEMBERS ON LEFT AND RIGHT FRONT SEAT

Campaign No. 2018060001, June 2018

SUBJECT: **Models 205 & 213 Model Year 2018**  
**Replace both seatback members on left and right front seat**

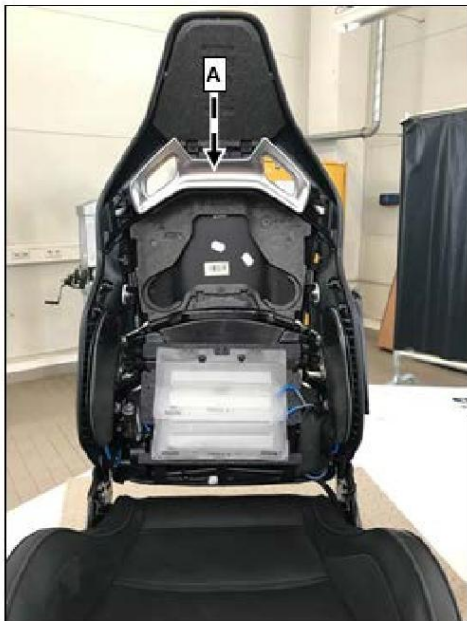
Figure 1

**i** Do not remove cover (A) (figure 1).

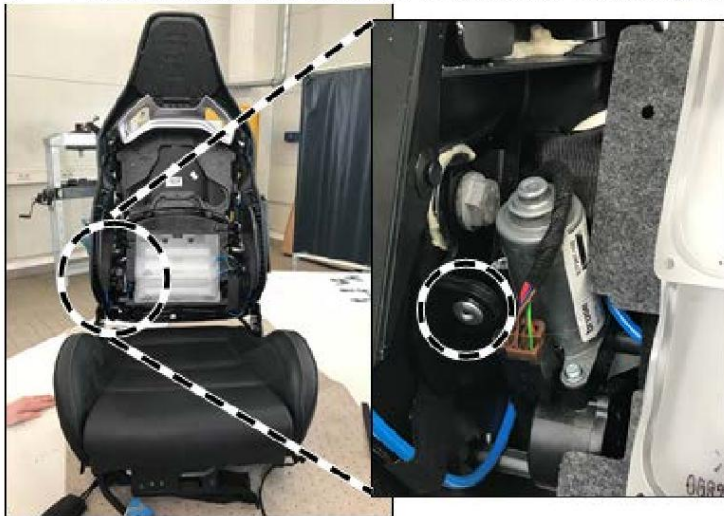
Figure 2

4. Remove the blind rivet on the holder of the motor for the seatback adjustment (**figure 2**).

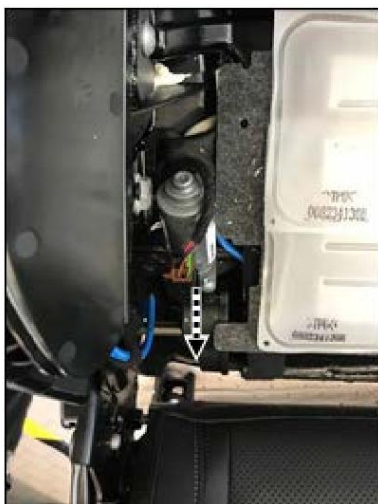
Figure 3

5. Press the motor for the seatback adjustment forwards (**figure 3**).
6. Remove the screw for the transmission shaft on the left side (**figure 4**).

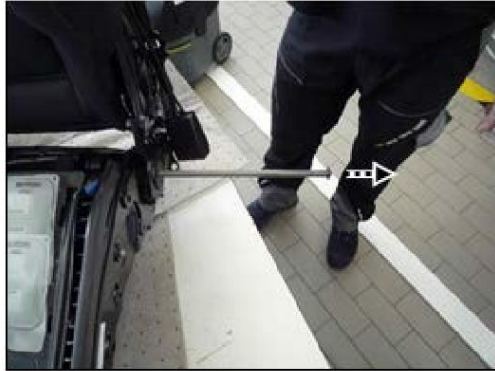
Figure 5

7. Remove the transmission shaft (**figure 5**).
8. Disconnect and remove the motor for the seatback adjustment (**figure 6**).

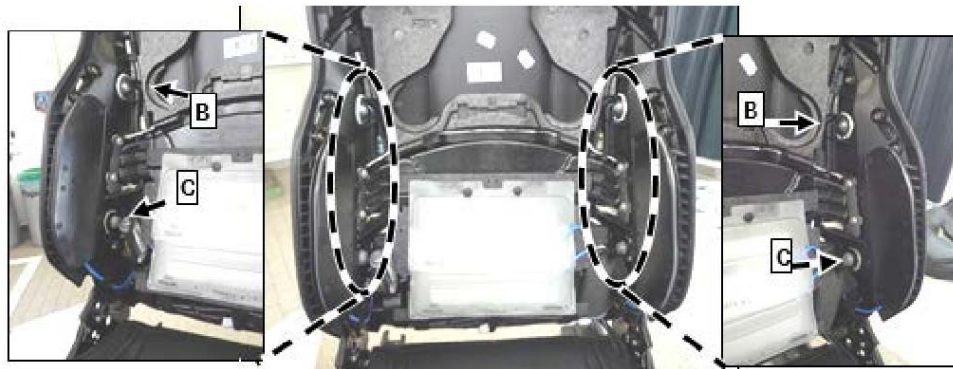
Figure 7

9. Remove the threaded connection of the seatback member (**figure 7**).

A Torx screw (**B**)(**figure 7**) is on the top.
-

A hexagon head bolt (**C**) (**figure 7**) is on the bottom.

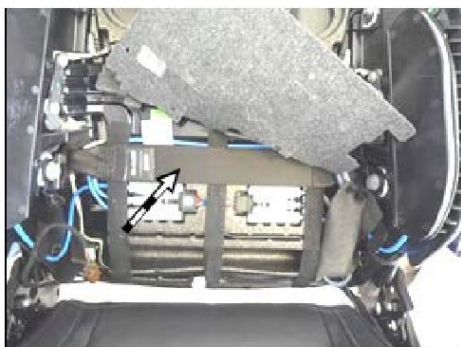
- i** Remove the seat belt strap with the lower screws of the seatback member (**figure 8**).

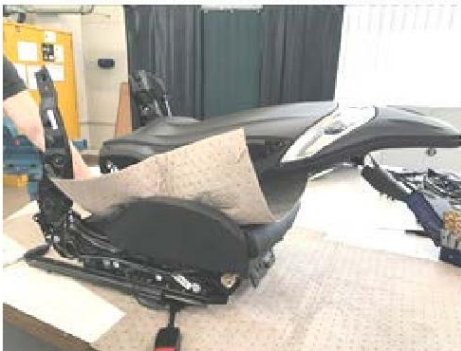
**Figure 8****10. Place the seatback shell on the covered seat shell (**figure 9**).**

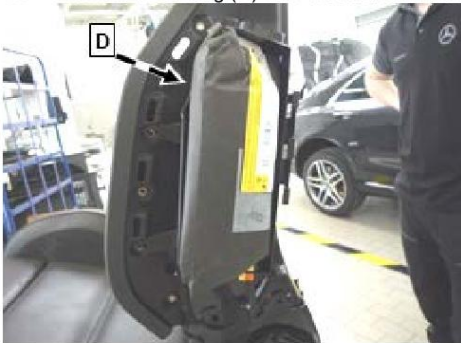
**Figure 10**

**Figure 9****11. Remove the airbag (D) from the seatback member (**figure 10**).**

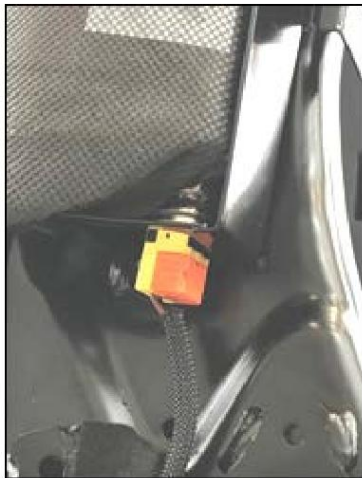
**Figure 11**

11.1. Disconnect the airbag (figure 11).

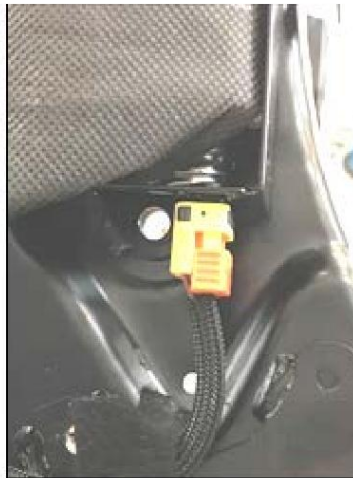
**Figure 12**

Lock downwards (figure 12).

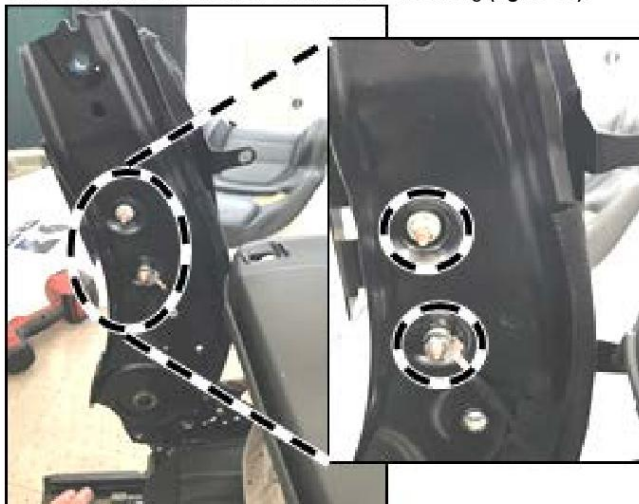
**Figure 13**

11.2. Remove the threaded connection of the airbag (figure 13).

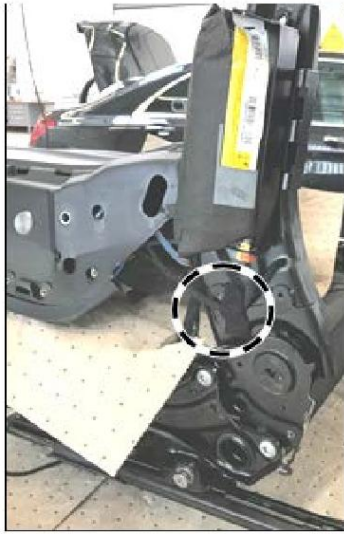
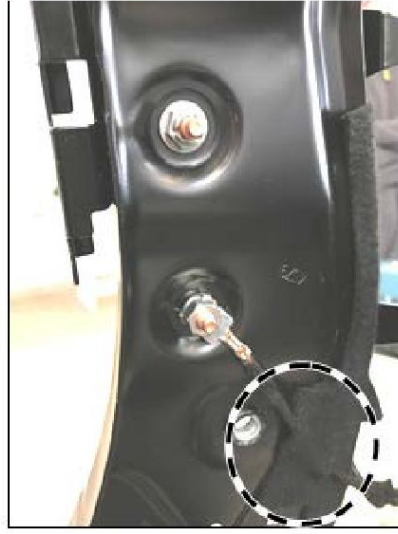
11.3. Remove the adhesive felt strips of the airbag wiring (figures 14 and 15).

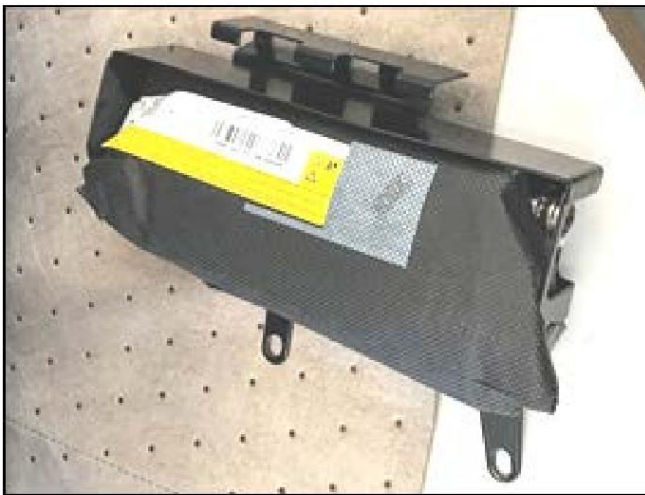
Figure 16

11.4. Remove the airbag with the holder from the seatback member (figure 16).

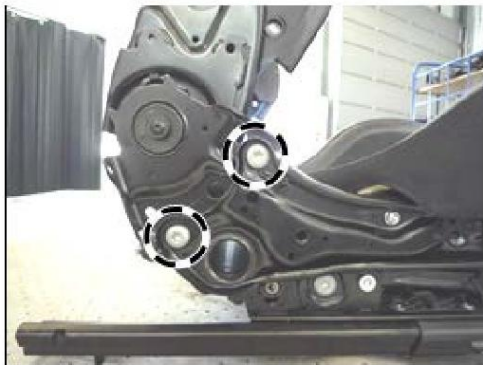
Figure 17

12. Remove the lower threaded connection of the seatback member (**figure 17**).

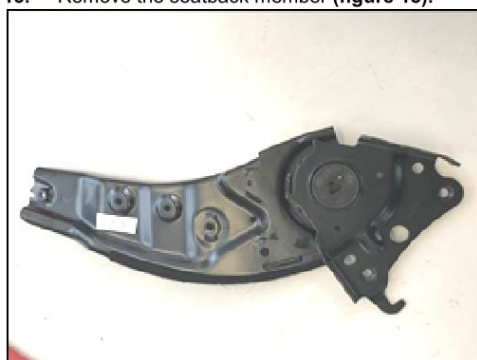
Figure 18

13. Remove the seatback member (**figure 18**).

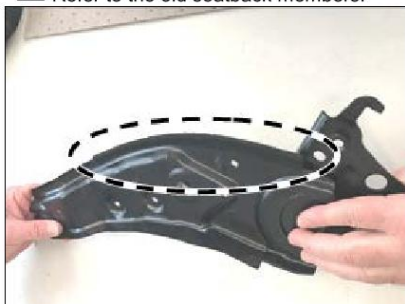
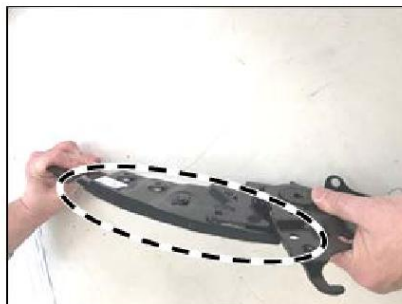
**Figure 19**

14. Apply the felt strips to the new seatback member (**on the side of the door**) (**figures 19 and 20**).

**i** Refer to the old seatback members.

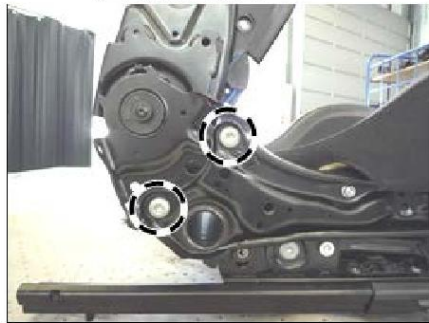
**Figure 21**

15. Install the lower threaded connection of the seatback member (**figure 21**).

Sequence of the installation of the threaded connection: front – rear.

40 Nm  $\pm$  5 Nm

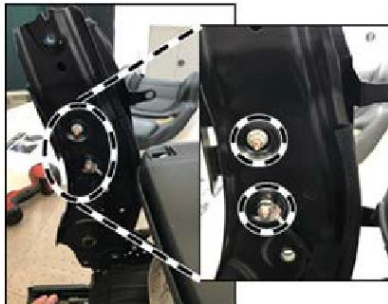
**Figure 22**

17.1. Position the airbag on the seatback member (**figure 22**).

Install the ground line with the bottom nut.

6 Nm  $\pm$  1 Nm

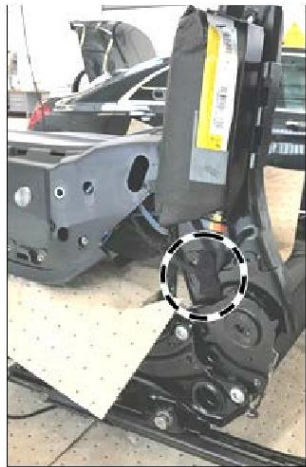
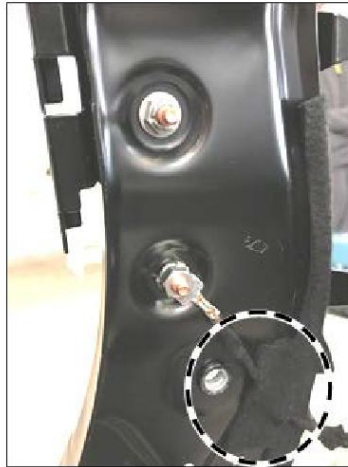
**16.5.** Apply the felt strips for the wiring and position on seatback member (**figures 23 and 24**).

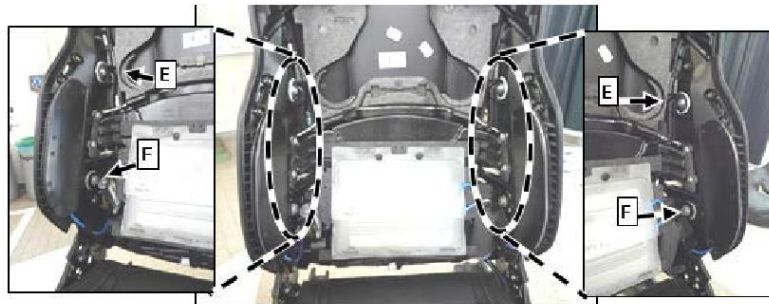
**Figure 25**

**17.1.** Fix seatback shell in place on seatback members at the bottom threaded connection point (**F**) (**figure 25**).

**17.2.** Install top threaded connection (**E**) by hand (**figure 25**).

**24 Nm  $\pm$  2.5 Nm.**

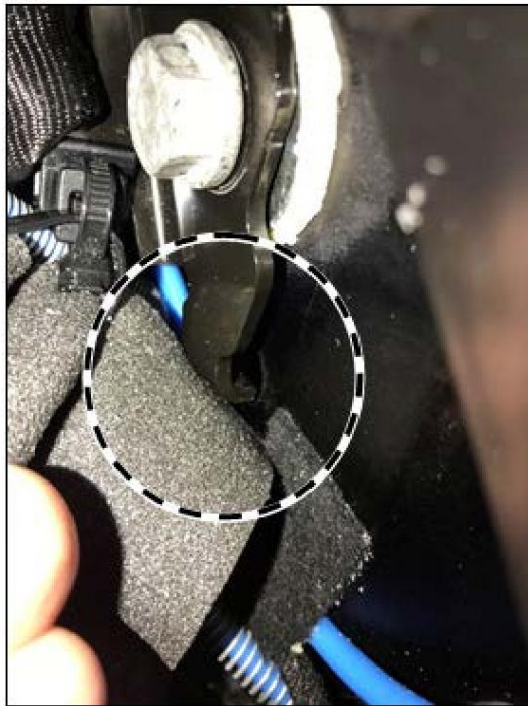
**Figure 26**

- 17.4. Align the seat belt strap on the bottom threaded connection point (**figure 26**).

Insert the nose of the seat belt strap into the backrest shell bore.

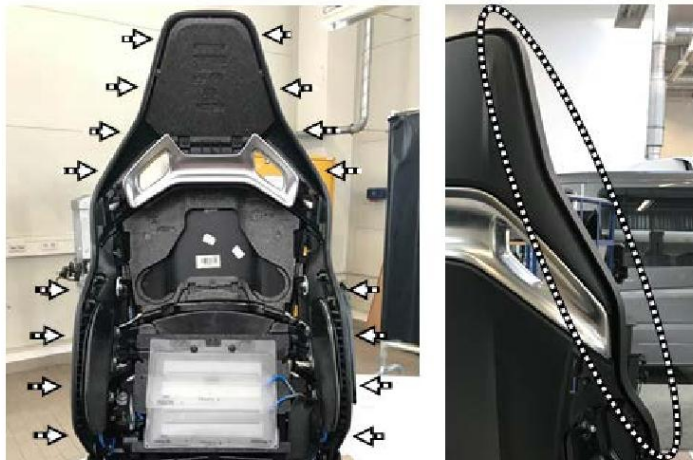
- Figure 27

Replace the expanding clips as required.
- 19.1. Position the expanding clips in the groove of the seatback shell (**figures 27 and 28**).

Position of the expanding clips in the groove shown in (**figure 27**).

The section with the groove of the seatback shell is shown in (**figure 28**).
