## Water Ingress at A-pillar

Topic number	LI77.00-P-063165
Version	2
Function group	77.00 - General
Date	2/1/23
Validity	All model series with sliding roof
Reason for change	Update of repair instructions

# Repair of sliding sunroof water drain hose

# Repair of sliding roof water drain hose generally applicable for all model series

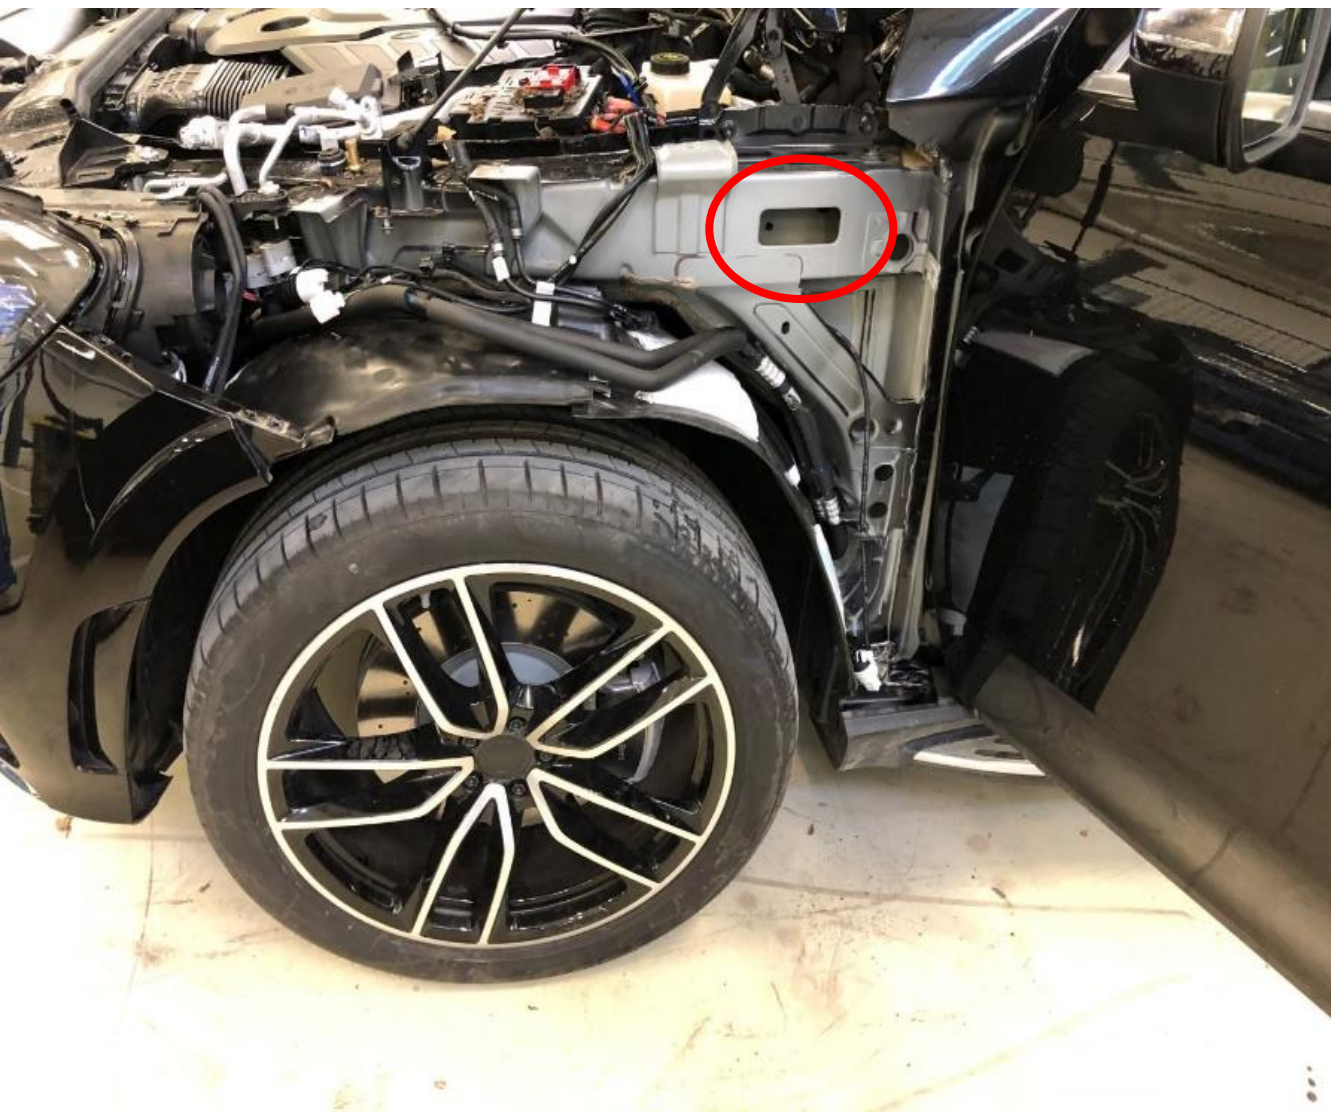
## Example illustration for model series 167

The water drain hose is foamed-in to the longitudinal member

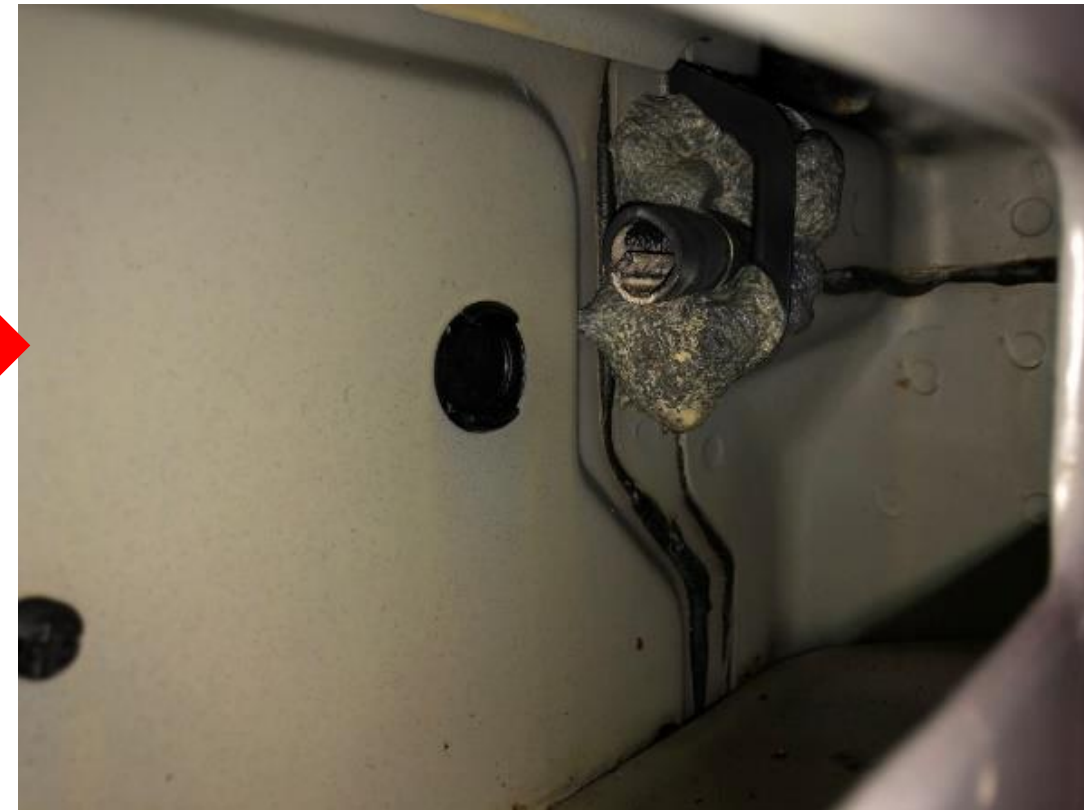
Disassemble front fender on side with damage, and the cockpit, then - depending on the condition of the body - dismantle the roof lining too.

- Disassemble front fender on side with damage, and the cockpit, then - depending on the condition of the body - dismantle the roof lining too.
- Slide the prepared wire pull through the damaged hose (thin welding wire, 0.9 mm thick). Secure the wire at top and bottom against being pulled out.

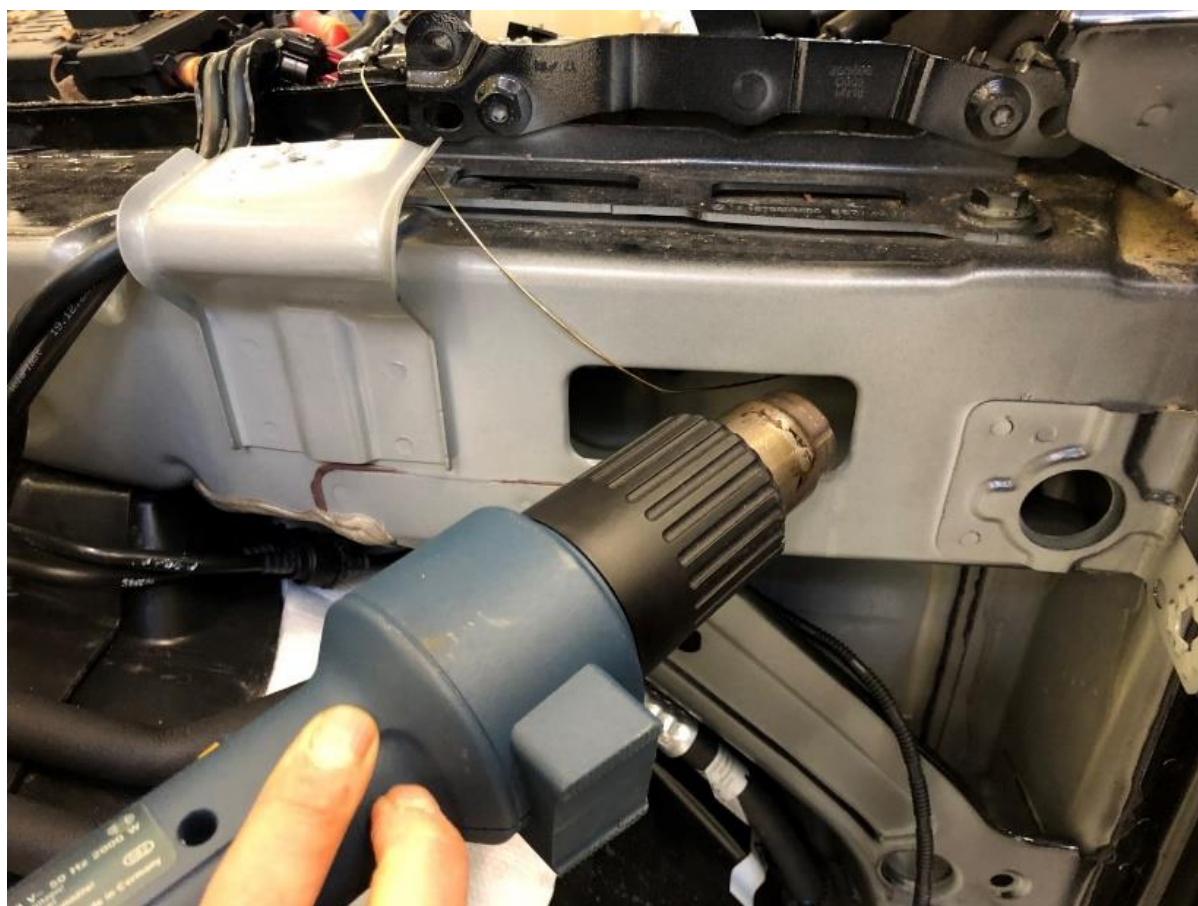
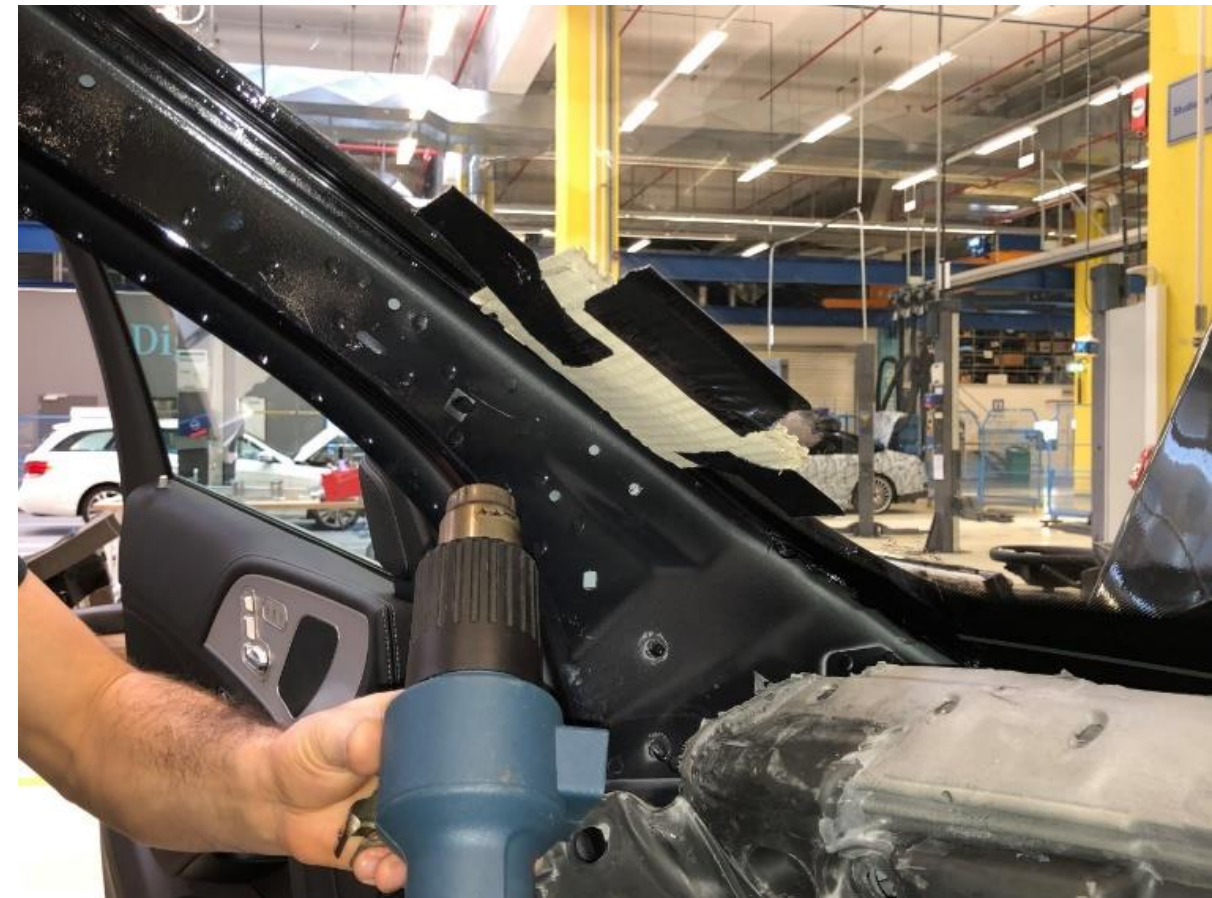
## Example illustration for model series 167

Use a heat gun to heat up the sliding roof hose at all the foam pieces (**max. 120° C**), this makes it easier to disassemble (**make sure that the paint or bodyshell adhesive are not burnt**)

- To make it easier to release the omega clips fastened to the hose, they can be heated up.
- Use a heat gun to heat up the sliding roof hose at all the foam pieces (**max. 120° C**), this makes it easier to disassemble (**make sure that the paint or bodysell adhesive are not burnt**)

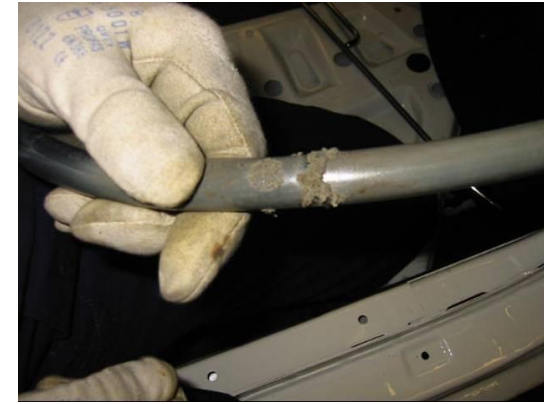
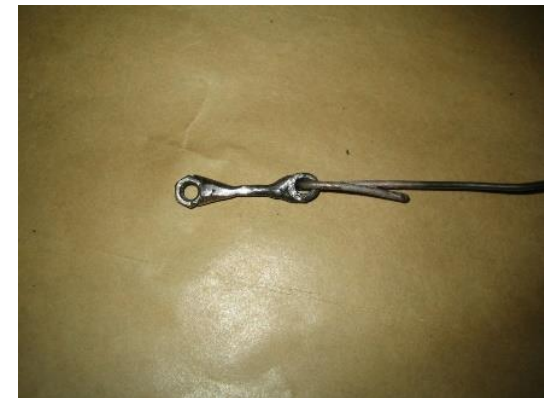
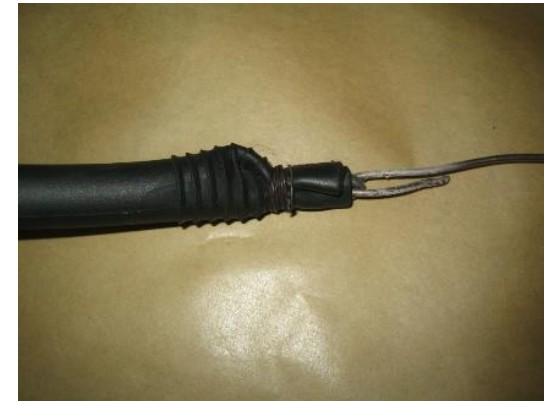
- Pull the new piece of wire, which must have an attachment point at its end, from top to bottom.
- Fasten the new hose onto the threaded pin using thin binding wire and wrap tape around it so that it does not get caught up when being pulled in.
- Coat the wire with soapy water when pulling in.
- Use the wire pull to pull the hose into the A-pillar from top to bottom.
- Use an endoscope to make sure that the hose does not have any blockages or kinks in it.
- Once the hose exits at the designated opening on the A-pillar, the tape, binding wire and wire pull must be removed again.
- Mount front fender and cockpit again.
- Check and acceptance to be conducted by supervisory personnel.
- Then run a water test to check that the connections are watertight.
