2018 Mercedes Benz E63S AMG 4MATIC Sed (213.089) V8-4.0L Turbo (177.980)

## HOLD DETENT FOR FRONT DOOR HINGES

<b>Topic number</b>	LI72.10-P-068218
<b>Version</b>	2
<b>Function group</b>	72.10 Front door
<b>Date</b>	07-20-2020
<b>Validity</b>	BR213.0/.1/.2 as of 04.2016 up to and including 02.2020 BR257 as of SOP up to and including 02.2020 BR290 as of SOP up to and including 02.2020
<b>Reason for change</b>	Validity revised with new time range and addition of BR257 and BR290

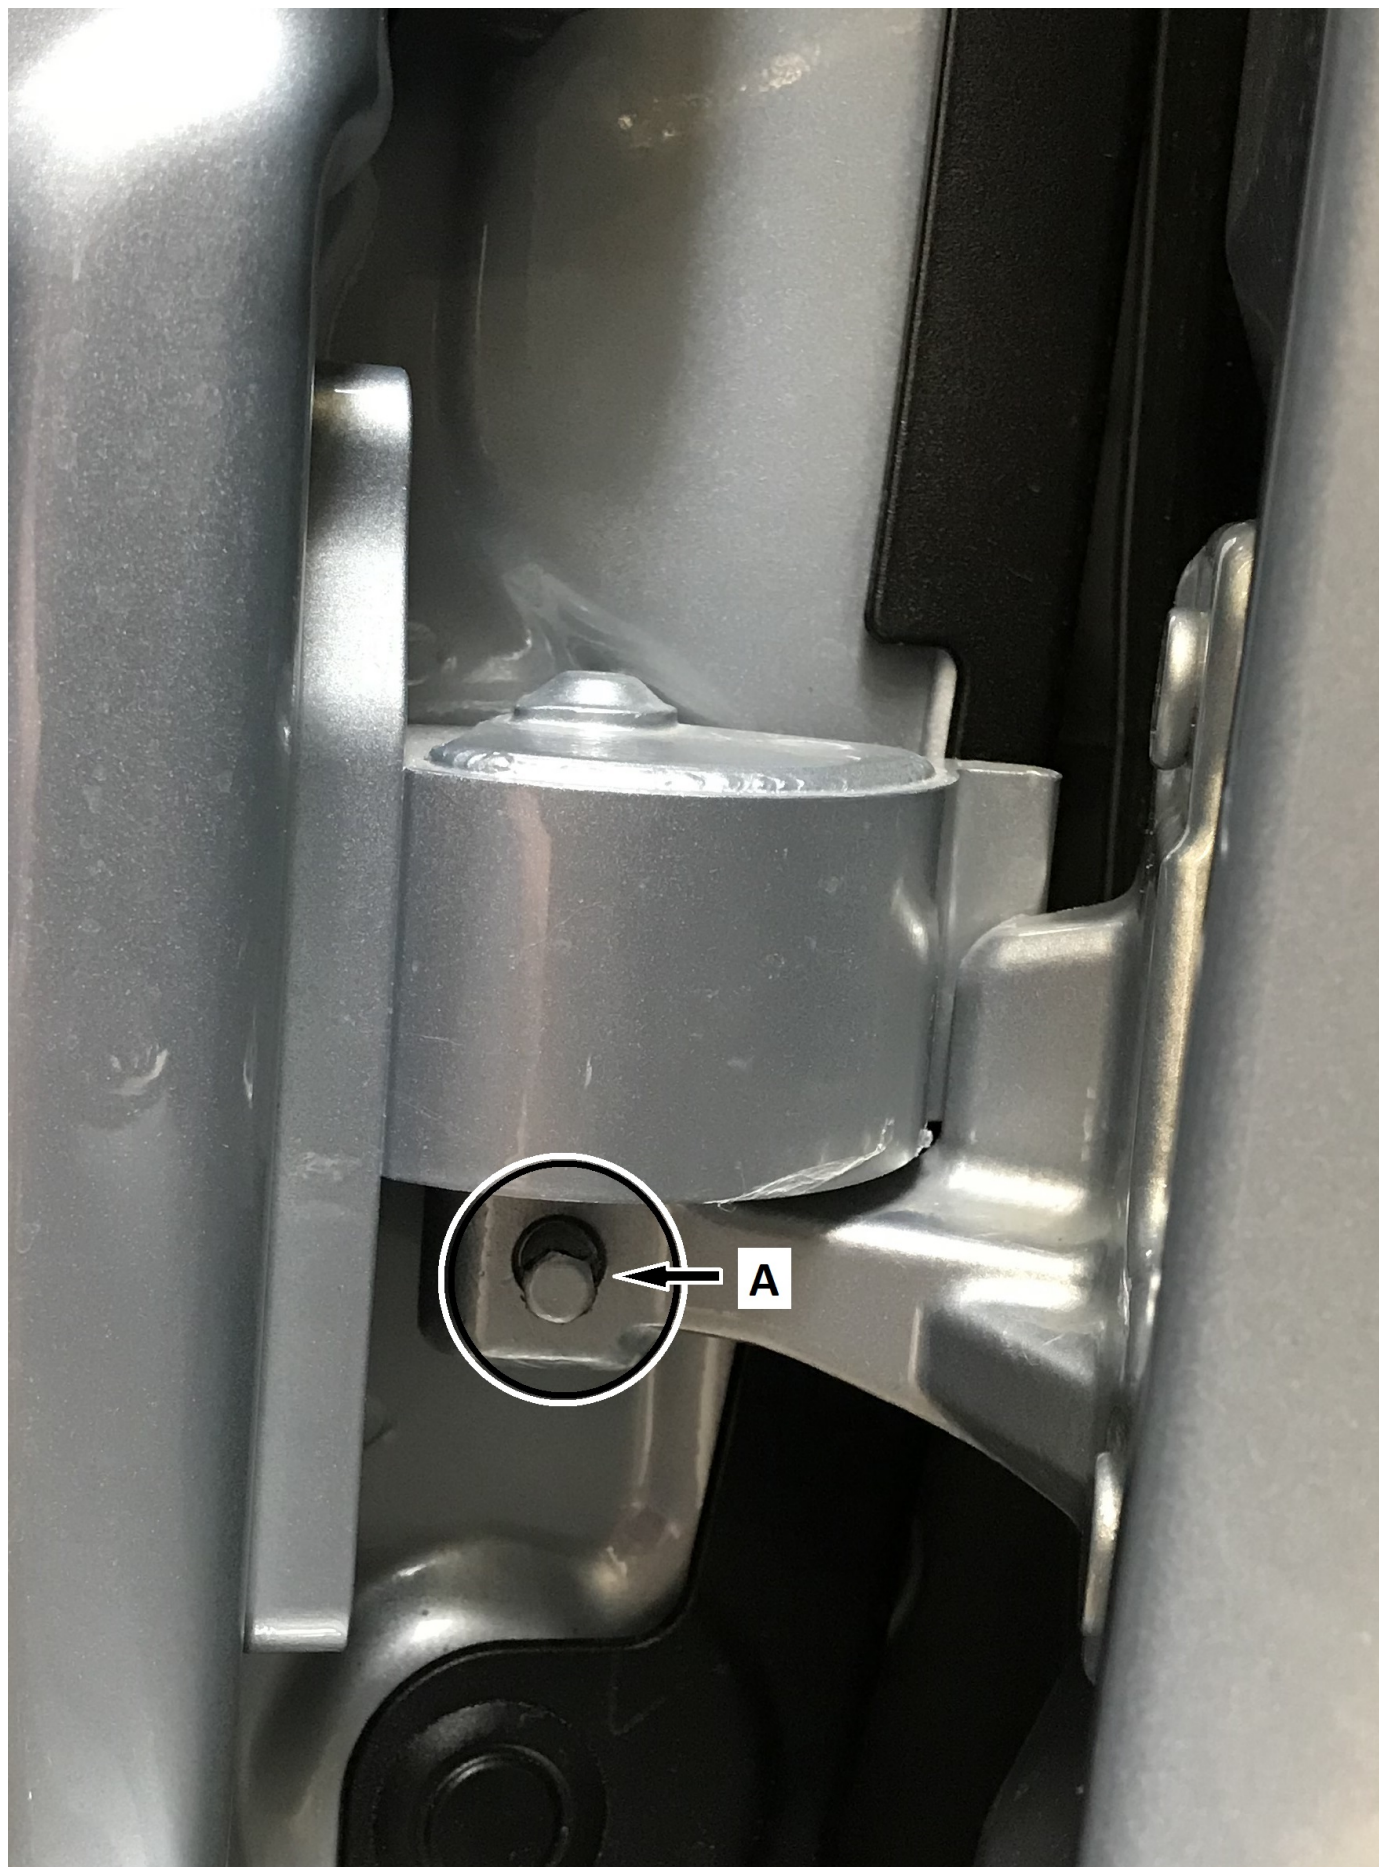
Abbildung 1

Grub screw

1. Open front door and unscrew grub screw (A, picture 1, 20 Nm) by three turns.
2. Mark installation position of lower front door hinge leaf. (Picture 2)
3. Unscrew both screws (34 Nm) on door side and remove lower front door hinge leaf (picture 3). Note: Before unscrewing the two screws, support the front door in the open position. (Picture 4)
4. Paint new lower front door hinge leaf (picture 5) in vehicle color.
5. Assemble in the reverse order. Align door and hinge leaf with the markings applied. Check gap dimensions at front door and readjust if necessary.
6. Remove markings applied and apply preservation agent to lower front door hinge leaf (contact area with door).

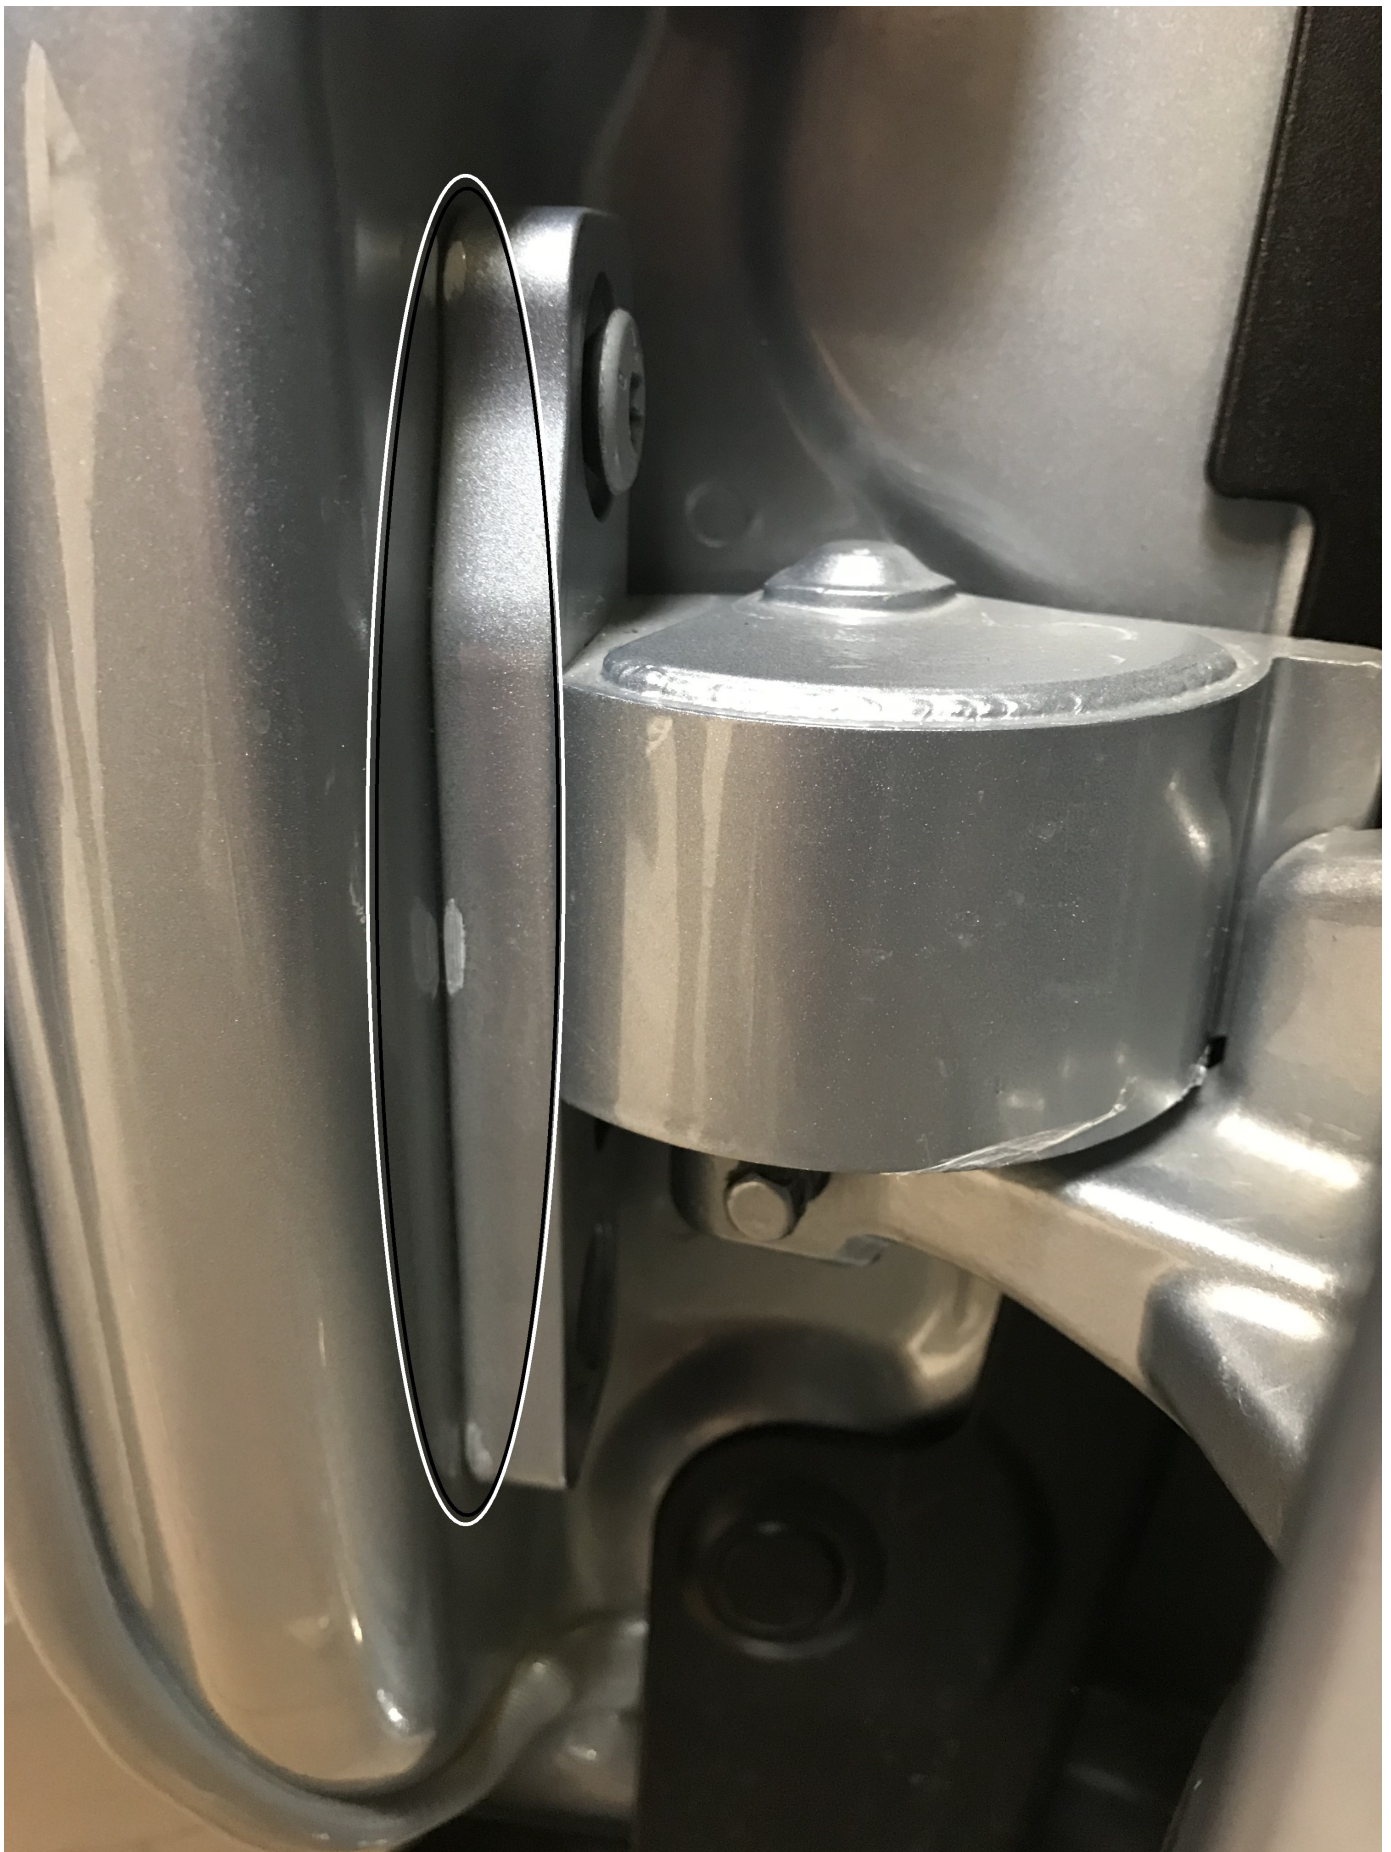
Abbildung 2

Mark installation position of lower front door hinge leaf

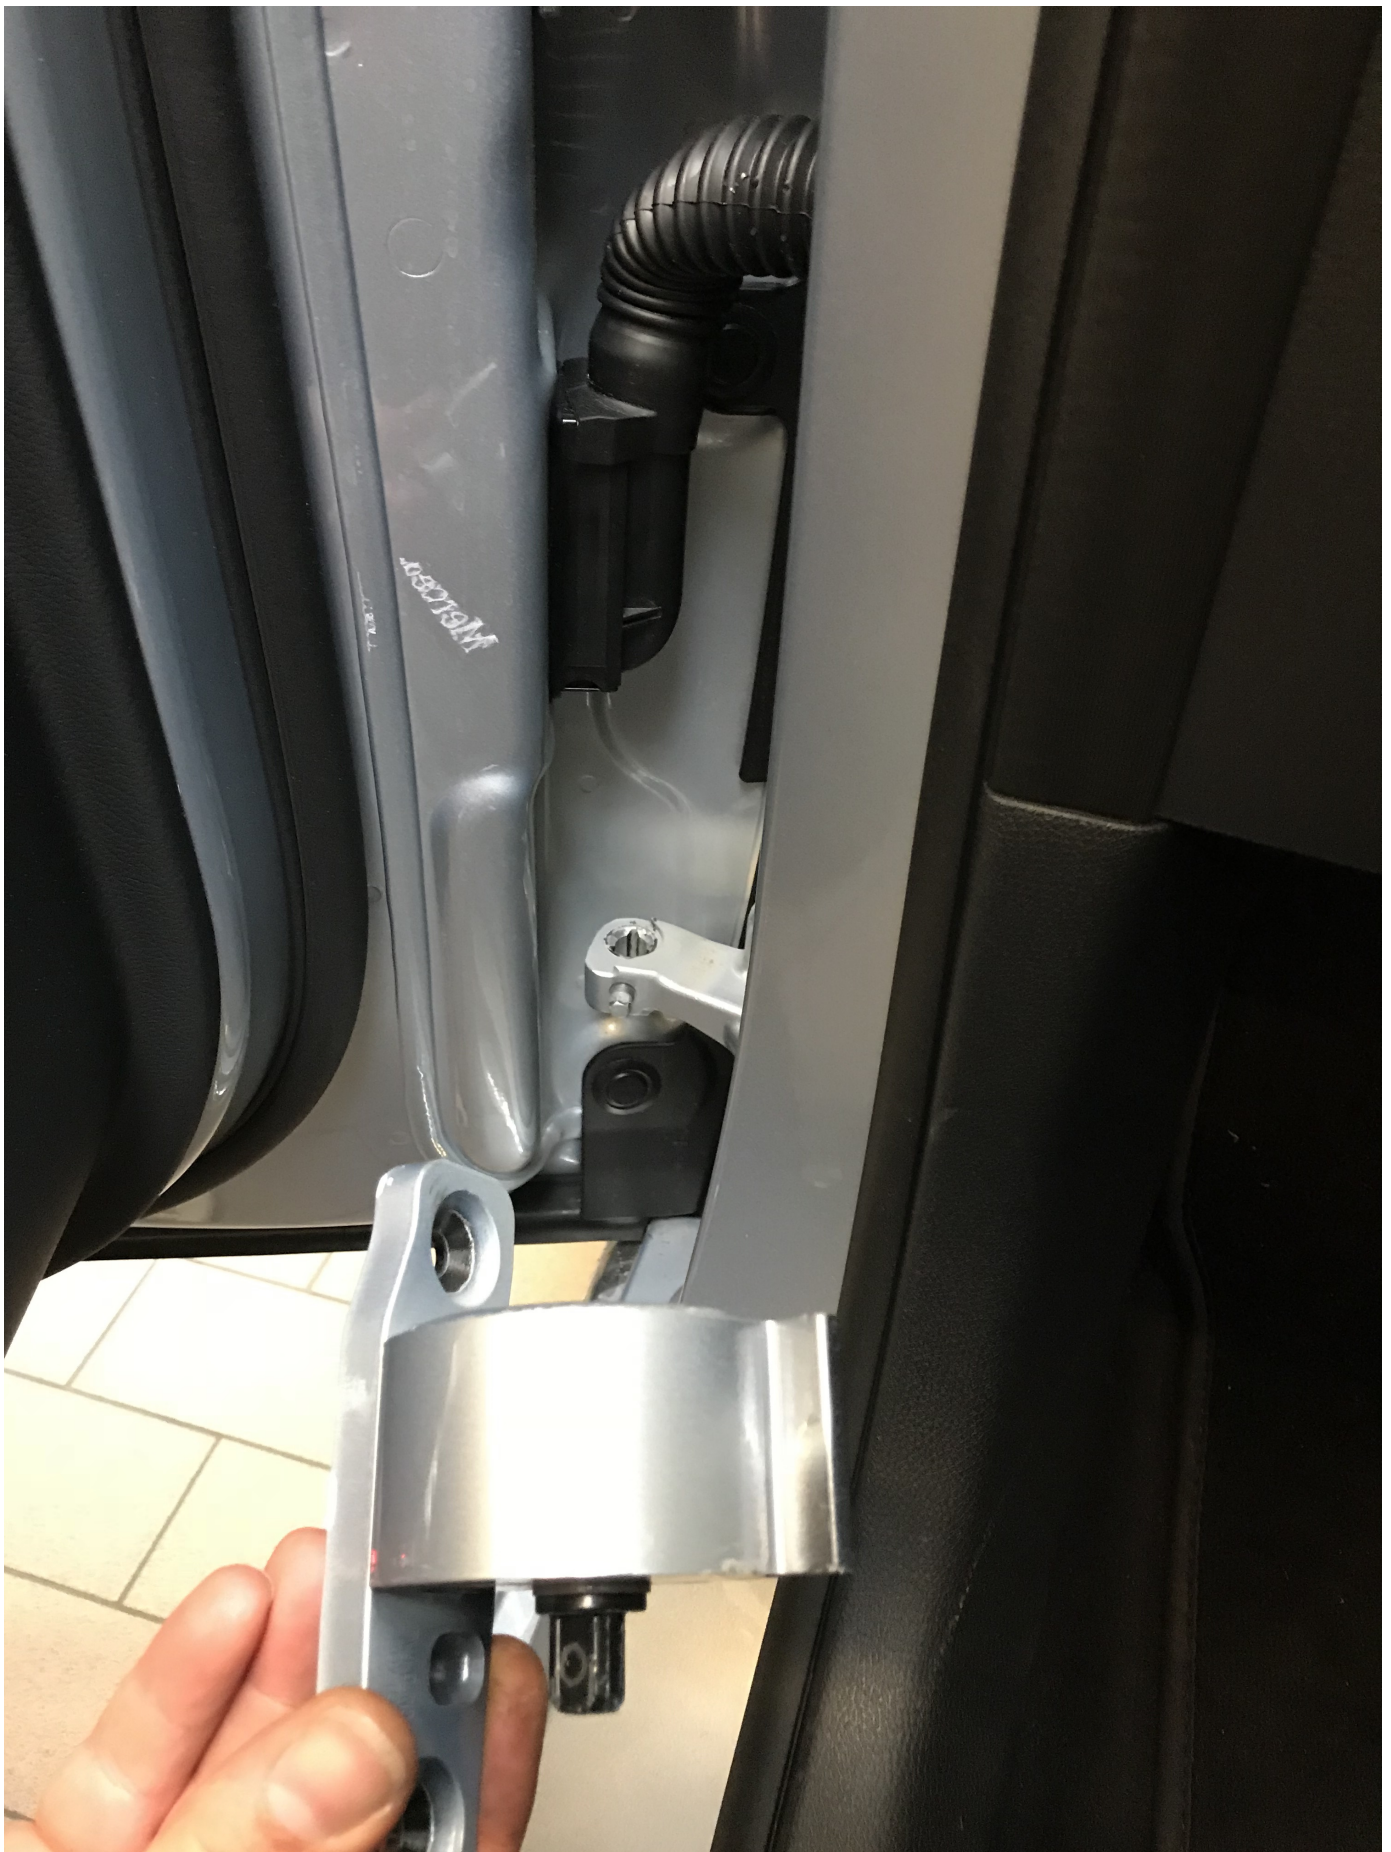
Abbildung 3

Remove lower front door hinge leaf

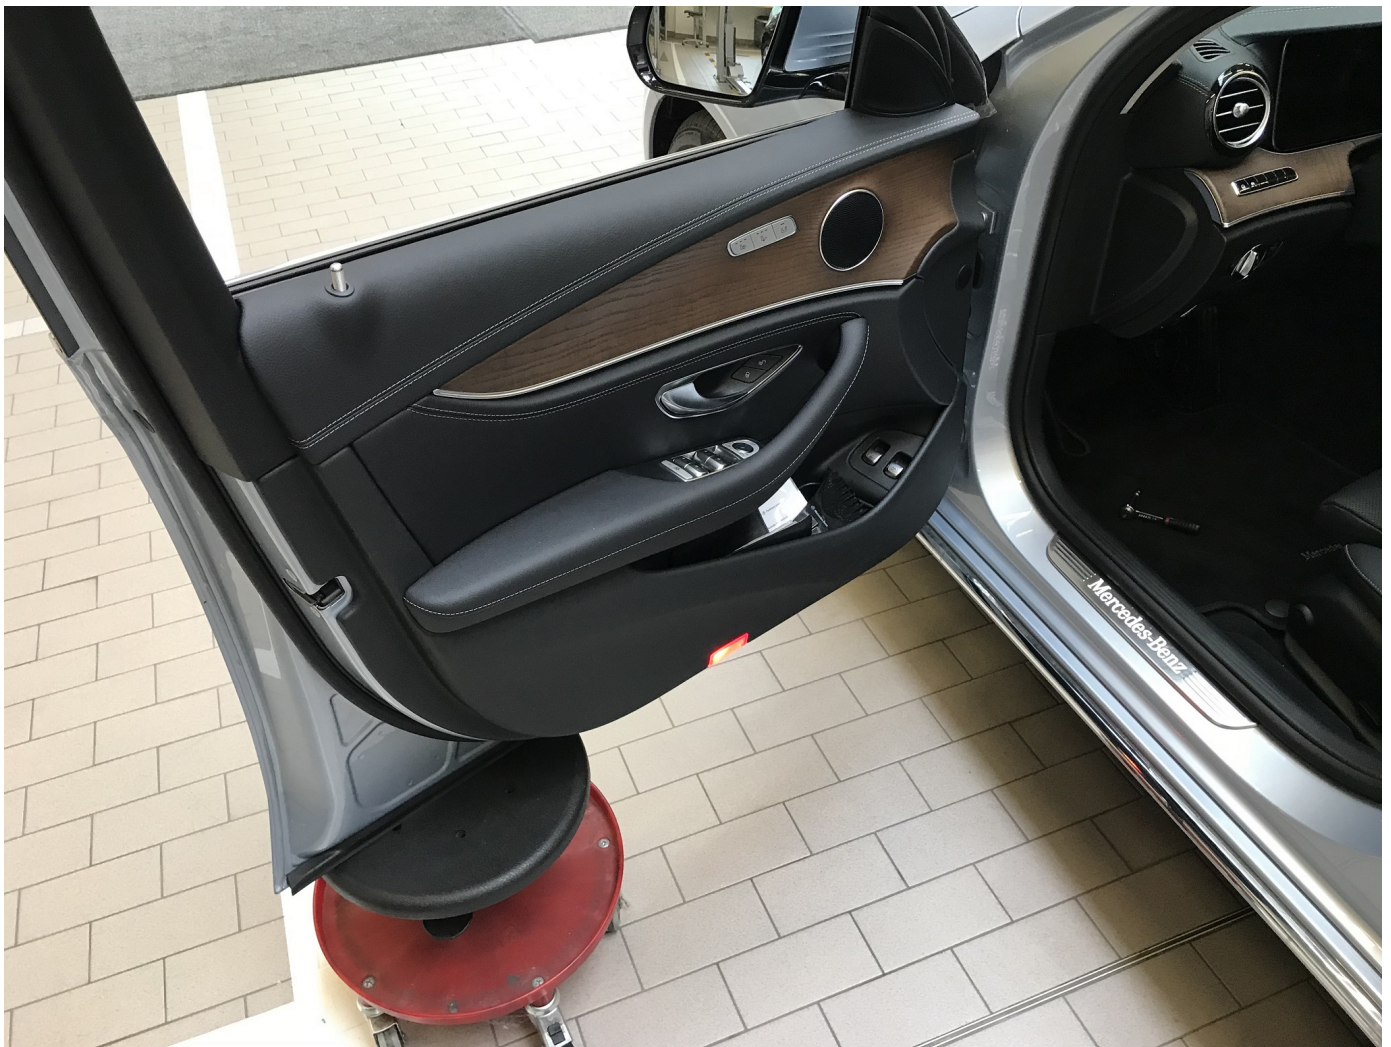
Abbildung 4

Support front door in open position

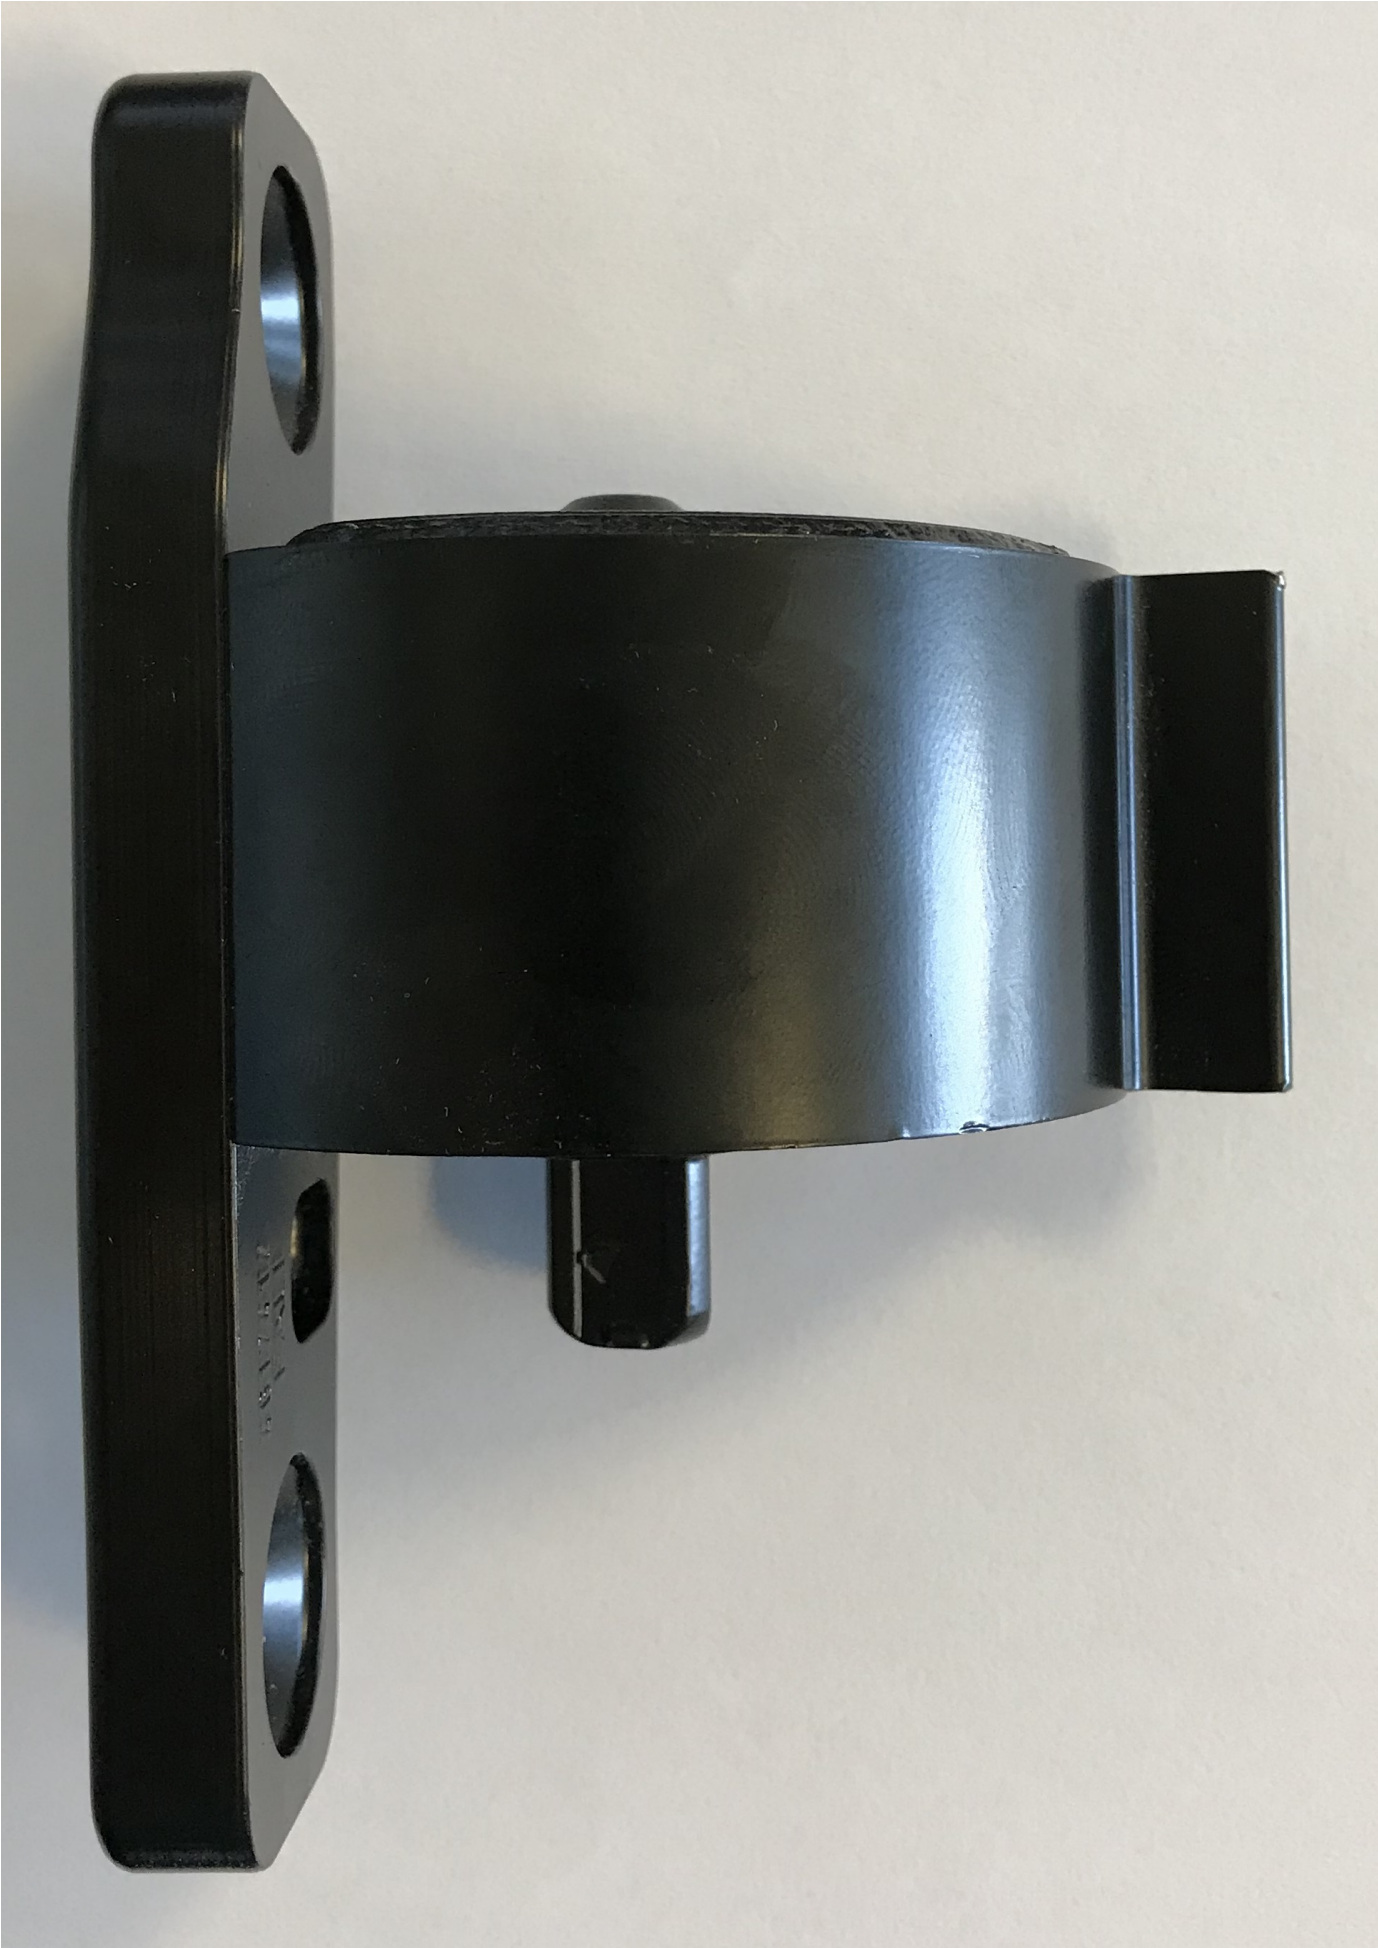
Abbildung 5

New lower front door hinge leaf
